徳島県那賀町白石地すべり地区の蛇紋岩のせん断挙動について On the shear behavior of serpentinite from Shiraishi landslide area, Naka, Tokushima Prefecture

○ 王 功輝・末峯 章・佐々恭二
○ Gonghui Wang, Akira Suemine, Kyoji Sassa

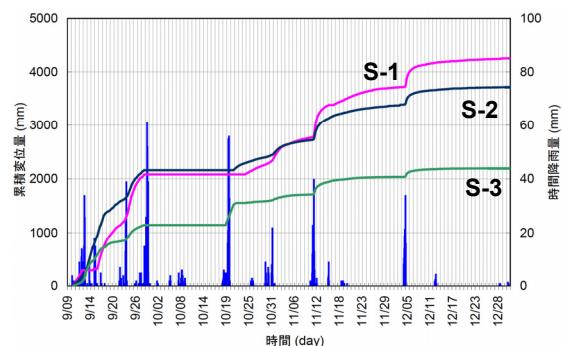
白石地区のフロン谷では、斜面上部において発生した地すべりが土石流化し、斜面下部で住宅が十数戸を全壊或いは半壊させた。しかしながら、住民が起きた前兆現象を見つけて、自主避難したため、人的被害は出なかった。この災害により斜面上部に形成された地すべり土塊が顕著な変動を示し、2005年3月まで避難勧告が出されていた。2004年9月から12月中旬までの観測結果(図-1)に示すように、この地すべり土塊が無降雨時に0.5-1 mm/h、豪雨時に2-25 mm/hの変位速度で移動していた。通常、变成岩地域における地すべりの移動量はあまり多くないが、この地域では4mを越える移動量が観測された。しかしながら、崩壊には至らなかった。この現象を解明するために、地すべり地の外(試料①)、地すべり移動土塊内部(試料②)とすべり面(試料③)から採取した試料(風化した蛇紋岩)に対して、リングせん断試験を用いてせん断試験を行った。

図-1 白石地すべり地での伸縮計と雨量計の観測結果

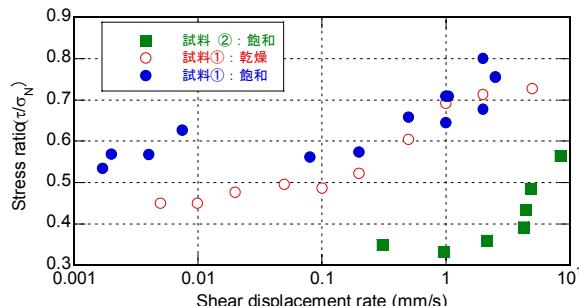
地すべり地から採取した蛇紋岩(試料②)の摩擦角度が小さく、20°程度である。また、三つの試料に対して、その残留強度がせん断速度に依存することが確認できた。せん断速度が増大すると、せん断抵抗が大きくなる。異なるせん断速度で求められたせん断抵抗は試料①が全体として大きい。しかし、何れの試料に対しても、せん断速度による応力比の変化範囲は約0.3である(図-2)。

(3) 地すべり粘土のせん断抵抗がせん断速度の増大に伴って大きくなることは白石地すべりが数メタの変動が発生したにもかかわらず崩壊に至らなかつた原因として考えられる。

図-2 蛇紋岩に対するせん断速度と残留強度の関係
