丹波帯山地斜面で 2007 年 11 月 22 日に起きた落石の復元
Restoration of the 22 November 2007 rock fall at a slope in the Tanba Zone, Japan

○諏訪 浩・石井孝行

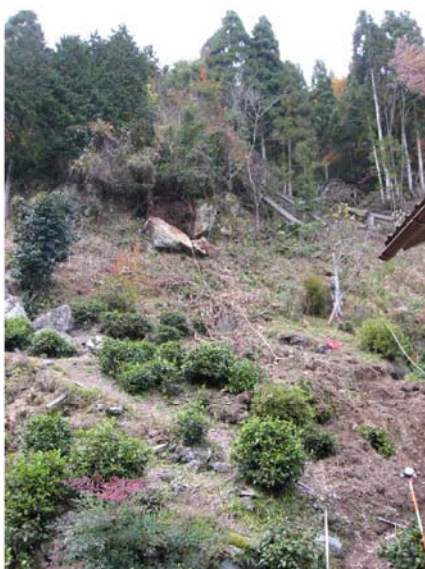
2007 年 11 月 22 日 午前 4 時 5 分頃、京都府南丹市美山で落石があり、住宅が半壊した。現地を調査して、以下の点を明らかにした。1) 体積 13m^3 余りの岩塊が傾斜 30° の斜面を斜距離 21m 落下して麓の住宅にめり込んで停止した（下図）。開始点と停止点を結び、これをエネルギー線と見なして運動速度を推定した。見かけの動摩擦係数は 0.6 である。岩塊が転動落下する場合には、斜面に沿う方向の速度の平均は 2.8m/s 、並進運動のみだと 3.5m/s となる。2) 斜面の陥没痕跡を詳しく調べると下図のようになる。岩塊がジャンプして陥没痕を残したと仮定すると、 7.7m/s 程度の射出速度を要する地点が生じる。これは上述の推定値より大きい。ジャンプよりも転動形式を主とし

落石が起きた斜面の様子

た運動であったとも考えられる。3) 尾根部に丹波帯のチャートが岩塔のように露出し、節理が発達している。とくに走行傾斜が斜面のそれに近い節理と、岩体を鉛直に切る節理があり、これらが共に開口亀裂となり、剥離型落石を生じさせた。4) 問題の岩塊背後の亀裂は、開口幅が 0.5m にも達し、開口部は崖錐材料で充填され、根系が密に侵入してスポンジ状の層が形成されていた。根系肥大による側方圧や土中水分凍結による膨張圧、岩体温度の日周・年周変化による変位蓄積などにより、岩塊のせり出しが進行したものと推定される。5) 付近には同様な岩塔状の地形と剥離岩塊が存在する。不安定な岩塊を調査・抽出し、対策を講じる必要がある。
