## 2009年美作市・館林市・土浦市で発生した竜巻による建築物の被害について Tatsumaki Damage to buildings at Mimasaka, Tatebayashi and Tsuchiura in 2009

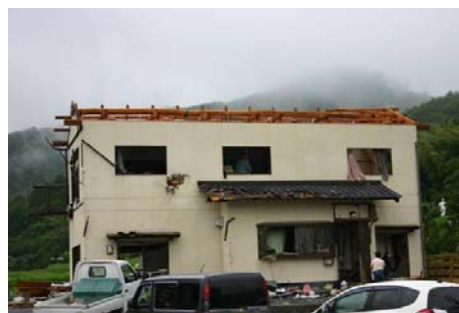
写真1～3はそれぞれ3つの竜巻被害の建築物の主な被害状況である。写真1は切妻屋根が飛ばされた住家の被害で、小屋束の上部と棟木との間にはかすがい等による留め付けの痕跡は認められなかった。写真2は工場の被害で、東側の壁面の仕上げ材と屋根ふき材の剥離（飛散）が著しい。また、屋根ふき材も広範囲に剥離していた。写真3は鉄骨造3階建ての住宅で3階の南側壁面が脱落していた。竜巻はこの住宅の南面に当たったと考えられ、外壁を外側に引張り出す力が作用したと考えられる。外壁は鉄骨の柱梁と床面に取り付けられていたが、竜巻の力に対してほとんどした跡が見られなかった。

写真1 切妻屋根が飛ばされた住宅（美作市）

これらの被害状況は、風荷重に対して屋根や外壁が抵抗した痕跡が見られないものがあつた。屋根みや外壁等の緊結部は、風荷重を意識し、引張り力に対してもある程度抵抗できるような設計が

必要である。

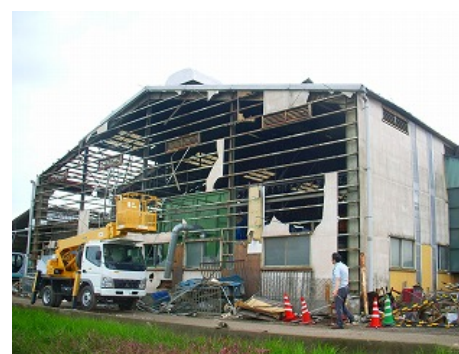
写真2 外壁等が飛ばされた工場（館林市）

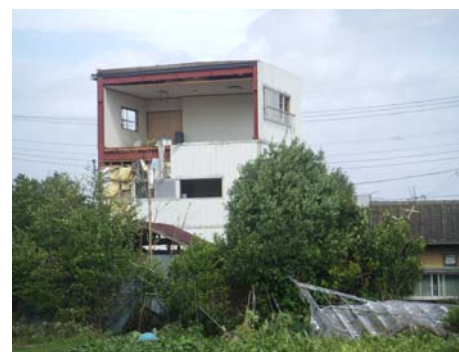
写真3 3階の外壁が脱落した住宅（土浦市）
