2011年長野県北部の地震の震源近傍における高密度の地震動推定と木造建物被害との比較

Estimation of Strong Motion and Building Damage Survey for the 2011 Northern Nagano Earthquake

○山田真澄・山田雅行・福田由惟・スマイス クリスティン・藤野義範・羽田浩二

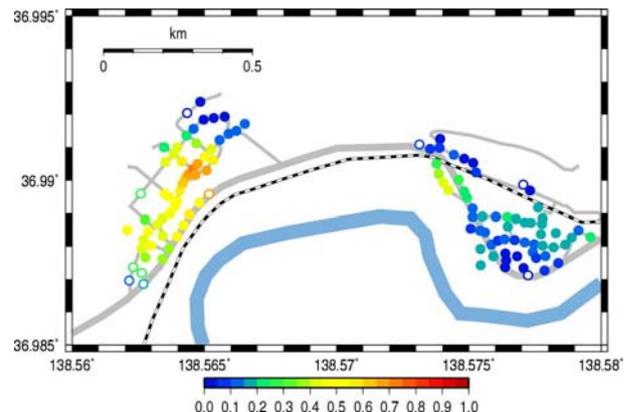
木造住家の全壊率は、長野県栄村の青倉地区と横倉地区で30%を超えており、観測記録の得られている森地区では10%以下であった。また、震源近傍で得られた地震観測記録と常時微動記録から青倉地区と森地区での強震時の地震動を推定した。推定された地震動は、地区の中の細かい地盤条件の変化を反映することができ、その特徴的をとらえた分布を示した。

図1：青倉地区、森の常時微動観測点におけるD4以上の建物被害率。青倉中心部および、森地区の北西部で被害率が高い。白抜きはサンプルが10点未満のため参考地点。
