# 長野県神城断層地震時に発生した長野県小谷村における斜面崩壊とその崩壊機構の検討 Mechanism of Slope Failure in Otari Village During the Kamishiro Fault Earthquake

○Ryoichiro SATAKE, Kazuki TAJIMA, Akihiko WAKAI, Gonghui WANG,  
Naoki WATANABE, Gen FURUYA, Fei CAI

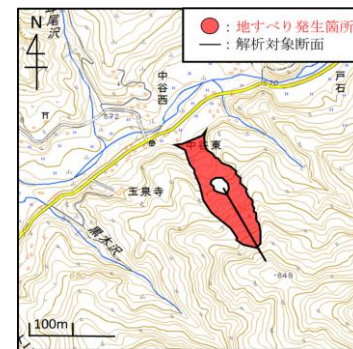
図-1 崩壊発生箇所

解析対象とした小谷村市場一号地区は、本地震の震央である白馬村から北東方向へ約 15km 離れた場所に位置する。同地区は以前から地すべりが多発しており、本地震においても長さ約 760m、幅約 170m の斜面崩壊が発生した。また、崩壊土砂が斜面下部に設置された砂防堰堤にまで到達した。図 1 に解析対象地区における崩壊範囲（国土地理院地図に加筆）を示す。崩壊範囲の中腹部には集水井が設置されており、集水井を避けて崩壊が発生している。また、斜面下部では表層が削り取られていることから、斜面上部において構造的な崩壊が発生したと思われる。本検討では崩壊範囲の上部 200m を解析対象断面（図 1 左 黒線部分）とする。図 3 に解析対象断面の地質区分を示す。この地質区分、及び著者らが現地にて実施した物理探査の結果を用いて、材料定数ならびに有限要素分割を決定していく予定である。

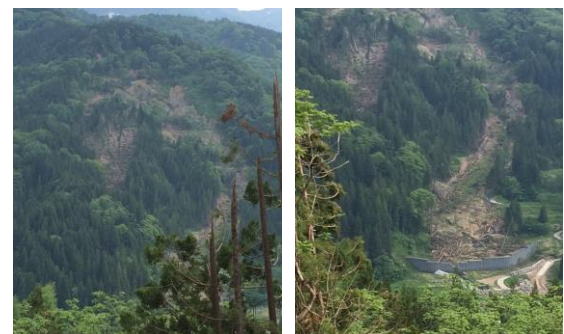
図-2 対岸から撮影した現地写真  
(左：源頭部 右：砂防堰堤付近)
