## Distribution Relationship Between Veins of Groundwater, Slope angles, and Slope Failures at a Landslide in Crystalline Schist Area

Gen FURUYA\*, Kyoji SASSA, Akira SUEMINE

### Synopsis

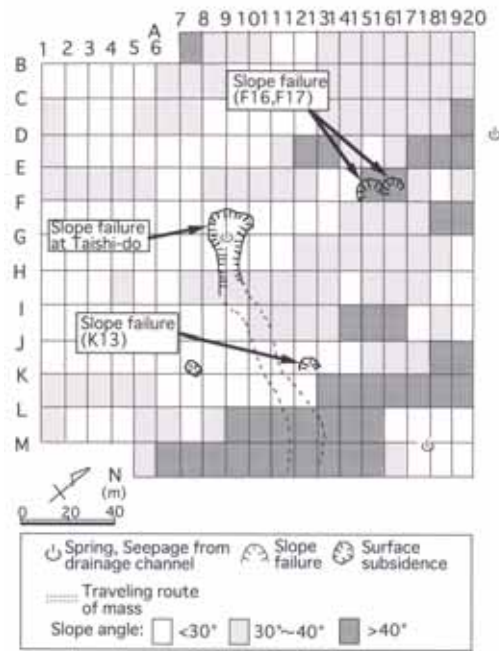
Fig. 5 Distribution of maximum slope angle at the Taishi-do area

Fig.5 shows a distribution of maximum slope angle at the Taishi-do area. In this figure, the slope angle is divided into three categories: less than  $30^\circ$ , more than  $30^\circ$  to less than  $40^\circ$ , and more than  $40^\circ$ . Although the slope greater than  $30^\circ$  distribute almost uniformly across the measurement net, the east part of the measurement net shows a higher concentration. The slopes greater than  $40^\circ$  are distributed mostly at southeast and a part of northeast. The slope failures at F16, F17 and K13 are located in the area of gradients greater than  $40^\circ$ . On the other hand, the slope failure at Taishi-do fall within the category of gentle slopes less than  $30^\circ$ .

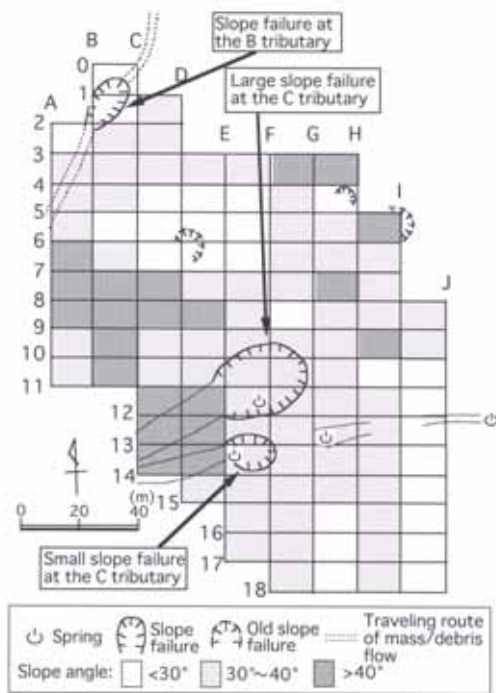
Fig. 6 Distribution of maximum slope angle at the B, C tributaries at Tobinosu torrent

Fig.6 shows a distribution of the maximum slope angle at the area of B, C tributaries in Tobinosu torrent. The classification of slope angles is the same as in Fig.5. In this area, the slopes less than  $30^\circ$  are

concentrated at southeast and northwest. In addition the slopes greater than  $40^\circ$  are distributed at northeast and southwest in the measurement net. These parts are nearby the thin part of surface layer mentioned above. The large and small slope failures locate within the area with slopes greater than  $30^\circ$ . However, the slope failure at the B tributary and old slope failure locate on gentle slope less than  $30^\circ$ , which is the same as the case of the Taishi-do area. Then, we estimate stability of each grid at these areas by using the slope angle in Fig. 5 and Fig. 6 under a formula (1).

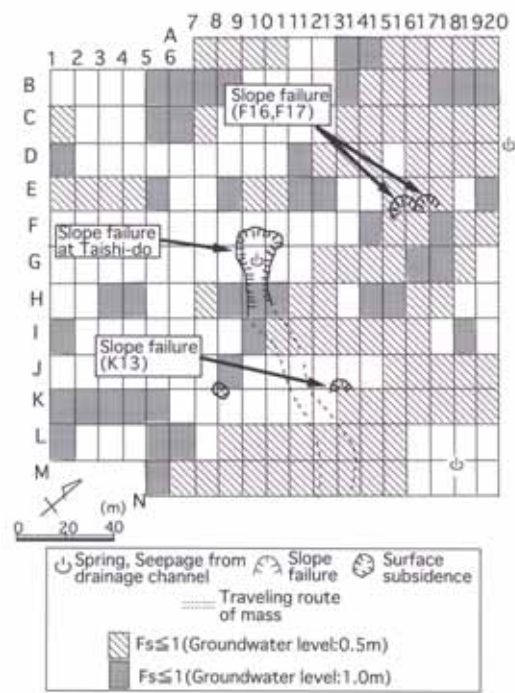
Fig. 7 Distribution of safety factors at the Taishi-do area

Fig. 7 shows the result in the case when pore water pressure value is equivalent to 0.5m of the groundwater level from slip surface and 1.0m (extreme condition) from this. In this figure, the slopes with  $F_s \leq 1$  for the water level at 0.5m occupy approximately 40 percent of the measurement net. Furthermore, the slopes showing  $F_s \leq 1$  for the water level at 1.0m occupy approximately 60 percent at that in the Taishi-do area. Although the members of potential slope failures estimated by calculation are significantly greater than the actual member of failures, three slope failures where are F16, F17 and K13 located in the area with  $F_s \leq 1$  for the water level at 1m. The slope failure at Taishi-do locates in  $F_s > 1$ , in other ward, locates in stable slope under each pore water pressure condition against to other slope failures.

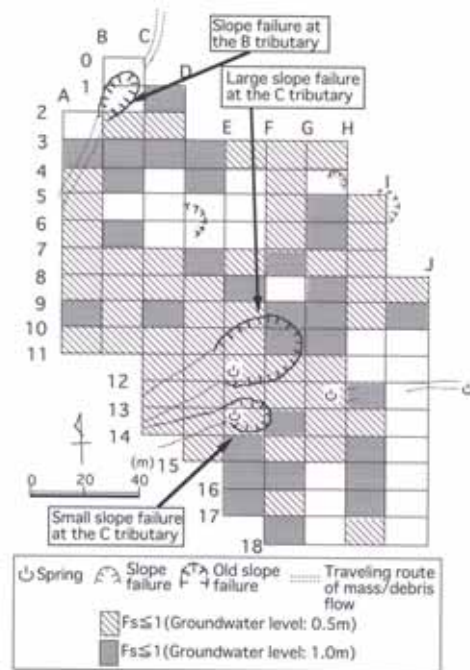
Fig. 8 Distribution of safety factors at the B, C tributaries at Tobinosu torrent

Fig. 8 shows the result of stability analysis under same pore water condition as in Fig. 7. The case of the B, C tributaries in the Tobinosu area is that the slopes with  $F_s \leq 1$  for the water level at 0.5m occupies approximately half of the area of the measurement

net, and for a water level at 1.0m occupies approximately 80 percent of the measurement net. The large and small slope failures at the C tributary locate in the area of  $F_s \leq 1$  for the water level at 1m. However, the slope failure at the B tributary and the old slope failure around D6 measurement point occurred within the area of  $F_s > 1$ , which is similar

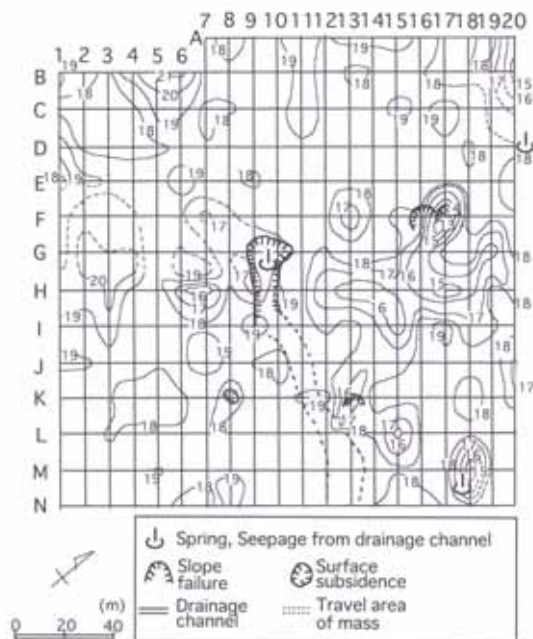
Fig. 9 Isothermal diagram at the Taishi-do area

Fig.9 shows the isothermal diagram of correction values from 12 to 22°C by 1°C at the Taishi-do area. Maximum ground temperature is 21.0°C (B6), minimum ground temperature is 12.3°C (F17), and average ground temperature is 18.2°C within this area. In this figure, the eastern part of the measurement net shows an underground temperature below the average. On the other hand, the underground temperatures in western part are higher than the average. There are three large zones with temperatures less than 18°C (i.e. slightly less than average value) at the Taishi-do area: 1) From C1 and C3 to G9 (E6 is a bit high value) which is approximately the direction from east to west, 2) From E17 to N15 through L12 direction which is approximately oriented on southeast northwest, and 3) From A17 and A19 to D20 located at north part of the measurement net. All slope failures at the Taishi-do area locate in the zone of temperatures less than 18 °C. The temperature of the slope failure at Taishi-do and K13 are a little lower than average underground temperature. However, the slope

failures at F16 and F17 locate within the low temperature zone. The slope failure at F17 is also in the zone of the minimum underground temperature. This is a characteristic fact in the Taishi-do area.

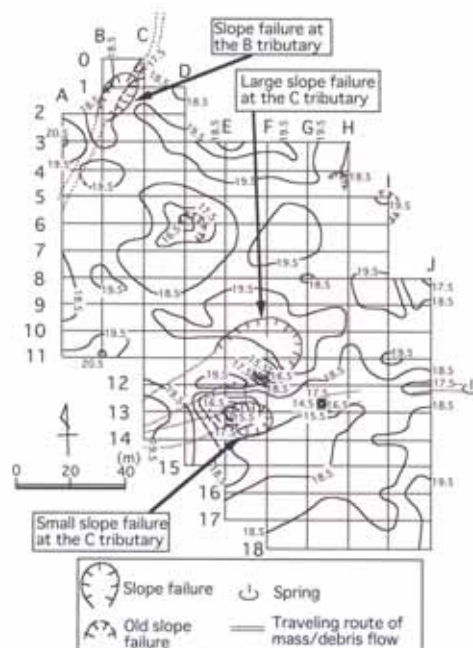
Fig. 10 Isothermal diagram at the B, C tributaries in Tobinosu torrent

Fig.10 shows the isothermal diagram of correction values of the one-meter depth underground temperature survey and local temperature around springs at the B, C tributary in Tobinosu torrent from 15.5 to 20.5°C by 1°C. Maximum ground temperature is 20.6°C (A3), minimum ground temperature is 15.1°C (E13), and average ground temperature is 18.9°C at this area. Groundwater temperature at springs in the B, C tributaries at the Tobinosu torrent are lower than minimum measurement value. The temperature at upper J12 is 12.7 °C; in point F12 (the large slope failure at the C tributary) is 13.9°C; at G12-13 is 14.1°C, and at E13 (the small slope failure at the C tributary) is 13.5°C.

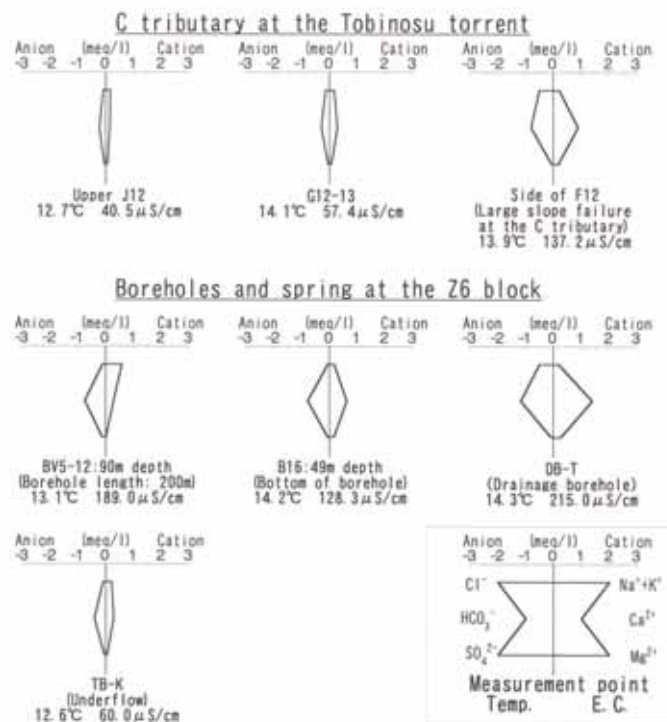
Fig. 11 Results of water quality analysis

Fig. 11 gives as the results of measured groundwater temperature, electric conductivity and hexa diagram of the ion concentrations at some springs of the C tributary at the Tobinosu torrent, as well as at the boreholes and underflow in the Z6 block during the one-meter depth underground temperature survey. In this figure, the measured groundwater temperature at the springs in the C tributary Tobinosu torrent are approximately the same as the values measured in all points of Z6 block (i.e., 12 to 14°C). When attention is paid to the results of electric conductivity, the springs at the C tributary have the values in two diagrams (Upper J12 and G12-13) the same as the results of boreholes in the Z6 block, and the value in third diagram (Side of F12: Large slope failure at the C tributary) the same as

the data of TB-K (Underflow) at the Z6 block. From the results of hexa diagram, the Upper J12 and G12-13 don't show a clear water quality pattern. This is similar with the analysis results at TB-K at the Z6 block. On the other hand, the Side of F12 has clear Ca-HCO<sub>3</sub> water quality type, which is the same as in points B16 and the DB-T of the Z6 block. This water quality type has the same tendency as the results provided by Yoshioka et al., (1973) who carried out investigation along the Iya River. The water quality at BV5-12 is Na, K-HCO<sub>3</sub> type, which is different from the water quality at another boreholes in the Z6 block. The reason for this difference may be the fact that the geology of the upper part of slope is different from the geology of middle part of slope at the Z6 block shown in Fig.2.

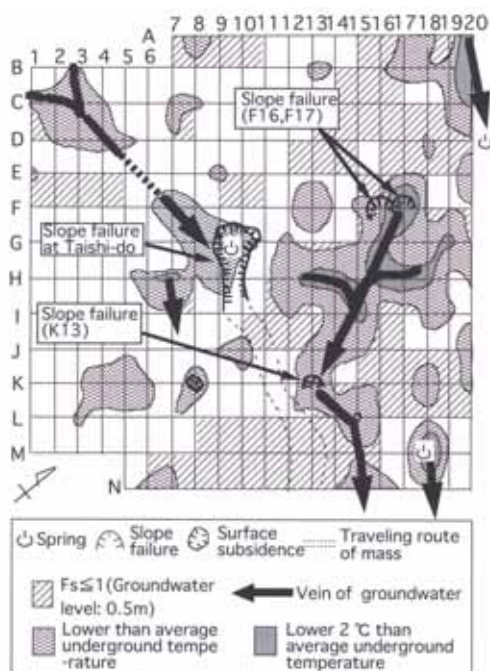
Fig.12 Distribution of veins of groundwater, safety factors, and slope failures at the Taishi-do area

into lower than average underground temperature zones (18.2°C) and zones with temperatures lower by 2°C than average underground temperature. There are five veins of groundwater at the Taishi-do area (Furuya et al., 2004): Zone 1 from C1 and C3 to G9, Zone 2 from E17 to N15 through K13, Zone 3 from A17 and A19 to D20, Zone 4 area around H7, and Zone 5 area around M18. Zone 1 and 2 are large veins of groundwater for the measurement net, however, the groundwater type is different in these two veins represent. In zone 1 the lowest value is 16.9°C at point H9 (Furuya et al., 2000) and the spring in slope failure at Taishi-do is 17.8°C as shown in Table 1. Thus the temperature in this vein is not so low compared with the average value, and is 4 to 5°C higher than the boreholes at the Z6 block. On the other hand, the lowest ground temperature at a depth of 1m in zone 2 is 12.3°C at point F17. This is also the lowest value in the measurement net, and is approximately equal to the groundwater temperature at the boreholes of Z6 block. In addition, when the ground temperature of F17 was measured, groundwater was oozing through the measurement hole of this measurement point (Furuya et al., 2000). Therefore, it may be stated that the vein of groundwater in zone 1 is of shallow origin, while the vein of groundwater in zone 2 originates groundwater from deep layers. The other veins of groundwater in the surveying area aren't widely distributed being rather than local. However, they have remarkable low underground temperature part. This may be attributed to the small scale of these veins rising from deep layers.

The slope failure at associated with  $F_s > 1$  in Fig. 5 (gentle slope less than 30°) is actually locates on the vein of groundwater corresponding to zone 1. Furthermore, the results of stability analysis indicate a stable slope even for a pore water pressure calculated from a groundwater level at 1.0m above the slip surface. Hence, it may be concluded that the slope failure at Taishi-do was caused by the increase in pore water pressure due to concentrated groundwater along the vein of groundwater in zone 1 during the heavy rainfall. The slope failures at F16 and F17 locate on and nearby the beginning of the vein of groundwater in zone 2. Recall that underground temperature at a 1m depth in point F17 is lowest, and is approximately equal to the groundwater temperature in the boreholes at the Z6 block. Thus we can consider as the outlet of groundwater originating from the deep layers. In these circumstances the occurrence of these slope failures could be related to the existence of a vein of groundwater originating from the deep layers. This vein of groundwater is flowing like underflow in subsurface toward K13. The vein of groundwater in zone 2 could also be responsible of the slope failure at K13.

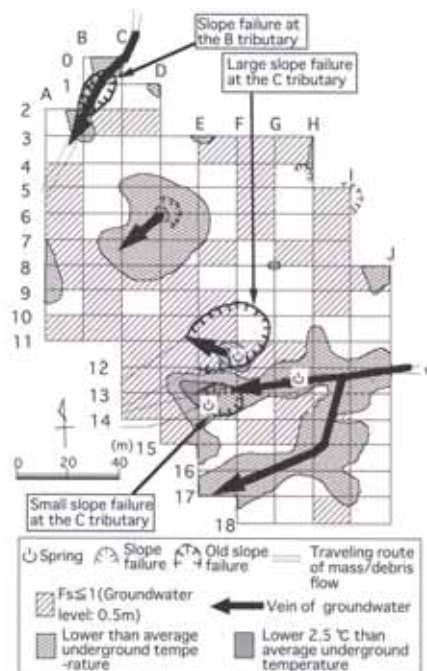
Fig.13 Distribution of veins of groundwater, safety factors, and slope failures at the B, C tributaries in Tobinosu torrent

Fig. 13 shows the coupled distributions of the low underground temperature zones, veins of groundwater, the real slope failures and the slope with  $F_s \leq 1$  at the B, C tributaries, Tobinosu torrent. The assumed water level for slope stability calculation was at 50cm

above the slip surface. This figure shows the lower than average underground temperature zones (i.e., 18.2°C) and zones with temperatures lower by 2.5°C than average underground temperature. The veins of groundwater are as follows: zone 1 along the B tributary (C0 to B3); zone 2 large slope failure at the C tributary; zone 3 upper slope of J12 to the small failure at the C tributary with branch vein at I11 to F17, and zone 4 the area within a range of approximate 40m x 40m around D6 (Furuya et al., 2001). The vein of groundwater in zone 3 is underflow type because the springs in the upper slope of the small slope failure at the C tributary are distributed over a line and these springs show a concentration of dissolved ions (electric conductivity) similar with the TB-K at the Z6 block (see the results of water quality analysis in Fig. 11). The branch stream of this vein of groundwater starting from I12 may also be of underflow type. No spring exists at the B tributary. However, it is believed that the vein of groundwater along the B tributary is flowing under the torrent bed of this tributary because the zone of low underground temperature is along the torrent bed. Hence, it can be concluded that the underflow type is the same as for TB-K at Z6 block. The low temperature distribution disappears around B3 suggesting that the vein of groundwater infiltrates into the deep zone of the torrent bed. The large slope failure at the C tributary has a spring on the lateral side at F12, which scale of vein is very small. The water quality type of this spring differs from that of the vein of groundwater in zone 3 which flows neighboring the large slope failure shown in Fig. 11. In the Zentoku area, many cracks were found on outcrops of bedrock during field investigations, as well as in the rock mass during the construction of a drainage well. Hence, the vein of groundwater in zone 2 appears to be of fissure water type. This vein of groundwater is presumed that raising steep angle from deep layers by the calculation results based on thermal conductivity type differential equation (Furuya et al., 2001). The water quality of this vein and the dissolved ion concentration are the same as at locations B14 and DB-T in Z6 block. Therefore, the vein of groundwater zone 2 is discharging from the deep layers equivalent to the slip surface at Z6 block. There is no spring around D6. However, it is believed that the deep layer of groundwater is rising nearby surface because the zone of underground temperatures lower by 2.5°C than the average is located around D6.

There are three slope failures generating debris flows in the analyzed measurement net. The common feature in these slope failures is that they occurred in the zones of low underground temperature. Among these, the slope failure at the B tributary and the small slope failure at the C tributary are related to the underflow type vein of groundwater. On the other

hand, the large slope failure at the C tributary is related to the fissure water type vein. However, it is presumed that this slope failure rather develops retrogressively towards the upper slope instead of occurring at once. There is an old slope failure at D6 that could have been caused by water rising from fissures. This study demonstrated that by coupling the results of stability analysis with the distribution of veins of groundwater within the analyzed domain, it is possible to narrow the regions associated with a high potential of slope failure.

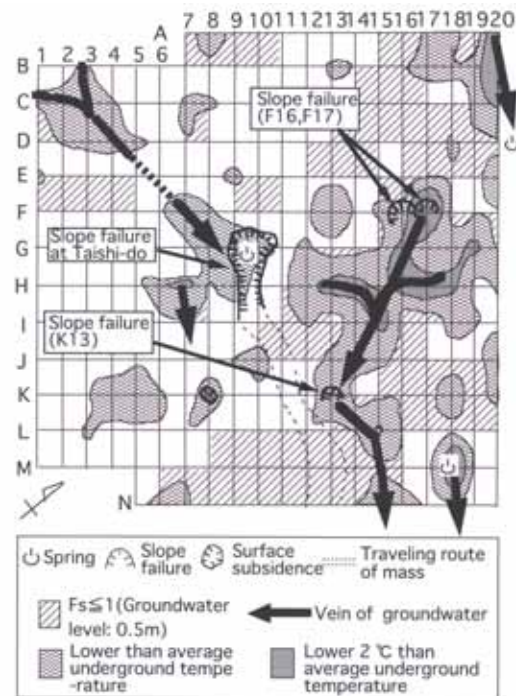
図 大師堂周辺における崩壊発生箇所、流動地下水脈および安全率1以下の分布

これらの調査対象地域の平均傾斜角は $32\sim 34^\circ$ である。斜面崩壊は従来から指摘されている遷移点（遷急点、遷緩点）周辺で発生しているが、図に示すように、すべり面上の間

隙水圧が同条件のもとで計算した結果において他の箇所（セル）よりも安定性が高いと評価される緩傾斜（ $20\sim 27^\circ$ ）の箇所でも発生している。流動地下水脈の分布に着目すると、調査対象地域では流動地下水の分布の有無による斜面傾斜角の違いはほとんど無い。斜面崩壊は土層深が著しく薄い箇所を除いて地下水脈の経路付近や斜面内部の地下水が地表面（付近）に流出する箇所が発生する傾向が高い。これは地下水が集中し易い箇所でも斜面崩壊が発生し易いことを示唆する。なお、調査対象地域における斜面内部から流出する地下水は、水質調査結果よりすべり面相当深度のものであった。以上より、結晶片岩の地すべり地で豪雨時に発生する斜面崩壊の危険度を評価するには斜面傾斜角に着目した評価だけでは不十分であり、現地の流動地下水の情報も併用する必要があると考えられる。
