Landslides in Kisawa area, Tokushima Prefecture during the 2004 Typhoon Namtheun

Gonghui WANG, Akira SUEMINE, Gen FURUYA,
Masahiro KAIBORI*, and Kyoji SASSA

Synopsis

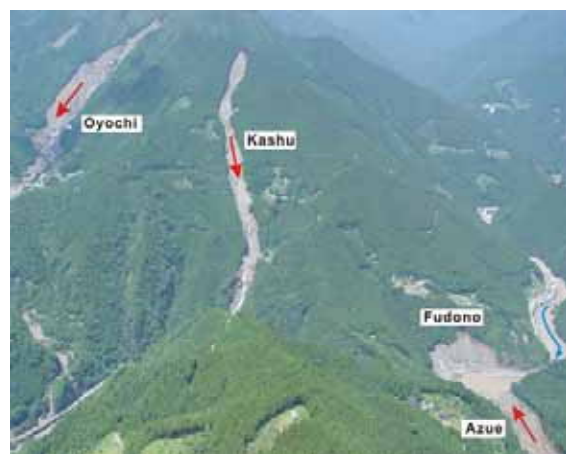
The Oyochi and Kashu landslides occurred on the same ridge and side of the mountain (Photo 1).

Photo 1 Oblique aerial view of the Oyochi, Kashi, and Azue landslides (photo by Shikoku Development Bureau, MLIT, Japan)

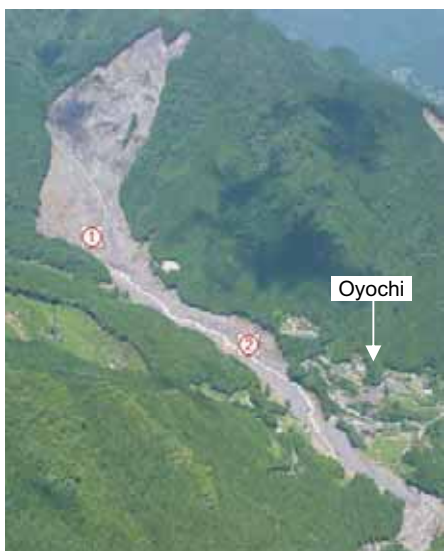
Oyochi landslide was triggered mid-slope on the mountainside, about 1 km from the Oyochi settlement (Photo 2) at approximately 20:30 hr, August 1. Two people were caught up in this landslide, and their bodies have not been found. The head scarp is situated at an altitude of about 1000 m, while the join of the slope to the Oyochi valley is about 560 m. The slope angle averaged 34 degrees. The displaced materials of about $0.5\sim 1 \times 10^6 \text{ m}^3$ from the cover and weathered bedrock moved downslope to the river, and hit the opposite side of the channel. A part of the displaced mass crossed a ridge on the opposite slope (area ① in Photo 2), and transformed into a large debris flow, traveling a further 2 km along the valley (area ② in Photo 2). In this area, the bedrock is mainly composed of greenstone and serpentinite with visible cracks. Immediately below the source area, the displaced mass is meters thick, and contains some huge boulders (Photo 3). The deposited mass could be liquefied by stamping feet, indicating the highly liquefiable character of the landslide materials.

Photo 2 Oblique aerial view of Oyochi landslide (photo by Shikoku Regional Development Bureau, MLIT, Japan)

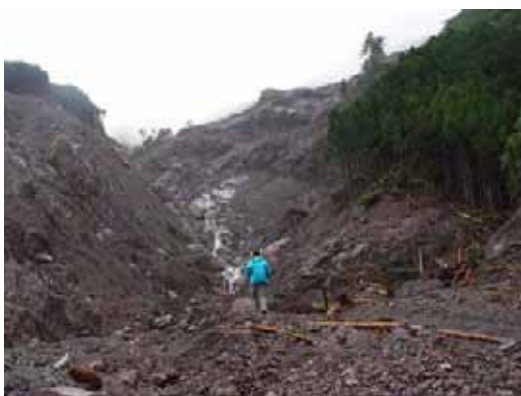
Photo 3 Deposits of landslide mass at Oyochi

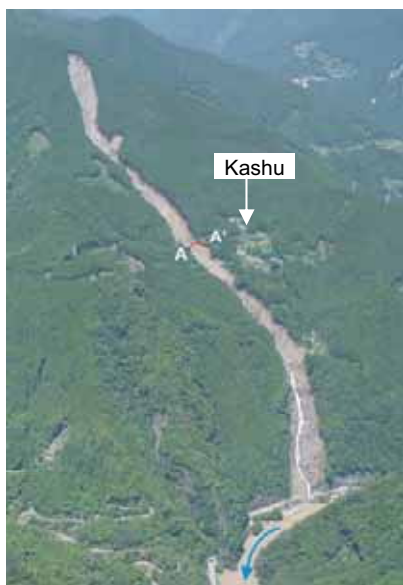
Photo 4 Oblique aerial view of Kashu landslide (photo by Shikoku Regional Development Bureau, MLIT, Japan)

Kashu landslide (Photo 4) occurred on the same slope near the Oyochi landslide, and almost at the same time as the Oyochi event. The head scarp is situated at an altitude of about 910 m, while the altitude of river floor is about 300 m. The slope angle averaged 27 degrees. According to a local resident, Kashu landslide started on the lower valley slope near Kashu settlement (below A-A' in Photo 4), and was followed by another two failures, finally retrogressing almost to the ridgeline of the mountain on August 2.

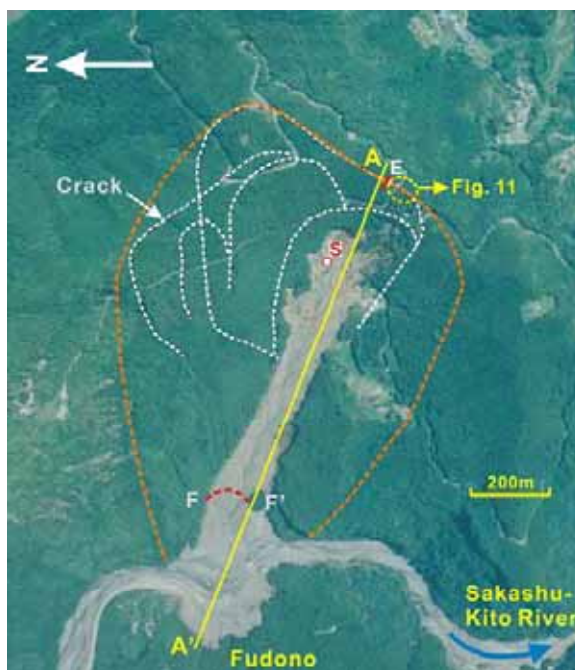
Photo 5 Oblique aerial view of Azue landslide and the unstable blocks after the August 1, 2004 event (photo by Nakanihon Sky Service Station, Japan). The broken brown line outlines the area of the ancient landslide

Azue landslide is located on the left side of Sakashu-Kito River, in front of the Kashu landslide (Photo 5). A remarkable scar indicating an ancient landslide is also visible at the same site (Photo 5 outlined approximately by the brown broken line). We also found a small-scale linear depression on the mountain top during our survey. The new landslide occurred near the southern boundary of the old landslide scar within the weathered bedrock layer. Azue landslide has a width of about 130 m, a horizontal length of about 1 km, and a depth ranging from 10 to 20 m. The volume of the displaced material was estimated to be about $1\sim 2 \times 10^6 \text{ m}^3$. The displaced material slid down the slope, crossed the river, and rose up the opposite mountain slope to about 30 m (immediately below the Fudono area), destroying and carrying away the Fudono bridge, which was built on the national road (Photo 6).

We were told that a landslide occurred 5 years ago on the area below the curve of F-F' shown in Photo 5, also during heavy rain. We noticed that a smooth surface of relatively hard bedrock crops out (below F-F' on Photo 5), which strikes N45°E and dips north (Hiura, et al, 2004). We infer that this surface formed an impermeable or less permeable layer, which facilitated a rapid rise in the local ground-water table during the storm, which in turn triggered the slope failure.

Above the main scarp of Azue landslide, another huge block moved slightly. After the landslide, numerous cracks with significant displacements were found on the slope above the main scarp (and along the scarp of the old landslide). The white dashed lines that were made basing on the observed cracks outline the boundary of each landsliding sub-block. The road on the left hand side of the old landslide scar was severed by a crack, where there was subsidence of about 2.0 m (Photo 7). The subsidence increased to 2.5m over about two weeks. It exposed a well-consolidated sliding surface of the old landslide (see Photo 8), which originated in the bedrocks and strikes N44°W and dips 48°W.

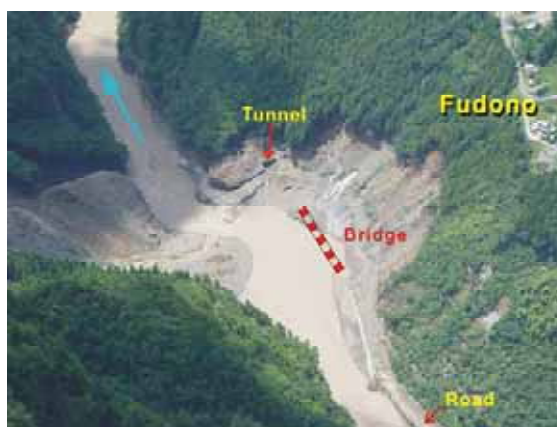
Photo 6 Oblique aerial view of the Fudono area after the landslide (photo by Shikoku Regional Development Bureau, MLIT, Japan)

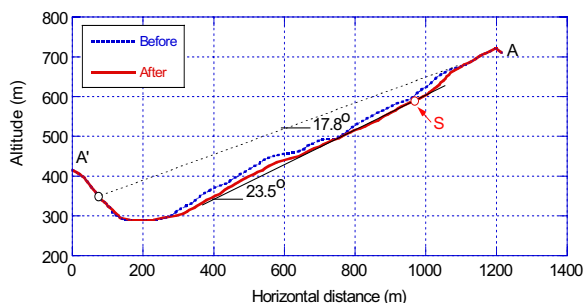
Fig. 4 Longitudinal section of the Azue landslide (A-A' in Photo 5; S is sample point for grain size analysis and ring-shear test)

A longitudinal section of the landslide (Fig. 4), was plotted using data from an airborne laser scanner after the failure (performed by Aero Asahi Corporation), and the pre-failure topography was obtained from a forest map with 2-m contour. The landslide originated on a slope of approximate 23.5 degrees with an apparent friction angle of about 17.8 degrees (Fig. 4). From the travel distance and the height reached on the opposite slope, the speed of the displaced landslide material was estimated to be very fast ($>20 \text{ m/s}$, Hiura, et al, 2004).

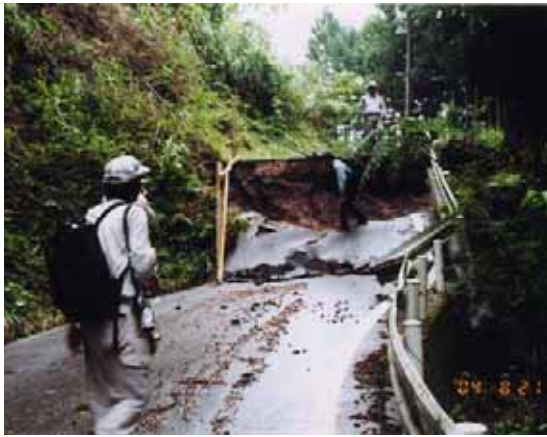
Photo 7 Subsidence on the left hand side of the landslide locating on the upper part of the Azue landslide scarp (yellow dashed region in Photo 5)

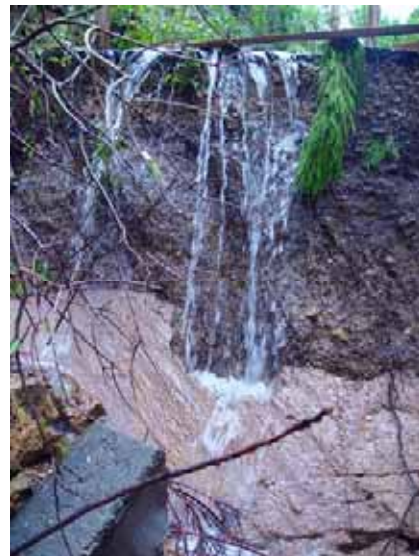
Photo 8 Exposure of the sliding surface beneath the old landslide. The materials above/below the sliding surface are weathered green stone

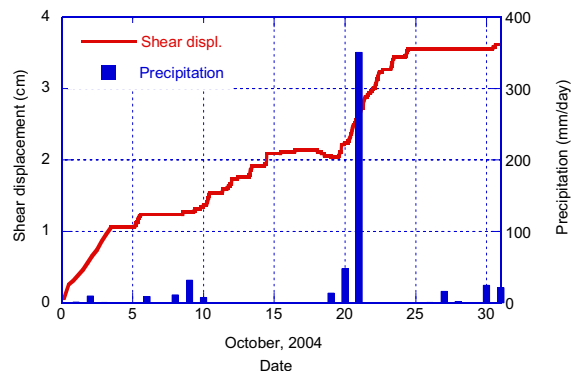
Fig. 5 Observed shear displacement and daily precipitation on October 2004 for the unstable block above the Azue landslide

Preliminary bore-hole data indicate that the unstable block ranges from 20–50 m in thickness. Therefore, the unstable landslide mass was estimated to be in the order of 10^6 m^3 . This landslide mass is still deforming, and measured displacements by the installed extensometers show that its movement is very sensitive to rainfall. This can be seen from Fig. 5, where the monitored shear displacement on October 2004 by means of an extensometer located on point E in Photo 5 is plotted together with the daily precipitation. A detailed account the deformation of this landslide mass is beyond the scope of this report and will be presented elsewhere.

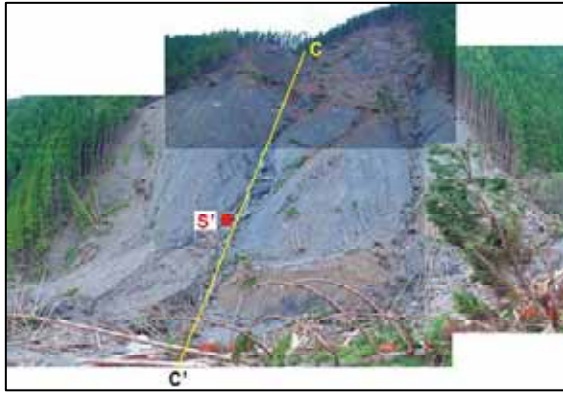
Photo 9 A general view of Kamagatani landslide. S' marks the sample site, and the red dashed cycle marks the site of Photo 10

Kamagatani landslide (Photo 9) is located on the right slope of the valley of Kamagatani River, the upper tributary of Sakashu-Kito River. This landslide is about 7 km north of the three landslides discussed above.

The landslide originated on a slope of about 33 degrees. It has a width of 120 m, a length of 200 m, and a depth of 10–15 m. The displaced landslide mass was estimated to be about $2 \times 10^5 \text{ m}^3$. The source area consists of mudstone, which is overlain by sandstone and ancient colluvial deposits. The failure occurred within the outer layers of these strata. In the middle part of the source area, a ridge-shaped roll existed, suggesting the presence of hard rock. A large amount of groundwater discharges near the mudstone-

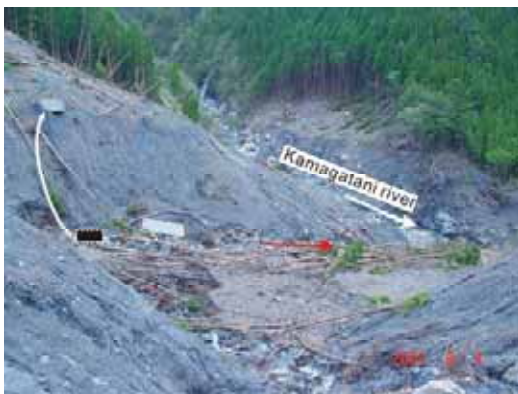
Photo 11 A displaced concrete block from the soil-conservation (check) dam (Black area outlined by the broken white line) on the slope opposite the landslide source (Red arrow: downstream of the valley; White curved arrow: move direction of the block)

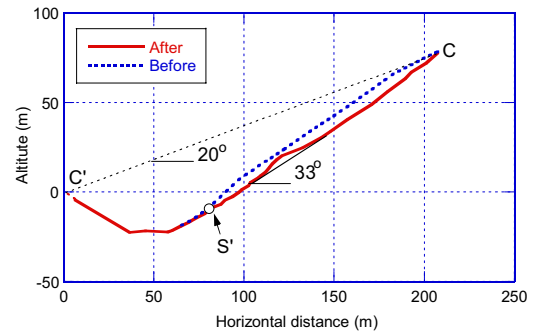
Fig. 6 Longitude section of the Kamagatani landslide (S' is sample point; the pre-failure topography was obtained from neighboring slope)

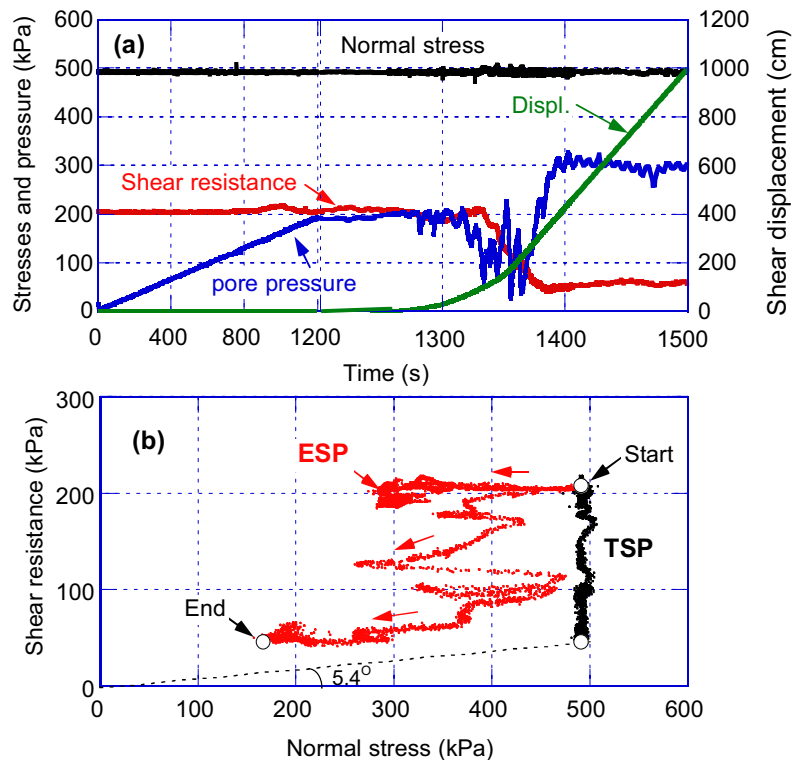
For Azue landslide, the sample had a specific gravity of 2.94 in the field, and dry density of 2.08 g/cm³. Because the test aim was to examine the shear behavior of the landslide material before and after failure, a soil element was selected from the sliding surface where the overlying soil was 25-m thick. The initial normal stress and shear stress acting on the soil element were calculated to have been 488 kPa and 212 kPa, respectively. The test results are presented in

the form of time-series data (Fig. 8a) and effective stress path (Fig. 8b). Shear failure was triggered when the pore-water pressure was increased to a certain value (Fig. 8a). The monitored pore-water pressure after failure showed a brief reduction and thereafter increased with further shearing. During this period, shear resistance was greatly reduced. The effective stress path fluctuated widely (Fig. 8b), probably due to problems in measuring pore pressure (as detailed in Sassa et al 2004b). The final apparent friction angle was very small, about 5.4 degrees.

Fig. 8 Results of a ring-shear test on a sample from the Azue landslide. (a) Time-series data for normal stress, shear resistance, pore-water pressure and shear displacement; (b) stress path (ESP: Effective Stress Path; TSP: Total Stress Path) (Pore-pressure parameter, $B_D = 0.96$, $e = 0.425$)

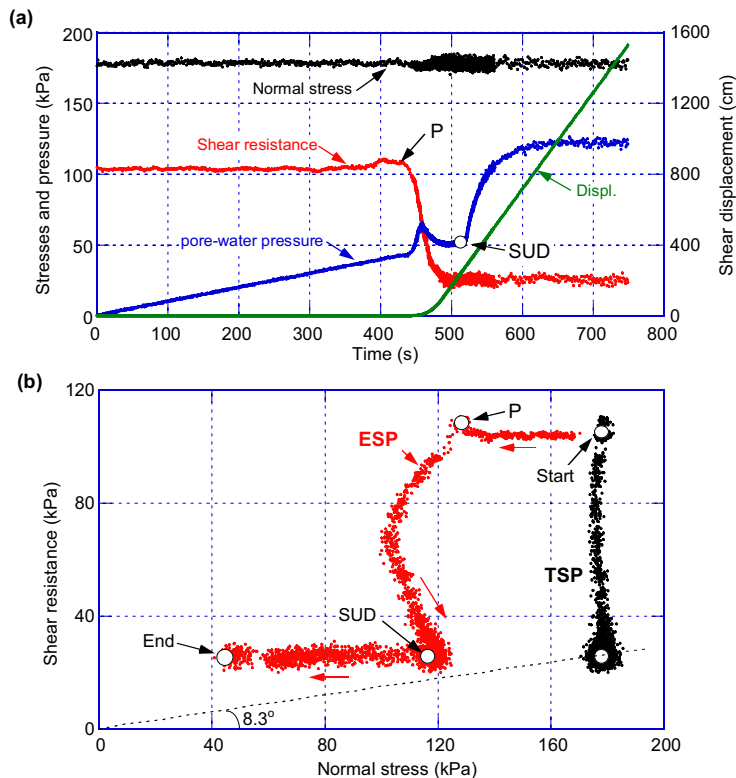
A similar test was performed on a sample from the Kamagatani landslide. Time-series data (Fig. 9) show that shear failure was triggered when the pore-water pressure was increased to point "P". After failure, pore-water pressure showed a sharp increase and then decreased. To measure the pore-water pressure within the shear zone, the shear box was switched to an undrained condition after point "SUD". The pore-water pressure increased with progress of shearing. The shear resistance showed almost no change in the final shear stage, indicating no further build up in excess pore-water pressure within the shear zone. The apparent friction angle was about 8.3 degrees (Fig. 9b). Although the final shear resistance shown in Fig. 9 is smaller than that in Fig. 8; the greater apparent friction angle in Fig. 9b is considered to be due to the smaller initial normal stress. The initial consolidated normal stress usually does not affect the shear resistance at steady state when a sample is subjected to undrained shearing, if other test conditions are the same (Castro & Poulos 1977; Kramer 1988).

Fig. 9 Results of a ring shear test on a sample from the Kamagatani landslide. (a) Time-series data for normal stress, shear resistance, pore-water pressure and shear displacement; (b) stress path ($B_D = 0.97$, $e = 0.513$)
