## Detection of Collapse Position in Mountainous Slope by Underground Sound Method

### Synopsis

**Keywords:** underground sound, water path, collapse position

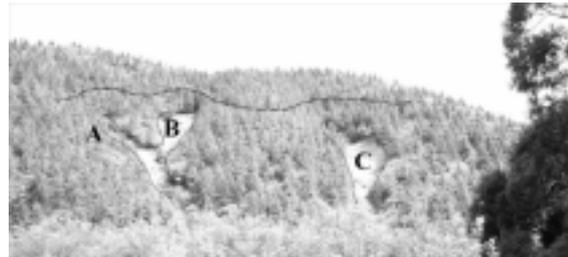
Photo 7 Collapse in natural slope B

catchments. Collapse A was 12m in width, and 2.0m in depth. Collapse B was 16m in width, and 2.0m in depth. Collapse C was 10m in width, and 1.0m in depth. All collapses were occurred on the bedrock as a boundary. And all collapse had no spring.

The underground sound in collapse position was bigger than other positions. And, collapse B and C was divided two blocks in scarps. Correspondingly, these collapse had two underground sound peaks. The collapse positions and the underground sound peaks

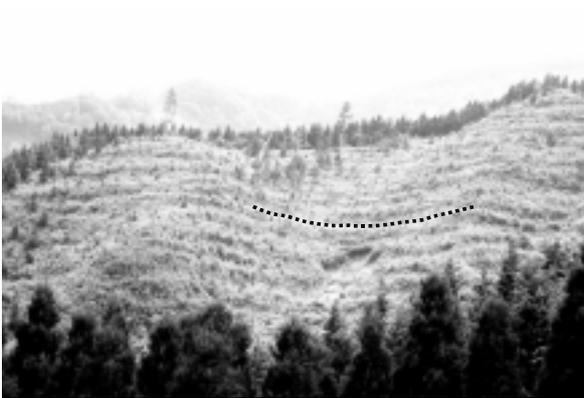
Photo 6 Collapse in natural slope A

Natural slope was catchments landform, and had one collapse. Width of collapse was 10m, depth was from 1m to 1.5m. Soil mass above the bedrock was collapsed. These were no spring when this site was inquired.

The underground sound in collapse position was bigger than another positions. And, Collapse position had 3 sound peaks. The collapse was divided into three blocks in photograph 6. And, each blocks was corresponding to each sound peaks.

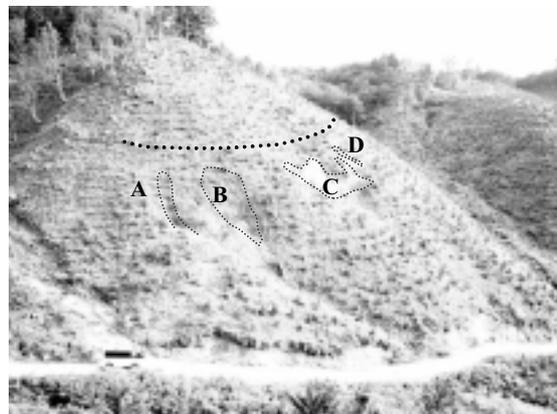
Photo 8 Collapse in natural slope C

Four collapses occurred in natural slope C. The geographical feature was ridge. Collapse A was 2m in width, and 1.0m in depth. There was one spring under the collapse. Collapse B was 6m in width, and 1.0m in depth. There were two springs under the collapse. Collapse C that was collapsed the soil mass above the bedrock was 12m in width, and 1.0m in depth. This collapse had no spring. Collapse D was 2m in width, and 1.0m in depth and also had no spring.

The underground sound in collapse position was bigger than another position. And, there were two sound peaks in collapse B that had two springs

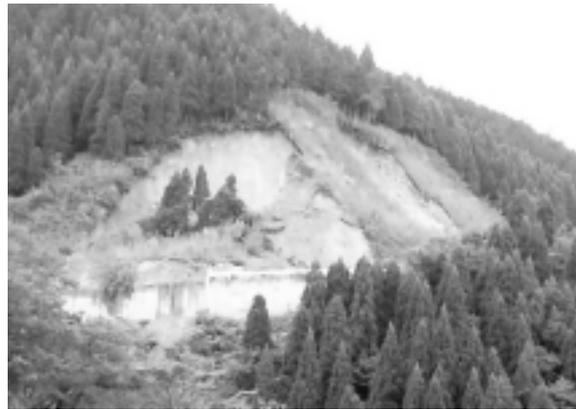
Photo 9 Collapse in road cut slope A

Two collapses occurred in ridge of forest road. Collapse A was caused by typhoon No.23 in 2004. Collapse B was caused by typhoon No.21 in 2004. Collapse A was 30m in width, and 5.0m in depth. One spring and wet zone were detected in the investigation immediately after the collapse. Collapse B was 14m in width, and 1.0m in depth. One spring was detected in the investigation immediately after the collapse.

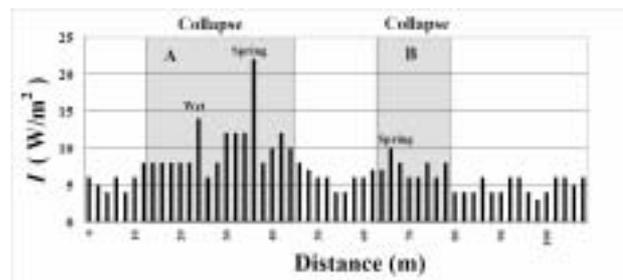
Fig. 11 Distribution of the underground sound in road cut slope A

The underground sound in collapse A and B were bigger than another position. And spring and wet zone in collapse A were corresponded with underground sound peaks. The under ground sound between collapse A and B was smaller than under ground sound in collapse A and B.

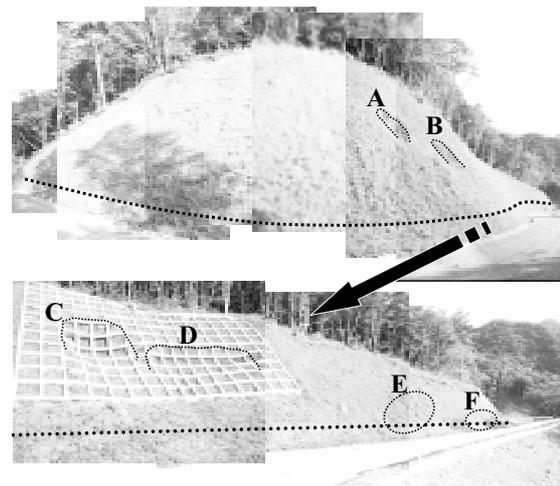
Photo 11 Collapse in road cut slope C

Four collapses and two water erosions were occurred in planting road cut slope. Collapse C and D was made by grating crib works. Collapse A was 2m in width, 1.0m in depth, and had no spring. Collapse B was 4m in width, 1.0m in depth, and also had no spring.

Collapse C was 6m in width, 1.0m in depth. Spring water occurred in heavy rainfall event in collapse C. Collapse D was 4m in width and 1.0m in depth. There is no spring in collapse D. Water erosions occurred in Position E and F.

Underground sound was big in each collapse positions and also big at position E and F that water erosion occurred

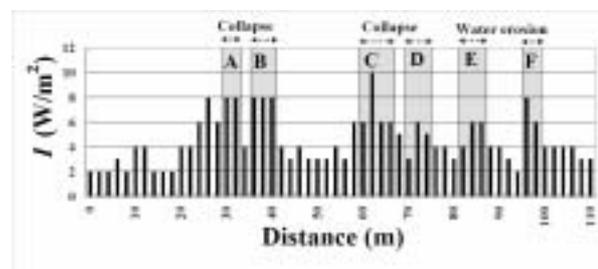
Fig. 13 Distribution of the underground sound in load cut slope C

It was examined that correspondence distribution of underground sound and collapse position. As the result, there was clear relation between underground sound and collapse position. And, the underground sound in collapse position was bigger than another position. This phenomenon indicated that collapses in natural slope or load cut slope occurred at the water collect position. And, even if the slope did not collapse in big underground sound position, water erosion occurred in that position.

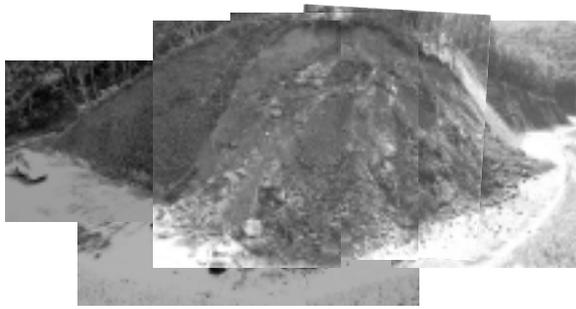
Photo 12 Road cut slope C after the Typhoon

Appearance of load cut slope C after the typhoon was shown Photograph 12. The road cut slope was collapsed by heavy rainfall of typhoon. Photograph 12 indicated that Collapse was occurred in left side of grating crib works. Collapse was 30m in width, and 1.5 m in depth. This collapse position was collated with the underground sound distribution chart (Fig. 15). The collapse was occurred in the part that had three peaks of underground sounds.

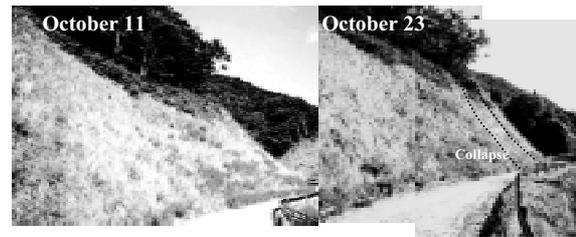
Photo 13 the appearance of road cut slope D before and after the typhoon approach

D before and after the typhoon approach. Cut slope was collapsed by the heavy precipitation. Collapse was 10m in width, and 0.5m in depth. Figure 16(a) showed the underground sound distribution that measured before typhoon approached.

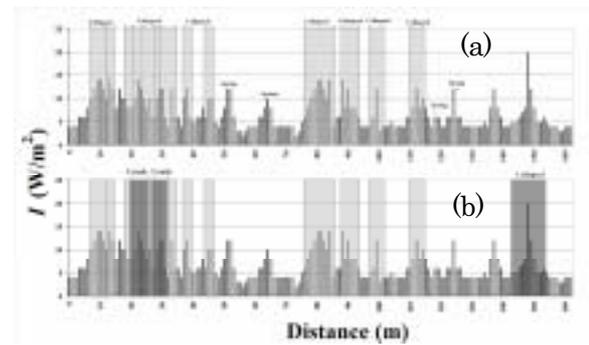
Fig. 16 Underground sound distribution and collapse position in road cut slope D

Figure 16(b) showed the position of collapses and distribution of underground sound that was measured on July 12 2004 before typhoon approached. The pale hatch in figure showed the position where the collapse round had already been occurred on July 12, 2004. The dark hatch in figure showed positions in collapses and water erosions that were occurred by typhoon 23. Collapses occurred in big underground sound position.

The non-failure position that had big underground sound was collapsed by the typhoon. There is a part which underground water daily concentrates in the slope. And, water path position was collapsed by the groundwater that was supplied to torrential rains.

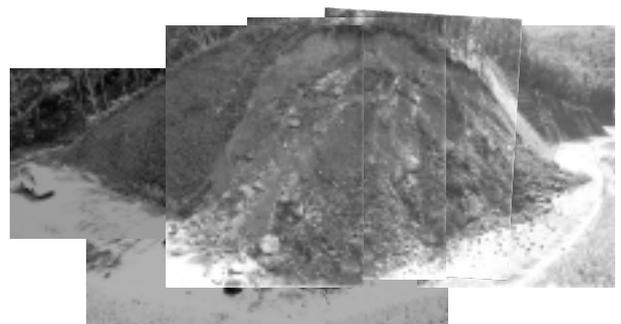
写真2 豪雨後に発生した崩壊

自然斜面には、日常的に地下水の集中する部位（水みち）が存在し、豪雨時にその部位に多量の地中水が供給されることで崩壊は発生する。
