Study on Landslides in Weathered Granite Areas of Hai Van Mountain, Vietnam

Pham Van TIEN, Kaoru TAKARA and Kyoji SASSA⁽¹⁾

Synopsis

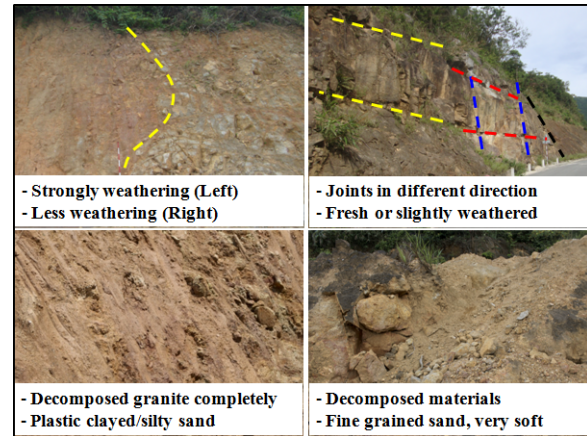
partly weathering in different layers and different directions (Fig. 8). Thus, formed materials are very different from grain size distribution, mineral composition, colors and hardness grade. As for a completely weathering degree, granitic rocks were changed into soil-like materials with brown, yellow and white colors and are very soft and slightly soft. Other partly weathering degree, material of granitic rocks is a mix of soil and stones with different grain sizes. Such kind of materials is a bit hard with red and grey colors mixing with a speckled mineralogical composition in black color. The more weathering materials are softer and finer than others. Materials of weathered granitic rocks are very loose and

unconsolidated. They are very easily to be eroded by rainwater and become earth flows.

Fig. 8 Weathered granitic materials on slopes

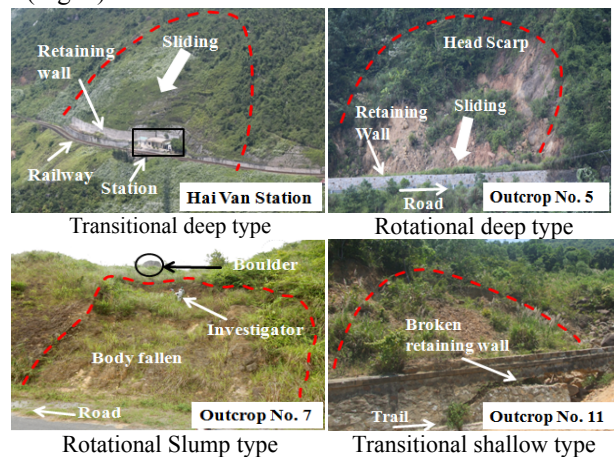
Fig. 9 Type and description of investigated landslides

The movement of landslide material may vary from abrupt collapses (the outcrop No. 5) to slow gradual slides (landslides on the slope behind the Hai Van station). Landslides are at different scales in both shallow and deep types, which depend on the thick of residual soil on slopes, weathering degrees of granitic rocks and fracture zones. The shallow landslides have a volume of 50 m³ to 500m³ with a depth of sliding surface about 2 m to 5 m. Shallow landslides were frequently induced by rainfalls due to a loose and unconsolidated material of slopes. More specifically, landslides are mainly populated a long national highway while large-scale and deep-seated landslides are situated next to the railway or at the edge of steep mountains. In the region, at least five deep- seated landslides were found around Hai Van Station, which have a volume ranging from several hundred thousand 200,000 m³ to several million m³. The estimated depth of potential sliding surfaces of those large-scale landslides in Hai Van Mountain often ranges largely about 5 m up to 50 m. Besides, site investigation revealed that most of failures were found with regards to artificially modified slopes (cutting/filling slopes for road constructions) and only several slides occurred on natural slopes.
