Photograph of the source area of the 2011 Uguhara landslide. Dashed lines are traces of the F2 and f4 faults.

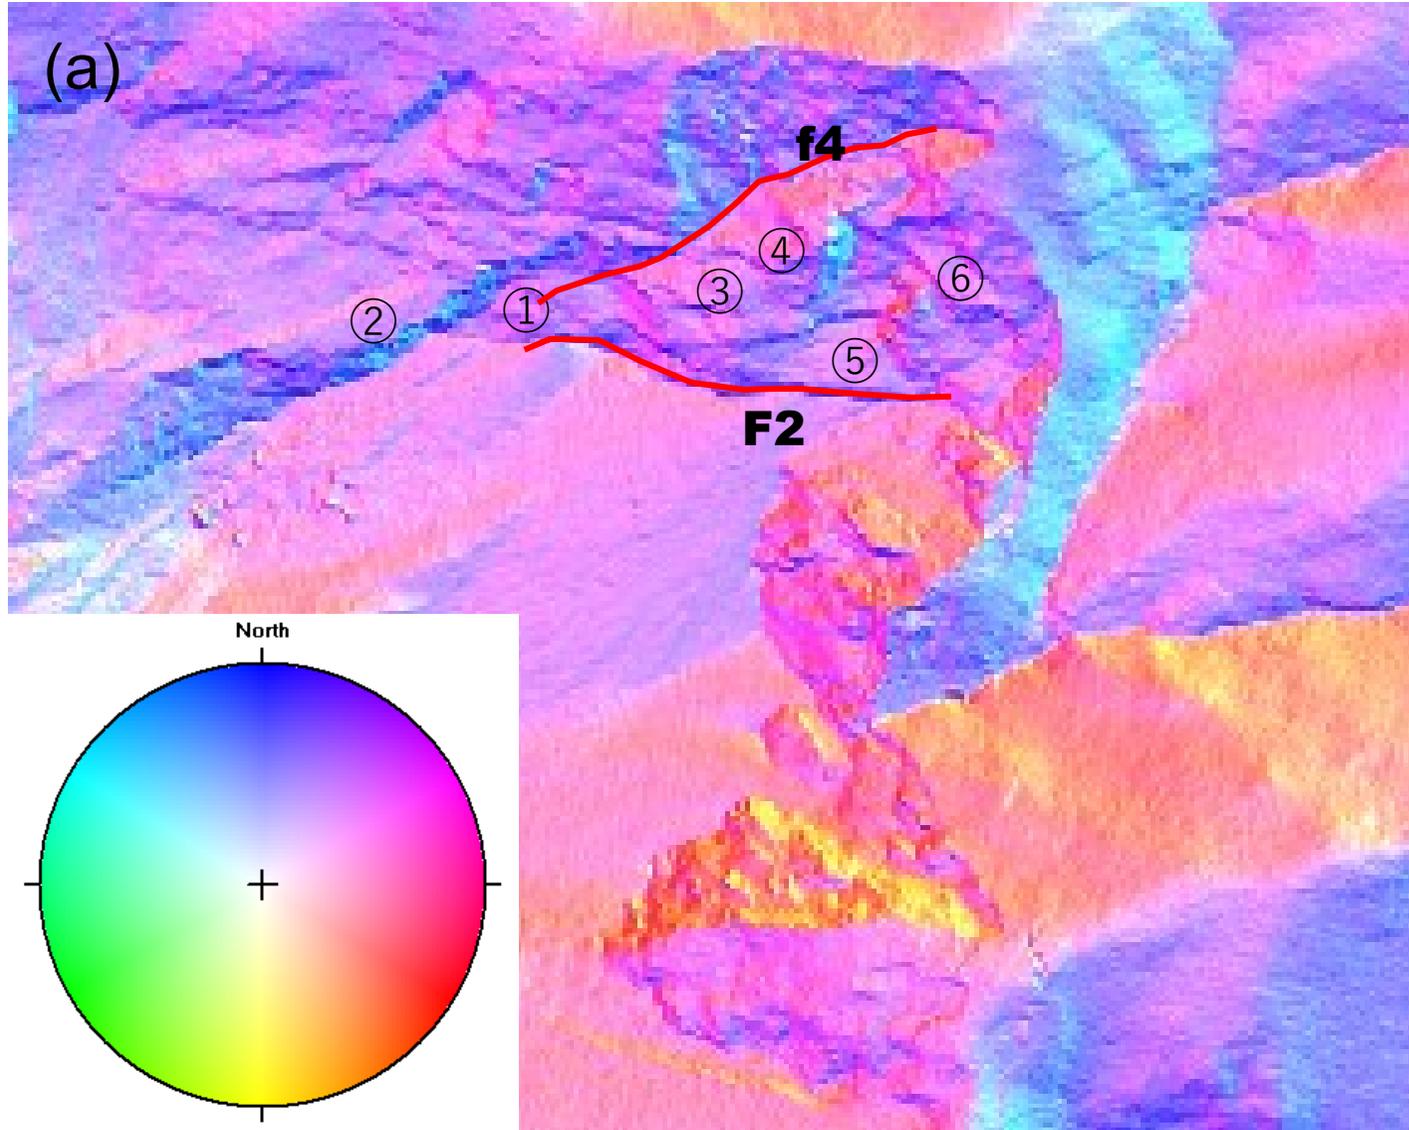
(a) Dip direction and slope angle of the source area of the Uguhara landslide in 2011 drawn by Coltop3D (Jaboyedoff et al., 2009). The yellow portion shows north-facing slopes.

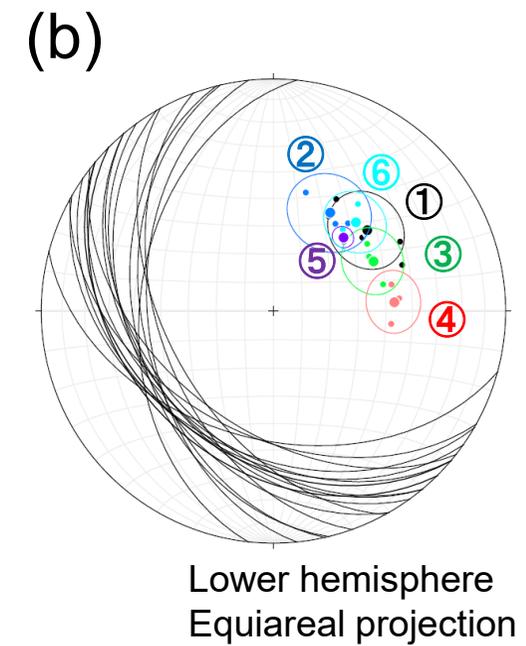
Fisher mean vector of poles

- ① Trend 48.9, Plunge 45.8
- ② Trend 29.6, Plunge 49.5
- ③ Trend 63.3, Plunge 50.4
- ④ Trend 85.6, Plunge 46.9
- ⑤ Trend 43.3, Plunge 54.0
- ⑥ Trend 42.6, Plunge 46.8

(b) Stereographic projection showing the orientations of geological discontinuities (shear plane) drawn by Stereonet ver.10.1.6. (Richard W. Allmendinger).
