詳細地形データを用いた泥火山の崩壊特性解析 Characterization of landslides on mud volcanoes by using precise DEM data

We applied airborne laser altimetry to mud volcanoes in Niikappu, Hokkaido, northern Japan, obtained high resolution DEM data with a mesh size of 1 m, and successfully characterized the morphology of the mud volcanoes and the landslides on them even though some mud volcanoes were hidden by trees. The landslide shapes visualized by using the DEM data had horseshoe peripheral outlines on plan view and were shallow and tabular in cross sections. The shallow and tabular morphology may suggest and could be due to slope-parallel stratification of mud ejected. By analyzing slope inclination in detail with the DEM data, we found there is a critical slope gradient for the slopes of the mud volcanoes.

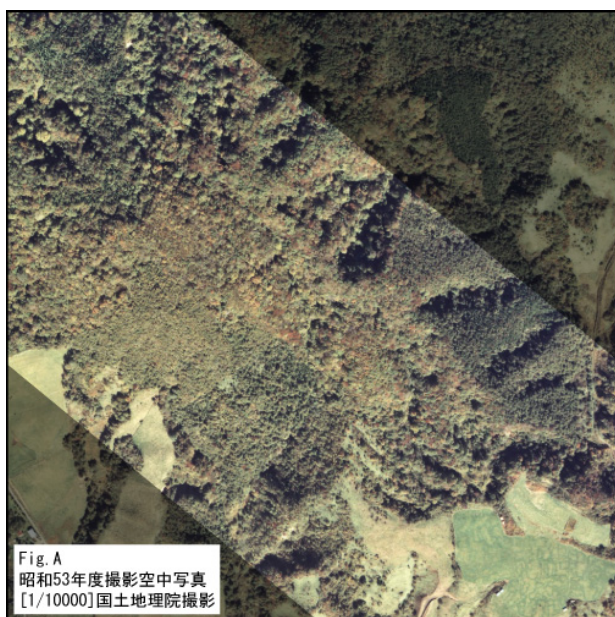
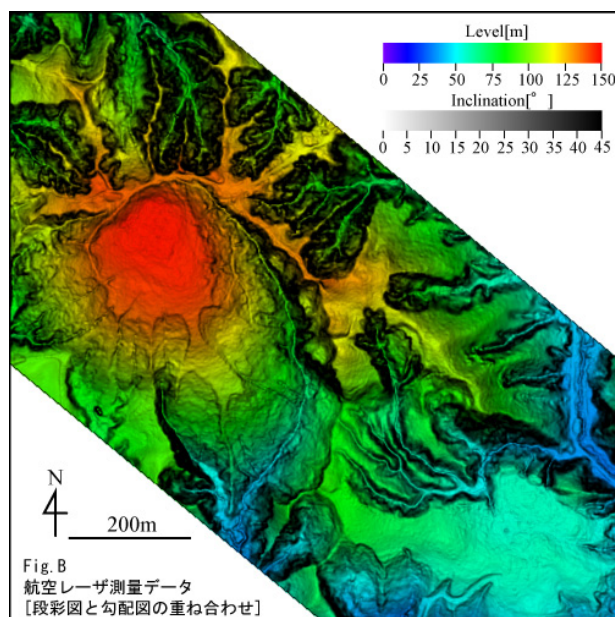
航空レーザ測量から得られたDEMデータ(1mメッシュ)を用いることで、植生に覆われた泥火山周辺地域でも詳細な地形データを得ることができた(Fig.A,B)。DEMデータの数値解析の結果、泥火山

の山体斜面において勾配値が 15° 以下の地域では崩壊は発生していなかった。一方、勾配値 20° 以上の地域は崩壊の縁などの崩壊を原因とした地形であることが確認できた。よって新冠泥火山の山体斜面には「限界傾斜(崩壊が発生しはじめる斜面の傾斜角)」があり、その傾斜角は 15° - 20° の間に存在すると考えられる。

また、新冠泥火山山体斜面で見られる崩壊は一般に馬蹄形の輪郭を持ち、浅い平板状の形態を持っていることが示された。これは泥火山の山体斜面において、泥の噴出・堆積を原因とした斜面と平行な層構造が形成されているためだと予想される。崩壊地内部に線状の高勾配値地域が見られるが、これは旧崩壊地内において新しい滑動が発生していることを示したものだと考えられる。
