## Hydrologic, soil, and topographic characteristics of a landslide site in Okaya City, Nagano Prefecture

○ Gholamreza Shoaiei, Roy C. Sidle

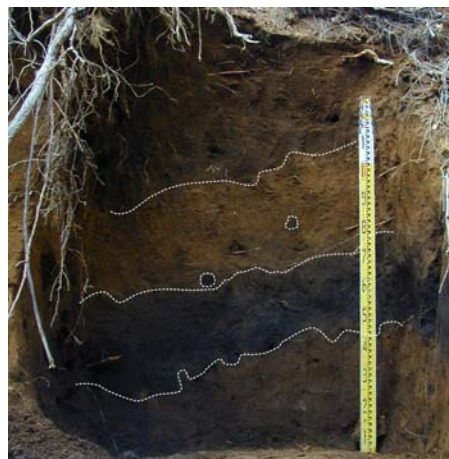
At first, a study focused on the soil structure and profile soil was conducted by excavating slices in a soil pit at the head of one of the landslides (Fig. 1). The dominant soil mantle of the hillslopes in the study area is ash from a neighboring volcano (Ontake). These field excavations revealed that the vertical structure of the soil is remarkably heterogeneous and consists of four distinct layers (from top to bottom): a dark surface layer of organic-rich soil, a lighter colored soil of original volcanic ash, a black layer of highly organic-rich subsoil, and an old volcanic ash layer continuing down to the tuff bedrock.

Fig. 1. Slice excavation in a soil pit
