白馬大雪渓付近で発生する崩壊と土石流

Landslides and debris flows at the big snow-patch of Mount Shirouma, Japan

諏訪 浩

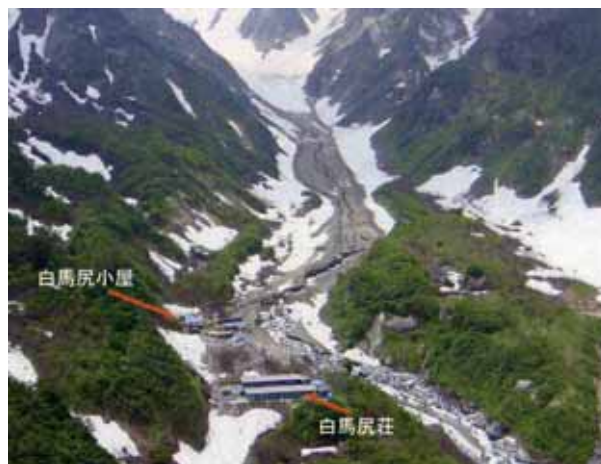
図 大雪渓を流下した2003年6月28日土石流
国土交通省松本砂防事務所提供、6月30日撮影

2008年8月19日寒冷前線東進通過に伴う豪雨のため、白馬大雪渓付近で斜面崩壊があり、これに巻き込まれた登山者3名が遭難した。白馬大雪渓周辺ではこのような崖錐斜面の崩壊だけでなく、落石、岩盤崩壊、これに伴う岩屑なだれ、豪雨による土石流などさまざまなマスムーブメントが頻発しており、これらに登山者が巻き込まれるという災害（事故）が起きている（表を参照）。落石や岩盤崩壊の誘因は明瞭ではないが、今回の斜面崩壊や、2003年6月28日に起きた土石流（写真参照）は豪雨によって引き起こされている。2003年の土石流は、雪渓にできた亀裂や大孔か

ら吹き出すという珍しい発生過程を呈した。土石流はさらに雪渓上を1kmあまり流走して山小屋の一部を埋積したが、人的被害は出ていない。現地調査と資料を検討して以下の点を明らかにした。1) 白馬大雪渓では土石流が比較的頻繁に発生している。土石流に多様性が見られる。2) 土石流が雪渓に長大な溝を形成することがある。劔沢大雪渓や焼岳上々堀沢の雪渓でも同様な溝が見られることがある。3) 土石流吹き出し発生メカニズムや雪渓上の土石流の流走過程。4) スラッシュ雪崩、あるいは雪代と呼ばれる現象との共通点・相違点。5) 氷河から発する土石流との共通点・相違点、など。
