2011 年東北地方太平洋沖地震の余震被害調査報告  
 Damage of the Aftershock off the Miyagi Prefecture on April 7, 2011

○Masumi YAMADA, Yasuhiro FUKUSHIMA, and Hiroyuki GOTO

We conducted earthquake damage reconnaissance before and after the aftershock of the 2011 off the Pacific Coast of Tohoku Earthquake on April 7, 2011 (Mj7.7). JMA intensity scale 6+ was observed in Tsukidate, Kurihara city, Wakayanagi, Kurihara city, and Miyagino, Sendai city. In some structure, seismic damage was accumulated after this aftershock.

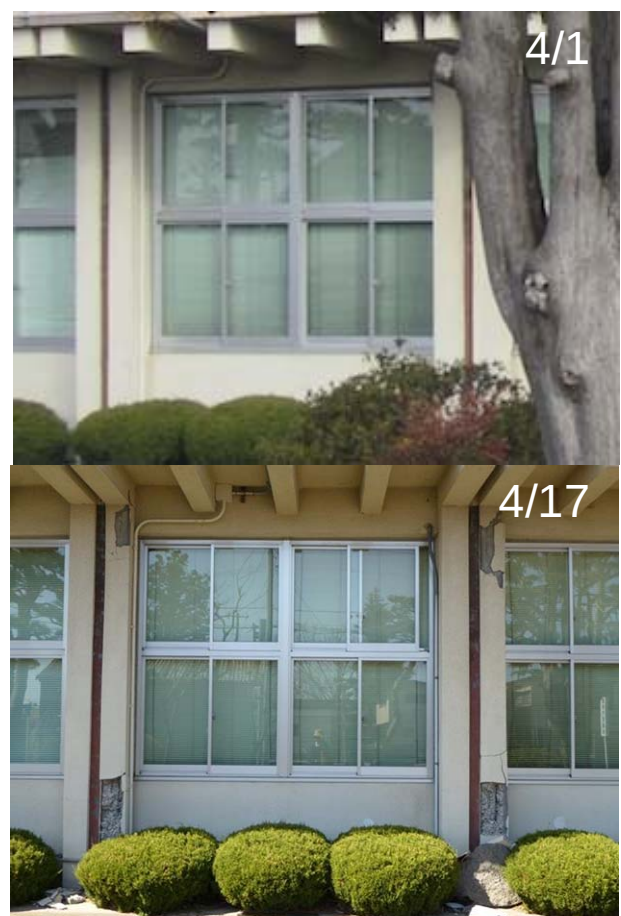
・構造物被害に関しては、余震前と余震後の両方の被害状況が写真で得られている栗原市築館、栗原市志波姫、栗原市若柳において、コンクリート柱の劣化や外壁の崩落、地盤変状などの被害が拡大する様子が観察できた。

図 1：余震によって柱脚に被害を生じた栗原市役所志波姫総合支所

以上の結果より、大地震の後の余震で、一部の構造物には被害が拡大する様子が観察できた。従って、本震において倒壊を免れた構造物も、余震で被害が累積し倒壊する危険性があるので、十分
