2013年9月15日に和歌山県串本町で発生した竜巻被害について
Tornadoes in Kushimoto, Wakayama, on 15th September, 2013

Taiichi HAYASHI, Kazuyoshi NISHIJIMA, Hiromori MIYAGI and Shinji KAWAUCHI

Three tornadoes occurred in Kushimoto of Wakayama Prefecture in the afternoon of 15th September, 2013. The weather condition during tornadoes was unstable because the warm and humid air flew from the Kumano Nada by the typhoon #1318 located in the southwest of Shionomisaki of Kii Peninsula, the southern end of Main Island of Japan. Main damages were 254 houses.

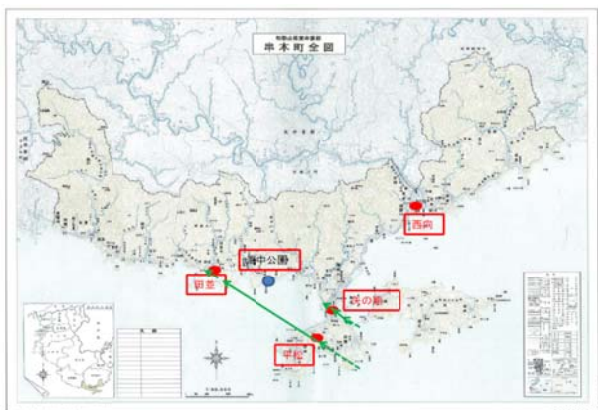
図1 3つの竜巻の経路

図1には、目撃者の証言と被害の発生状況から推定した3つの竜巻の経路を示す。最初の竜巻は14時30分頃に潮岬の南東部で被害が発生させ、一旦海上に出て田並地区に再上陸して被害を発生させた（被害の総延長約9km、幅は約100m）。17時10分

頃には西向地区（被害の長さ約600m、幅約200m）、18時05分頃に矢の熊地区（被害長約500m、幅約130m）で竜巻による被害が発生した。

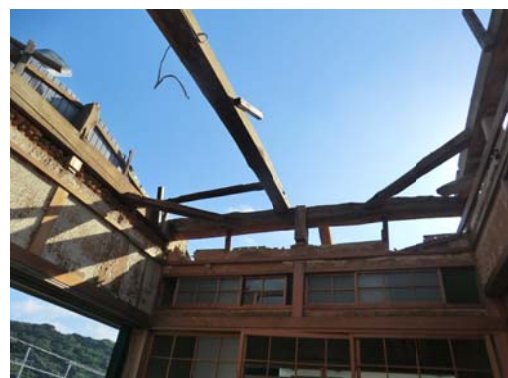
家屋の被害総数は3つの竜巻を合わせて245棟に達した。最も被害が激しかった田並地区の被害には、ランク5の「家屋が倒壊（全壊）する」相当する被害が出た。図2に2階建ての家屋の屋根部分が完全に破壊された事例を示す。この原因としては、竜巻通過時の強風によって完全に吹き飛ばされたか、または急激な気圧の低下にともなって、家屋内外の気圧差によって、破壊されたと考えられる。

図2 田並地区で屋根が完全に破壊された
2階建て家屋
