平成 24 年 8 月宇治豪雨時の斜面崩壊と下流浸水域での堆積土砂との関係について
 Relation between slope failures and deposited sediments in the inundation area of Uji City
 during the heavy rainfall in August, 2012

The relation between the deposited sediments in the inundation area of Gokasho, Uji City located around the downstream section of the Midajiro River and the deposited and exposed soils/gravels due to slope failure/bank erosion in the upstream area of the river was investigated to identify the origin of deposited sediments using X-Ray Powder Analysis of sediment samples.

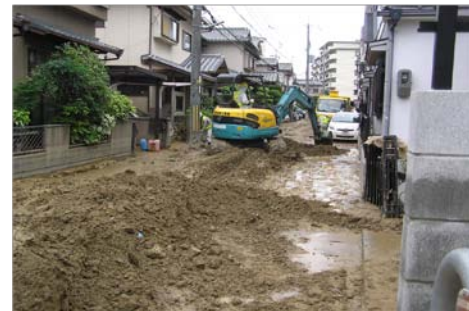
図-1 弥陀次郎川破堤地点周辺の土砂の堆積状況 (撮影: 細田)

宇治市を流れる宇治川の支川である弥陀次郎川、戦川の流域では河川沿いに広範囲に溢水氾濫による浸水が発生した。浸水域では氾濫水が流下した後大量の土砂が堆積した。図-1 に土砂の堆積状況を示した。

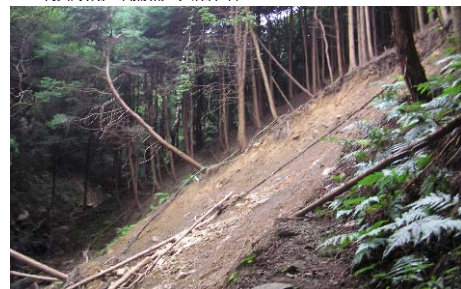
図-2 山地域での表層崩壊 (撮影: 細田)

山地域では多数の表層斜面崩壊（一部は土石流を伴う）が生じ、赤色の地肌があらわになっている箇所が多数存在していた。表層斜面崩壊の一例を図-2 に示す。一つの表層斜面崩壊箇所横の岩石と崩壊土砂の粉末 X 線分析結果を図-3、図-4 に示した。岩石の方はカウントのピークがすべてシリカ成分の位置にあり、岩石がチャートであることを示している。崩壊土砂の方も岩石とほぼ同様であり、崩壊斜面はチャートの風化土層で構成されていると考えられる。
