Geology and Geomorphology of the 2017 Xinmo Landslide and its Preceding Gravitational Slope Deformation at Maoxian, Sichuan, China

OSiyuan ZHAO, Masahiro CHIGIRA

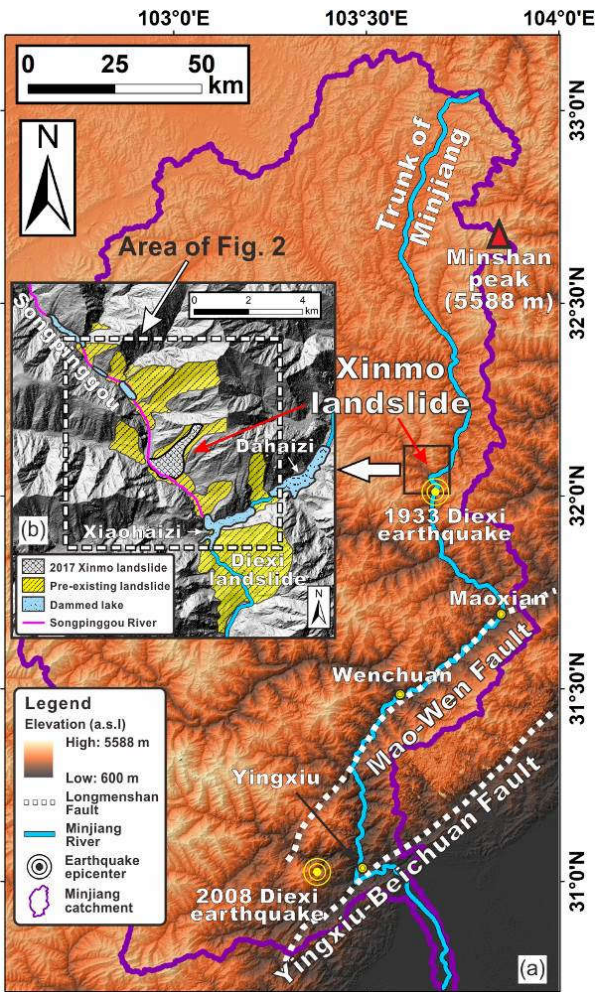
Fig. 1. Tectonic and geomorphological setting of the 2017 Xinmo landslide along the Songpinggou River.

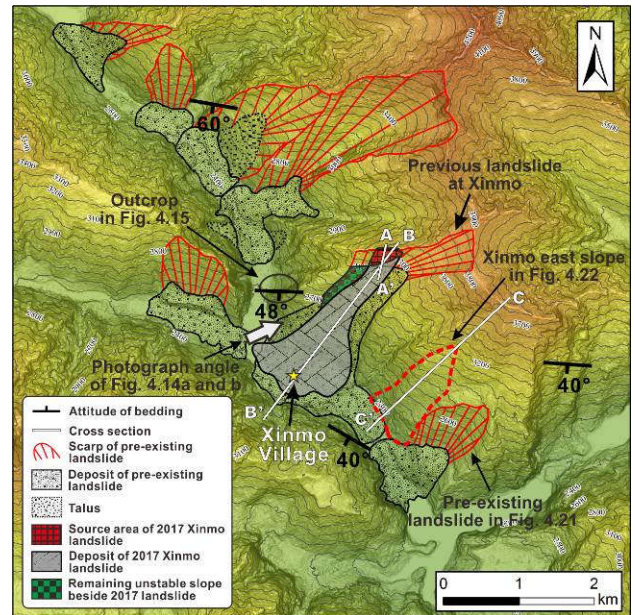
Fig. 2. Geomorphic map and landslide inventory of the study area along the Songpinggou River

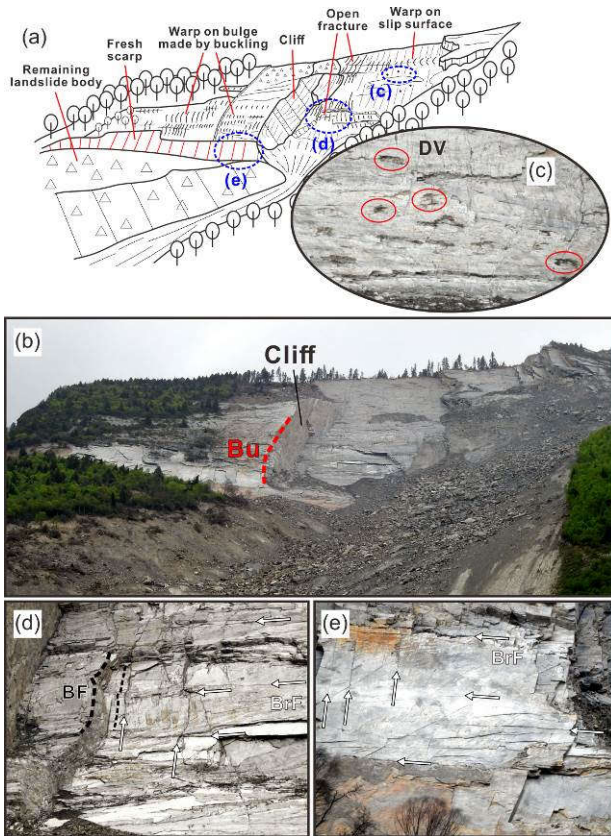
The landslide occurred on a dip slope of Triassic calcareous psammitic and pelitic schists. The bedding plane, which dips downslope at 48° , and high-angle joints trending along the maximum slope line bounded the landslide at its base and sides, respectively. Satellite image analysis and field observations of the landslide scar before and after the landslide strongly suggest that the beds in the source area had already begun gravitationally deforming (e.g., buckling) prior to the landslide.

Fig. 3. Characteristics of the geological structures of the landslide source area.

Moreover, pits on the sliding surface, which observed, were likely the result of the dissolution of calcareous material. This dissolution probably reduced the rock strength along the bedding plane. A rainfall event occurred from 16th to 24th June probably dominated the groundwater drainage and finally triggered the catastrophic rock avalanche.

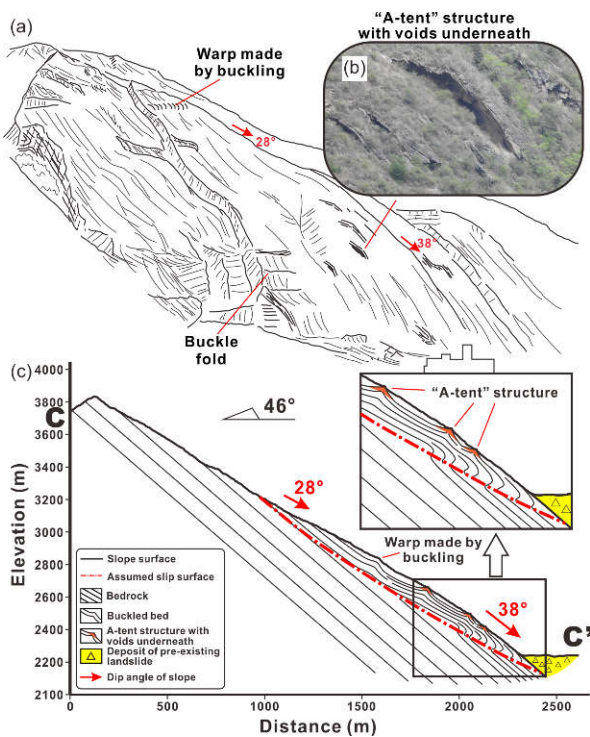
In addition to the 2017 landslide, the hillslope just to the east of the Xinmo landslide also exhibits pronounced gravitational slope deformation, including “A-tent”-like structures and warps induced by buckling. This suggests that this slope could also fail like the Xinmo rock avalanche in a future rainfall or earthquake event.

Fig. 4. Unstable hillslope (Xinmo east slope) to the east of the Xinmo landslide.
