## The 2009 L'Aquila, Italy Earthquake (M6.3) Damage and Response to a Moderate Event

James MORI

### Synopsis

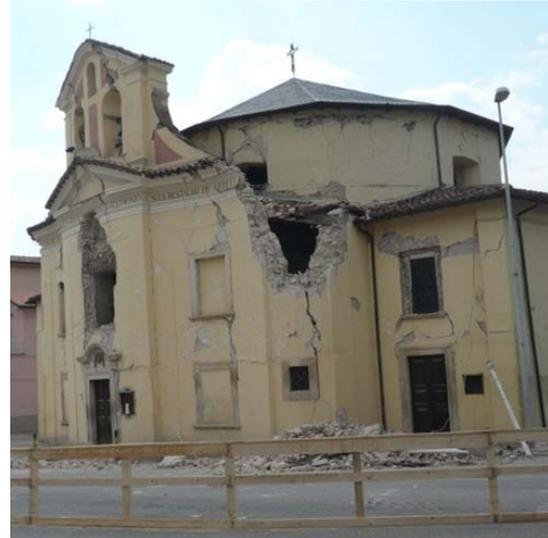
Photo 1. Damage to an old church in Paganica

The town of L'Aquila has a population of about 73,000 people and there was reported damage to over 10,000 buildings in the area. Many of the damaged buildings were old structures that were built several hundred years ago. However, many modern buildings were also severely damaged. There was much publicity in the Italian media about a collapse in the San Salvatore hospital which was built in 2000, and collapse of modern buildings on the campus of the University of L'Aquila where a number of students were killed. These failures in newly built structures raised questions about the quality of their construction.

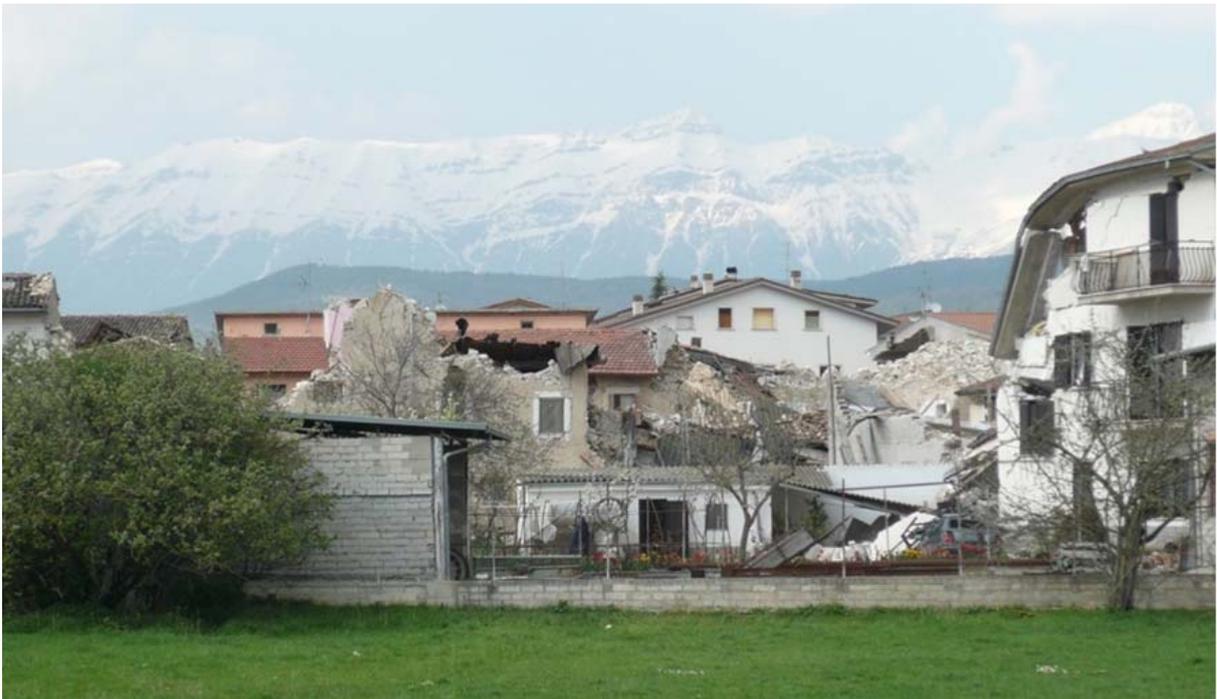
Photo 3. Severe building damage in the village of Onna.

Some of the most severe damage was in the village of Onna located about 7 km southeast of L'Aquila. Almost all buildings in this small town were destroyed. The severe ground shaking in this locale can probably be attributed to close proximity to the area of large slip on the fault combined with soft soil conditions.

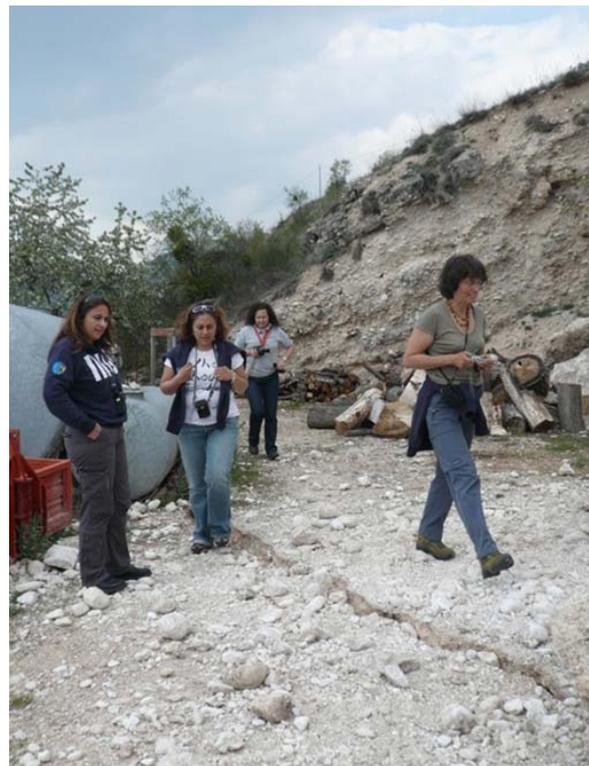
Photo 4. Fissure located at the surface position of the Paganica fault.

Geologists from INGV and other institutions carried out extensive surveys looking for surface displacements from the earthquake. Ground fissures were found in the region where the projected Paganica fault should surface (Photo 4). There is still debate whether these features represent co-seismic rupture or cracking in response to shaking or down slope subsidence (Falcucci et al., 2009). In either case, the amount of surface rupture would be several centimeters or less.

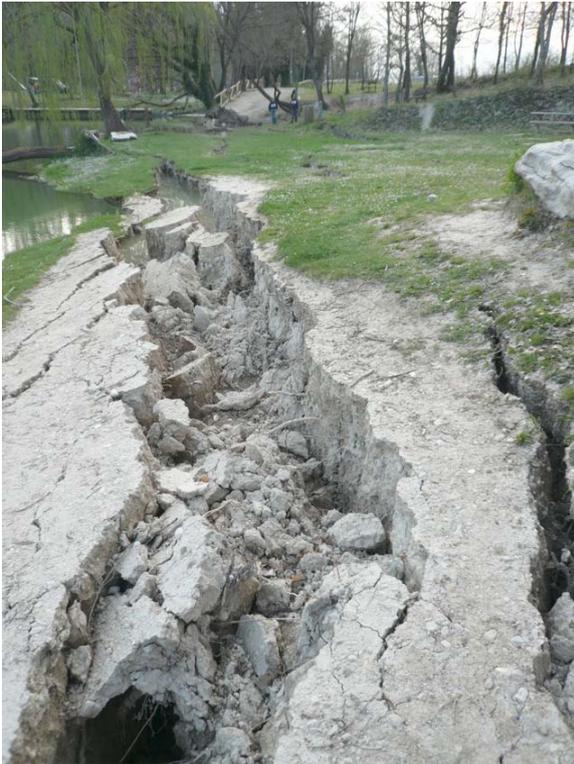
Photo 5. Ground cracking due to subsidence at Lake Sinizzo.

Large ground cracks due to local spreading were also seen at Lake Sinizzo were (Photo 5).
