## Portable Ring Shear Apparatus and its Application on Croatian Landslides

### Synopsis

## 3. Test Apparatus and Test Procedures

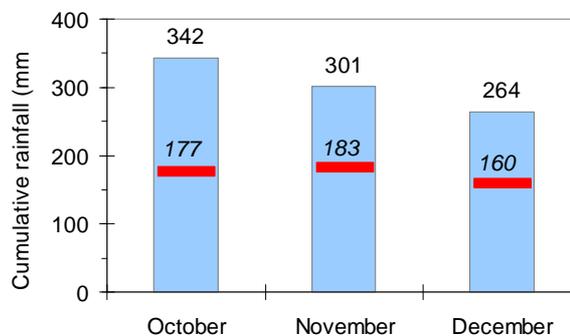
Fig. 2 Cumulative rainfall at the Rijeka rain gauge for October, November, and December 1996.

Red lines and italic numbers show long-term (1948–2009) monthly averages.

Figure 2 shows the cumulative rainfall measured in October, November, and December, 1996, at the Rijeka rain gauge. In the considered period, the monthly rainfall was from 94% (October) to 64 % (November) higher than the average monthly values in the period from 1948 to 2009 (red lines in Fig. 2) (Ostric et al. 2011).

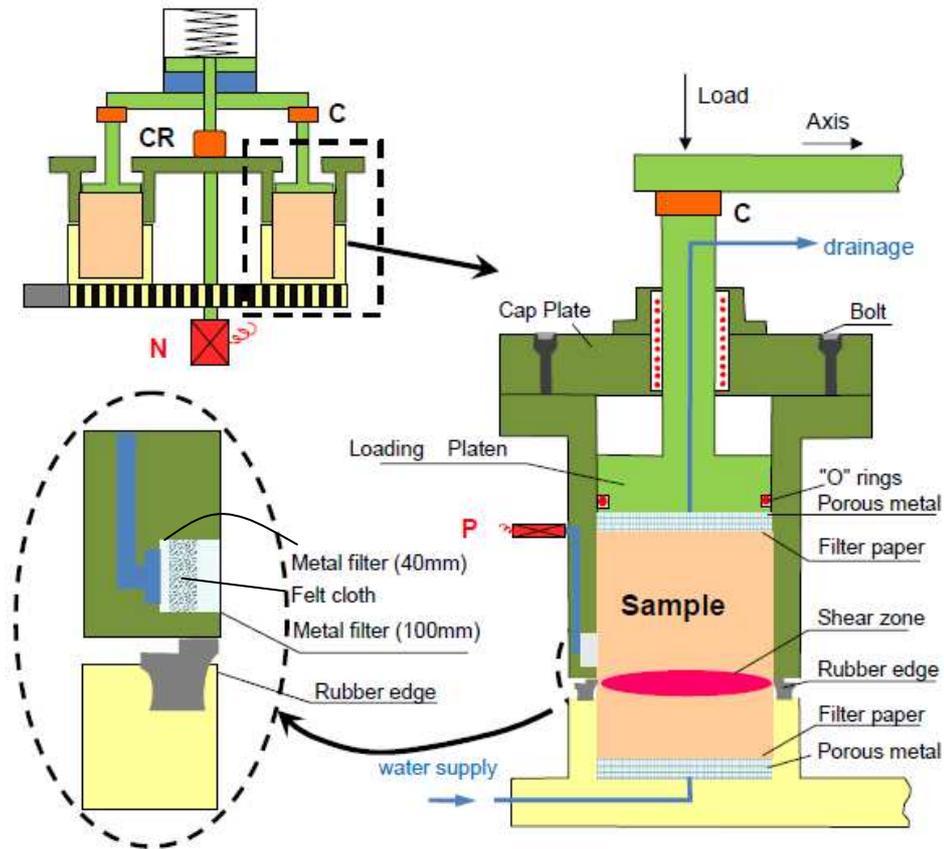
Fig. 3 A half cross-section of the shear box and the close-up diagram of the edges (CR - Connection Ring, C - Connection , N - Load cell for Normal Stress; P - Pore pressure transducer)

The most essential part of the ring shear apparatus is the construction of the undrained shear box (SB). Design of the shear box is illustrated in

Figure 3 with enlarged diagram of the right half of the cross section of the SB and its surroundings, including the water pressure measurement system

The sample in the ring-shear box is laterally confined between pairs of upper and lower confining rings, forming the shape of two

doughnuts. .During the test, the sample is loaded normally through an annular loading plate connected to an oil piston. The lower half of the shear box rotates while the upper half of the shear box is retained by two shear resistance cells that measure shear resistance.

Pore pressure is measured by pore-pressure transducers, which are connected to a gutter along the circumference of the inner wall of the upper outer ring. The gutter is located 3 mm above the shear surface and it is covered by two metal filters. As it is shown on Figure 3, two annular metal filters with pore sizes of 100  $\mu\text{m}$  and 40  $\mu\text{m}$  (from inside) were placed inside the annular gutter. A felt fabric cloth was placed between these two metal filters to prevent the outside (40  $\mu\text{m}$ ) filter from becoming clogged with clay particles.

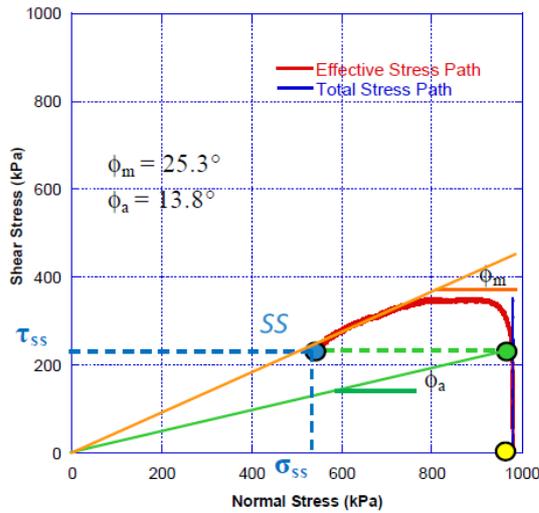
Fig.4 Stress path of Undrained Speed Control Test on saturated marl sample from Kostanjek landslide ( $B_D=0.95$ ; initial dry density:  $1.48 \text{ g/cm}^3$ , specific gravity,  $G_s=2.70$ ).

Figure 4 shows stress path that reached the failure line and moved down along the failure line. In this test, the peak failure line was not observed. The straight line fitting the stress path gave values of the friction angle during motion as well as peak

friction angle of  $25.3^\circ$  and apparent friction angle,  $\phi_a=13.8^\circ$ . We assumed cohesion is zero.

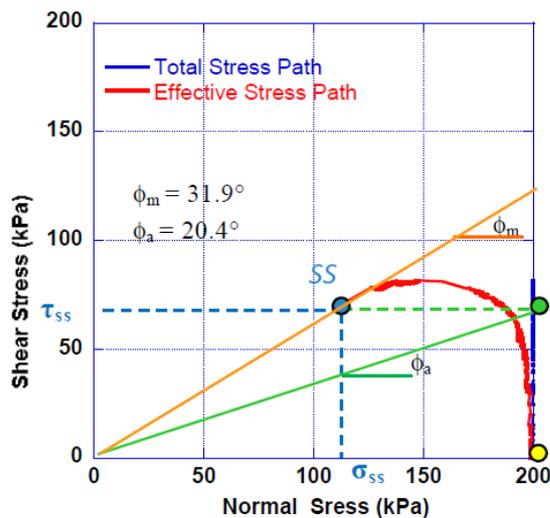
Fig. 5 Stress path of Undrained Speed Control Test on saturated clayey sample from Grohovo landslide ( $B_D=0.95$ ; initial dry density:  $1.51 \text{ g/cm}^3$ , specific gravity,  $G_s=2.664$ ).

Figure 5 shows stress path that reached the failure line and moved down along the failure line and like in the previous test, the peak failure line was not observed. The straight line fitting the stress path gave values of the friction angle during motion and also at peak as  $\phi_p = \phi_m = 31.9^\circ$  and apparent friction angle,  $\phi_a=20.4^\circ$ . We assumed cohesion is zero.

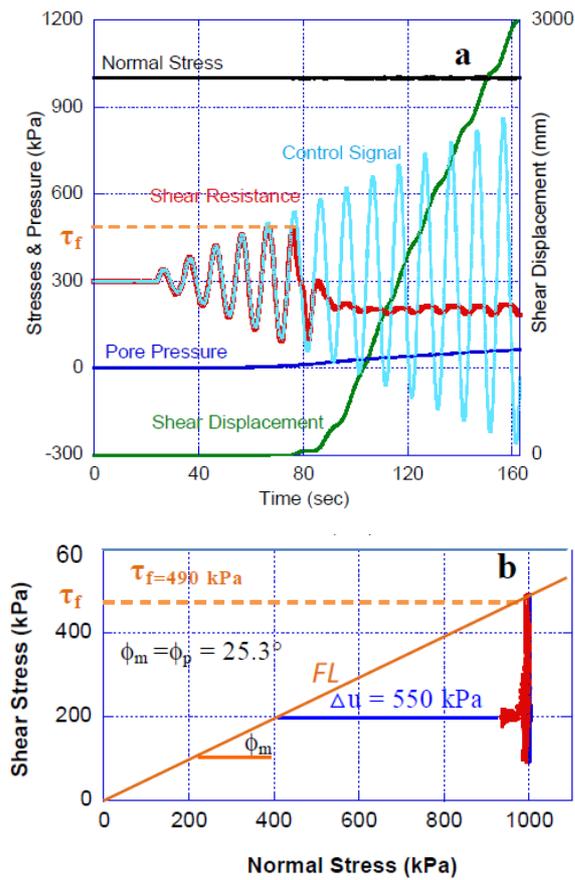
Fig. 6 Undrained cyclic loading test on saturated marl sample from Kostanjek landslide ( $B_D=0.96$ ; initial dry density:  $1.48 \text{ g/cm}^3$ , specific gravity,  $G_S=2.70$ ). a) Time series data for stress, pressure and shear displacement and b) Stress Path.

After consolidation of the sample, cyclic shear stress loading was applied in the undrained condition. The results of cyclic tests are presented in Figures 6 and 7. Figures 6a and 7a are showing time series data of cyclic tests, where the black line shows normal stress, the light blue line shows the control signal for shear stress which was given to the servo-stress control motor. The red line shows the shear resistance mobilized on the sliding surface, the dark blue line shows the monitored pore pressure and the green line shows the shear displacement. Figures 6b and 7b are showing stress path, with red line showing effective stress path and blue line showing total stress path.

Figure 6 shows time series data and the stress path of cyclic test conducted on the Kostanjek marl sample. For this sample, initial normal stress of 1000 kPa and initial shear stress of 300 kPa was applied before cyclic (sine wave) shear stress was loaded at 0.1 Hz and stepping up shear stress by 40 kPa/ cycle.

Although pore pressure must have been generated in the shear zone, it could not be well monitored as it can be estimated on Figure 6b. During the post failure movement after 80 sec in Figure 6a, the effective stress should be on the failure line. So the horizontal difference between the failure line and the monitored effective stress (550 kPa) is excess pore water pressure value which was not monitored by the pore water pressure sensor shown in Figure 6a. This is due to the slow response resulting from the lower permeability of the material tested.

The accelerated motion was produced after failure, as it is shown on Figure 6a. Although, initially both lines of the control signal for shear stress and the mobilized shear resistance are the same, they differ after failure. Shear resistance decreased from the maximum value of 490 kPa to the steady state although control signal is continued to be increased. The difference of stress is used for acceleration of shear motion.

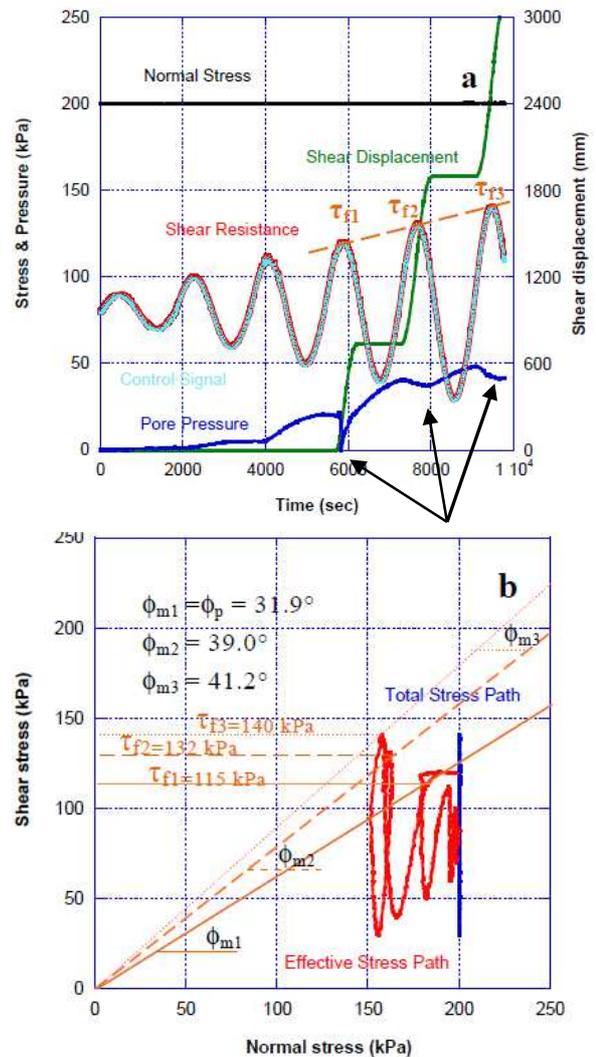
Fig. 7 undrained cyclic loading test on saturated clayey flysch sample from Grohovo landslide ( $B_D=0.96$ ; initial dry density:  $1.51 \text{ g/cm}^3$ , specific gravity,  $G_S=2.66$ ). a) Time series data for stress, pressure and shear displacement and b) Stress Path.

Figure 7 shows the time series data and stress path of cyclic test conducted on the Grohovo clayey flysch surface sample. Due to the low permeability of this sample, we chose much slower cycle shearing of 2 cycles/ hour.

For Grohovo sample, initial normal stress of 200 kPa and initial shear stress of 80 kPa was applied before cyclic shear stress was loaded with the amplification increment of 10 kPa/ cycle at 0.1 Hz. The sample failed, but without rapid failure motion. Figure 7a shows that displacement of 700 mm occurred after 6, 000 sec and pore pressure of app. 20 kPa was generated. Unlike the previous case (Kostanjek sample), both lines of the control signal for shear stress and the mobilized shear resistance are the same during the test.

Shear displacement occurred in a different mode then for Kostanjek sample. Each time shear stress given by control signal reached value of shear resistance, shear displacement occurred.

When shear stress decreased, displacement stopped and shear resistance moved down with loaded shear stress lower than failure line. Sample showed dilative behavior, which is indicated by black arrows on the graph, showing negative pore pressure generation at each displacement step. Consequently, the peak friction angle increased as well, from the initial value of  $31.9^\circ$  to  $39.0^\circ$  and  $41.2^\circ$ . The sample showed strength-hardening behavior.
