Earthquake Damage Evaluation of 2018 Hokkaido Eastern Iburi Earthquake Based on Estimated Substructure by Microtremor Observation at Oiwake, Hayakita and Mukawa

○Ting YE, Shinichi MATSUSHIMA

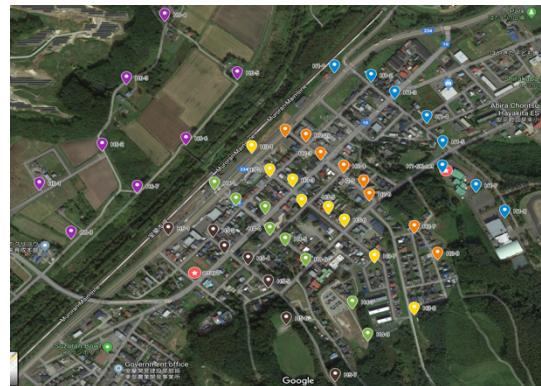
Figure 1 Microtremor observation sites at Hayakita

in order to obtain the microtremor Horizontal-to-Vertical spectral ratio (MHVR) and the phase velocity, respectively. This information will be used to identify the subsurface structure at the target sites. The designed single-station microtremor observation points were designed that the interval between points are about 100m on lines that go through the damaged and undamaged parts of the town. The array apertures were up to about 10 meters in order to estimate the shallow subsurface features. The duration of observation for each point was 15 minutes. Figure 1 shows the observation points at Hayakita as an example.

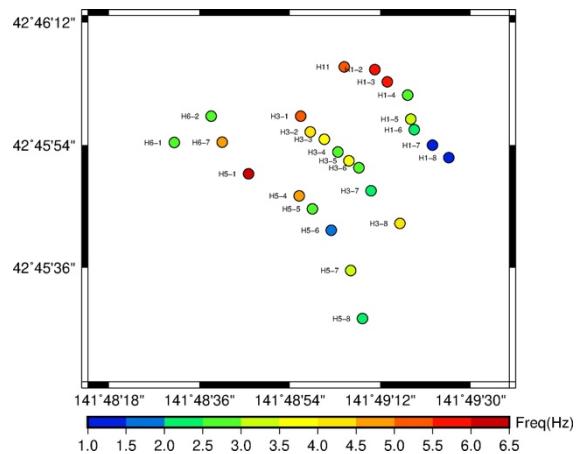
In order to calculate the MHVRs, the total duration was separated to 40.98 sec segments overlapping 50%, and then averaged. The segments with traffic noise was neglected. The predominant frequency of Oiwake district is about 2.3 to 6.3 Hz and of Hayakita district is about 1.5 to 6.1 Hz shown in Figure 2. On the other hand, Mukawa district has first peaks at low frequency ranging from 0.7 to 1.0 Hz. The peak frequency of Oiwake and Hayakita was quite high, it can be inferred that the strong motion affected by shallow structure.
