## Study on Seigyu Structural changes and its effectiveness in promoting geomorphological management under floods conditions

Fujii Temma, Almamari Mahmood, Takemon Yasuhiro, Tetsuya Sumi, ○Kantoush Sameh

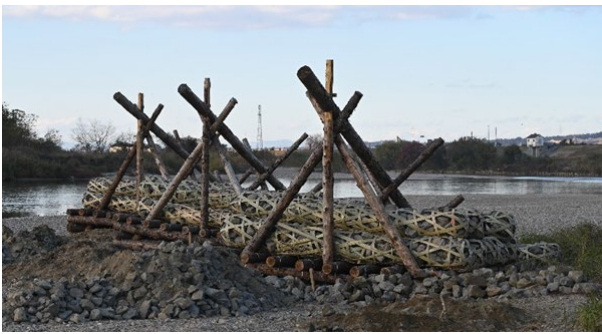
Fig. 1. Seigyu installed in the bar-tail

Japanese rivers are facing the problem of reduction in sediment supply below dams resulting in riverbed degradation and geomorphological changes. For restoration of the riverbed geomorphology, dissipation of flow velocities, and flow diversion, a series of Japanese traditional river training structures called “Seigyu” (Fig. 1.), were constructed on a sand-gravel bar in Kizu River.

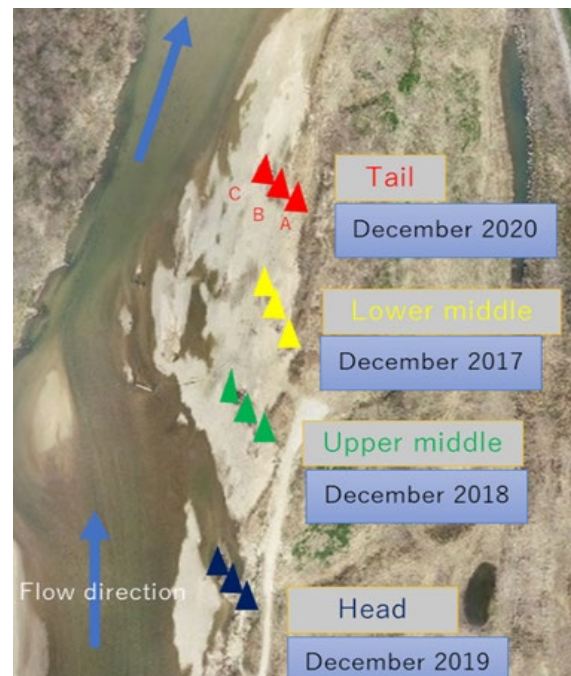
Fig. 2. Installation date and locations

The development of Seigyus works in Kizu River started in 2017. Four sets, each set consisting of three single Seigyus, in total 12 single Seigyus structures were installed as a group at an angle to the main flow and spatially distributed along the sand-gravel bar with different spacing between the four sets. Fig. 2. shows the dates of construction work and the location on the sand-gravel bar. To develop design guidelines for Seigyu’s practical implementation, it is important to answer the following questions:

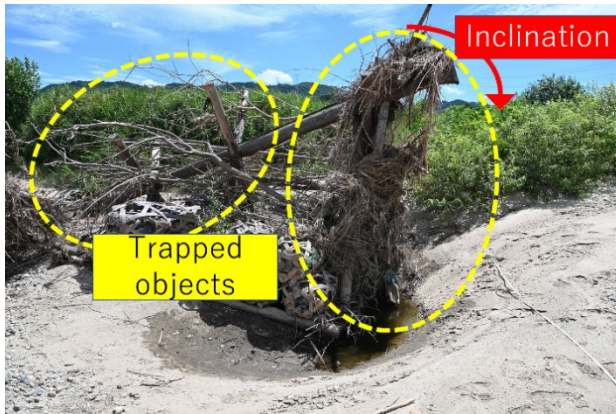
Fig. 3. Transformation of Seigyu wooden piles

UAV using large-scale particle image velocimetry (LSPIV). To investigate the transformation of the Seigyu structure, which consists of inclination and trapped floating debris as shown in Fig. 3. The transformation was assessed based on the inclination angle and opening-space ratio of Seigyus wooden piles, obtained from a 3D model generated by photogrammetry software.

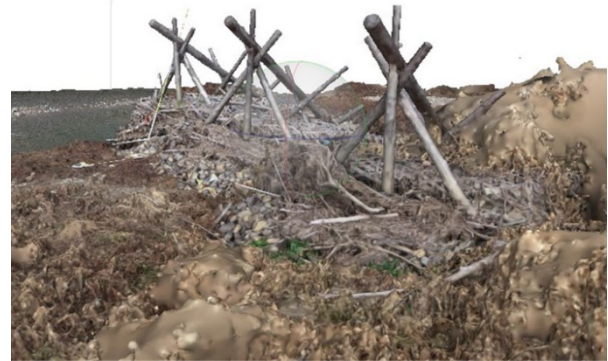
Fig. 5. 3D-model of the 3 Seigyus in the bar-tail
