## 火災後の流域管理に向けたアルジェリアでの林野火災調査 Investigation of wildfires in Algeria toward postfire basin management

○峠嘉哉・Sameh Kantoush・Mohammed Saber・Asma Bouamrane・  
Ali Bouamrane・Mahmoud Mohammed Rasid Al-Maamari・田中賢治・角哲也  
○Yoshiya Touge, Sameh Kantoush, Mohammed Saber, Asma Bouamrane,  
Ali Bouamrane, Mahmoud Mohammed Rasid Al-Maamari, Kenji Tanaka, Tetsuya Sumi

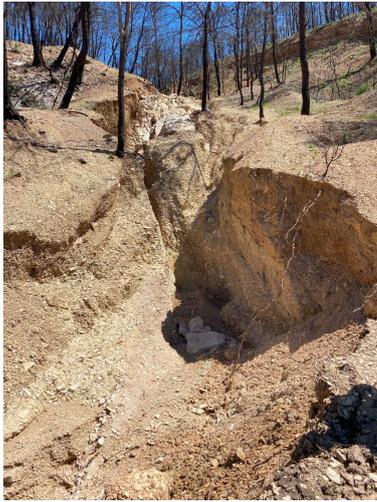
図2 焼損域内の斜面崩壊

スーカラス周辺で生じた林野火災焼損域では, 樹木が頂部まで焼損し, 地表火・樹冠火の双方が生じたと考えられた. 焼損域内では複数の斜面崩壊が生じており, 図2は集水面積は狭くないが焼損度の高い領域からの流出で生じたと考えられる. その周辺で崩壊地点より集水面積が広い地点では, 複数の建物に土砂が堆積し, mud flow によるとみられた (図3).

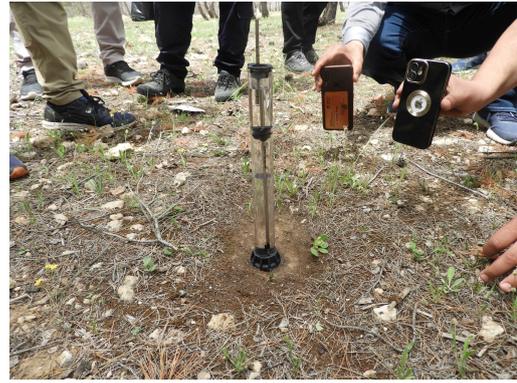
図4 変水位透水試験

図4はインフィルトローメーターを用いた変水位透水試験である。林野火災後は土層が撥水性を帯びることが知られており(DeBano 2000),それによる流出率の増加は下流側で洪水・斜面崩壊の原因となる。火災後豪雨の数値解析を見据えると林野火災の影響は透水係数で表現することとなるため実測値は必須である(Tozato et al. 2022)。火災の影響を受ける土層は表層の数 cm 程度でしかないため、土壌コアを採取し透水試験を実施する一般的な方法ではコア内で土壌の状態を均一にできない。現場で実際に計測できる手法も有用である。

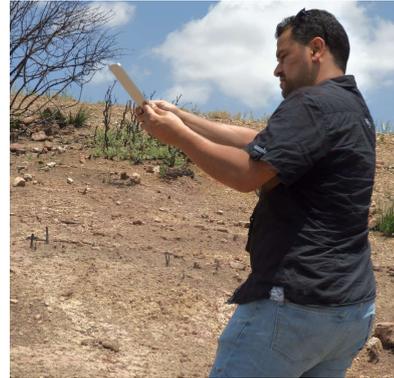
図5 地表面の写真測量

図5は写真測量による地表面観測である。図2-3に示した斜面災害を踏まえると、火災後の地表面を UAV で継続観測することで土壌浸食の経緯を記録することが有用と考えられる(Touge et al. 2023)。しかし、アルジェリアでは法律により UAV

での飛行観測が困難であった。そのため、図5のように地上で写真を撮影することで地表面を記録した。撮影結果を DEM に変換するためには画像合成技術が必要であり、観測・解析手法の双方を技術提供した。今後現地機関による林野火災後の調査観測できる体制として、今後に研究展開が期待できる。
