## A Preliminary Report on the Landslides and Other Ground Surface Movements Induced by 1999 Chichi Earthquake, Taiwan

### Synopsis

Preliminary discussion on the geomorphological conditions of characteristic ground surface movements induced by the 1999 Chichi Earthquake is presented on the basis of the field reconnaissance study in December, 1999. The displacement of the soft ground by the earthquake-inducing fault was dominated by the horizontal movement and induced damage of structures. Two gigantic landslides visited in this study suggest that the dip of the intercalated mudstone and sandstone of the Neogene and the groundwater conditions determined the occurrence of large-scale landslides. Extensive occurrence of surficial landslides suggests the importance of the weathering characteristics of coarse sedimentary formation of weak cohesion.

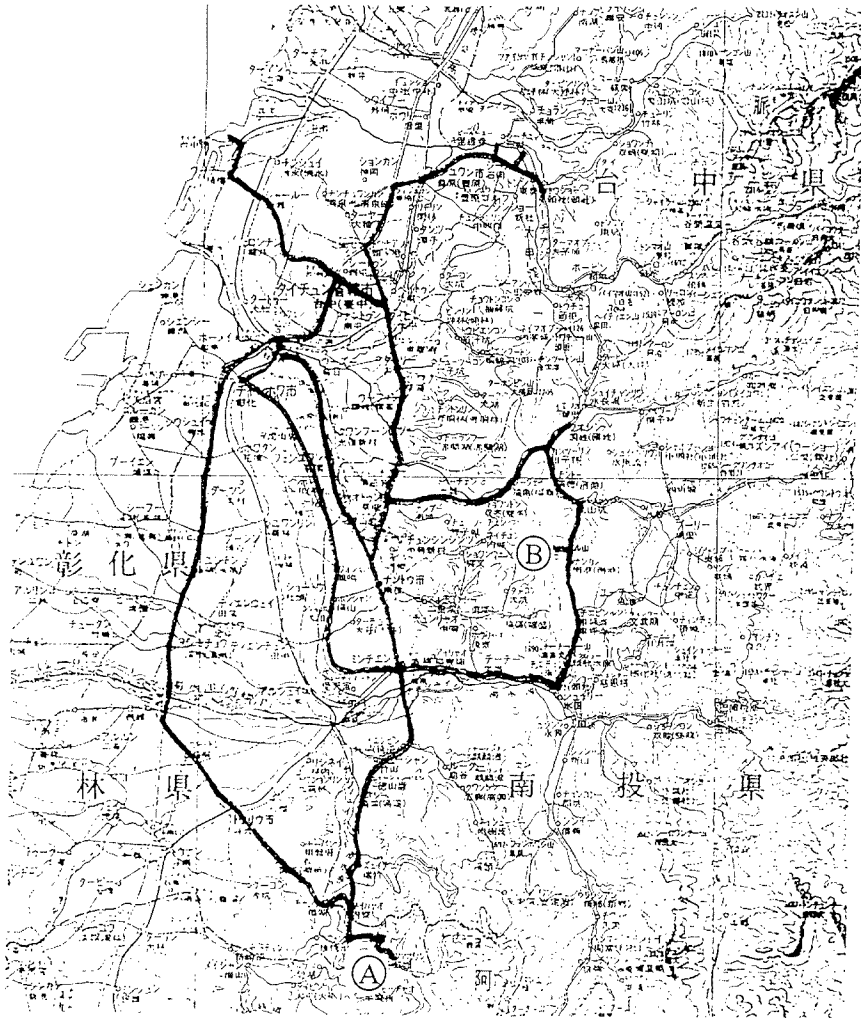
Fig. 1 A route map of the ground survey by car. A: Tsaolin, B: Chiufengershan.

The Chichi Earthquake of a Richter scale magnitude of 7.6 on 21 September, 1999 induced a variety of ground surface movement including large-scale landslides. In comparison with recent earthquake hazards in Japan (e.g., Okunishi et al., 1999), it is marked that hazardous ground motion took place along a long distance of the outcrop of the fault, and that a number of large-scale landslides including several gigantic landslides caused a catastrophic disaster in a wide area (Lin, 2000). Here is reported the result of our reconnaissance study between 6 and 12 December 1999. The route map of the field investigation is shown in Fig. 1.

This landslide occurred on the eastern slope of a ridge stretching in the north-south direction and dividing the drainage basins on the both sides (Fig. 1 and Photo 13). This ridge is accompanied by a peneplain with farmlands and 30 houses, among which 21 houses were demolished causing 39 victims due to the landslide. A house was found standing at a place about 1 km apart from the original place, presumably because its base was appropriately soft so as to avoid crushing, still maintaining its consistency (Photo 14). Another house was found about 100 m apart from the original place, standing on a base of a cubic rock mass of about 1,000 m<sup>3</sup>. As shown in Photo 13, the landslide scar of the denudational area is planar suggesting the slide along the bedding plane. It should be, however, noted that, immediately after the landsliding, this plane had not been so flat as shown in Photo 13. The longitudinal colored stripes on the exposed slip surface suggest that the bedding plane was oblique to the slip surface and that its dip is a little greater than the gradient of the latter. It is, however, inferred that the sliding was essentially along the bedding plane. The horizontal linear object across the landslide area is a tentatively restored road. A part of weathered mantle that had been left intact is found at the upper edge of the denudational area.

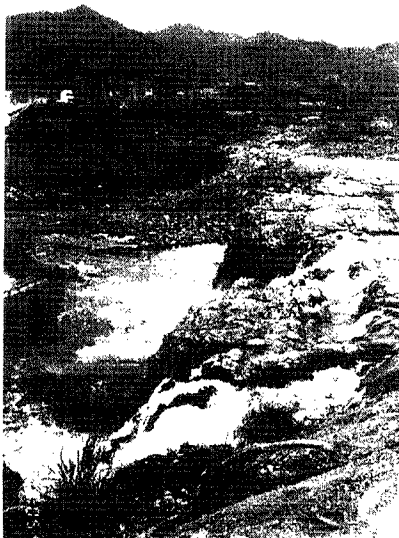
Photo 1 A water-fall created by the earthquake fault in the Dachia-shi River near Fengyuan. Crushed rock is left on the high-water bench beyond the river. Erosion by running water is already in progress in the central part of the river.

girder. The outcrop of the earthquake fault was at high angle when it crossed the bedrock (Photo 1) and at low angle when it crossed a soft stratum, presumably reflecting the difference in friction angle. An anticlinal uplift was observed on a soft and cohesive stratum (Photo 2).

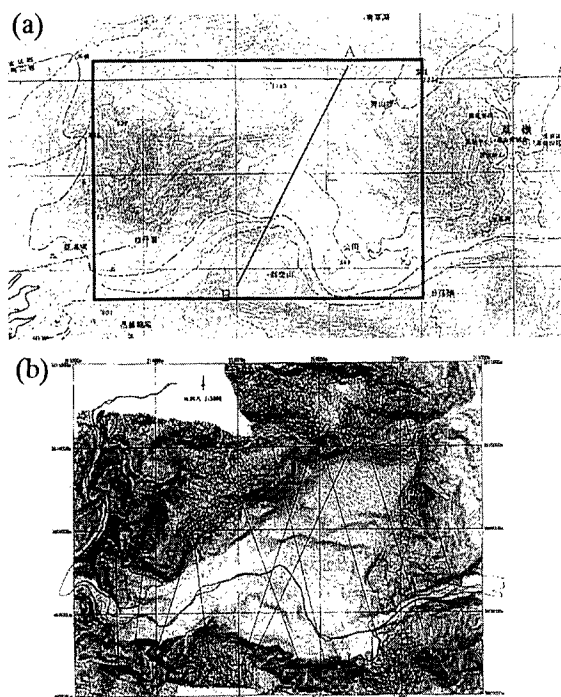
Fig. 2 Topographic map of the Tsaolin Landslide Area before the earthquake (a) and after it (b), after Lin (2000). Grid interval is 1 km.

landslide mass was  $120,000,000 \text{ m}^3$  and the affected area is 698 ha with a distance of about 4 km between the top of the slip surface and the snout of the debris avalanche. There were only small casualties because the landslide area was off the village center of Tsaolin. The aerial photograph and the topographic map of this landslide area are shown in Photo 3 and Fig. 2, respectively.

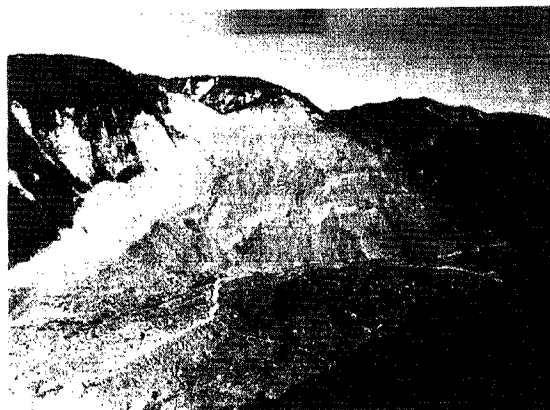
Photo 4 The denudational area and the area of former channel of the Qingshui-shi river of the Tsaolin Landslide.

There is a main scarp of horseshoe type at the center of the top part. It was accompanied by two shallow landslides on its right and left side at a little higher position (Photo 4). The main block extends to

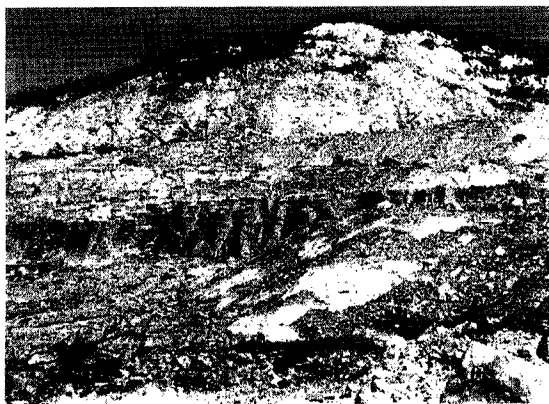
Photo 5 Outcrop of the bedding plane at the secondary landslide scar of the Tsaolin Landslide.

southwest from the main scarp and there are two steps of the secondary scarp. Viewed from the bottom, the upper one represents a cross section of layered strata and the other does not present obvious lamination (Photo 5). Such structure is characteristic of the sliding along the bedding plane of a gentler angle. The denudation area and the transport area were not easily distinguished, since many landslides had been repeated here. The depositional area was beyond the original channel of the Qingshui-shi River. The sliding was inferred to be caused by the intercalation of permeable sandstone and impermeable siltstone, which store perched groundwater lubricating the interface, as demonstrated at the eastern edge of the lower step (Photo 6). There, water was found to seep out of the interface between sandstone and siltstone and flow on the planar surface of the latter. The discharge was thought to have decreased from that at the time of landsliding, since the white powder (main constituent is  $\text{Na}_2\text{SO}_4$ ) was seen covering the rock pieces and debris besides the watercourse. It suggests the leaching of  $\text{Na}_2\text{SO}_4$  associated with the hydration of clay minerals (Sato and Aoki, 1990).

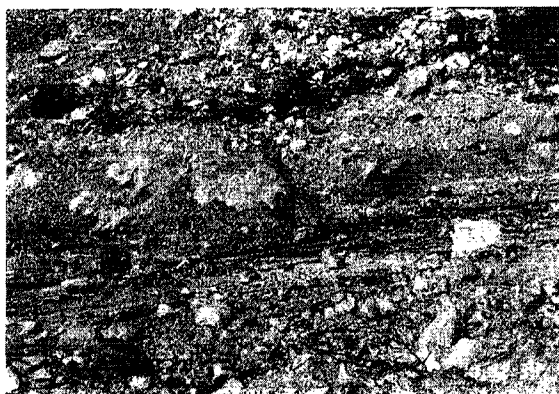
Photo 6 Water running out of spring on the bedding surface of siltstone.

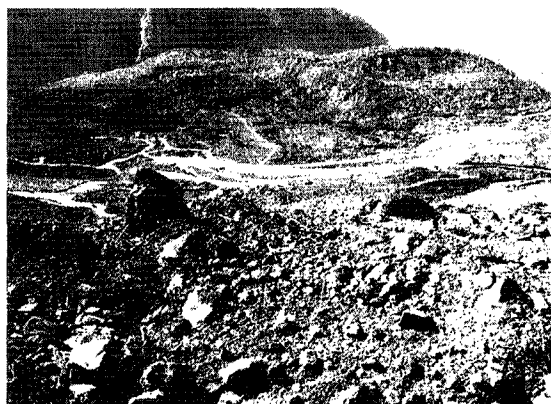
Photo 7 Depositional mound of the main block of the Tsaolin Landslide. Tong-like snout is visible at its head and slip-back scars are at its tail facing the site of the original channel.

the southern side of the original channel of the Qingshui-shi River. There are secondary scarps towards the rear side of the depositional area suggesting the back-slip according to the inverse gradient of the ground surface. A wide and shallow valley had been left along the original channel, not by the channel erosion but by the high-speed transit of the sliding mass. The snout of the depositional area is formed by sheets of debris with a shape like a tongue (Photo 7). It suggests the liquefaction by the water which was squeezed out of the sliding mass (Suwa et al., 1985). A schematic illustration of the main block in its moving state is shown in Fig. 3 according to the above consideration.

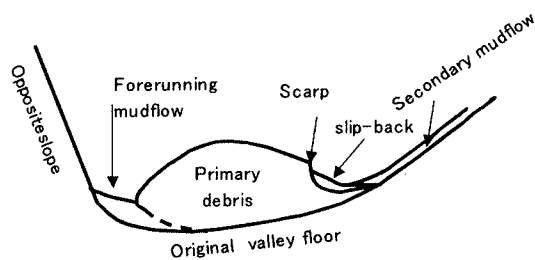
Fig. 3 Schematic illustration of the depositional features of the main block of Tsaolin Landslide

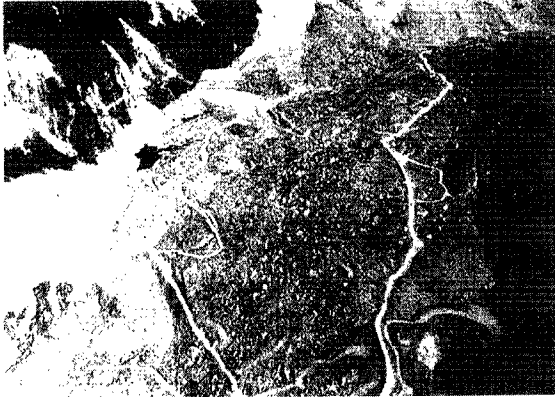
Photo 8 An overview of the western side block. It consists of two zones of different color. The black object a little at the upper left of the center is a pond.

The western boundary of the upper part of the landslide area is a rocky cliff. The debris falls on it is obviously independent of the gigantic landslide. The part of the gigantic landslide that is adjacent to the border is distinguished from the main block by its color suggesting a high mobility. A group of flow mounds form hummocky zone between this part and the main block. This zone is interpreted as the transitional zone between the main block where the sliding mass was essentially rigid, and the fluidized part. Thus these two parts should be lumped as a side block. Photo 8 shows the central part of the western

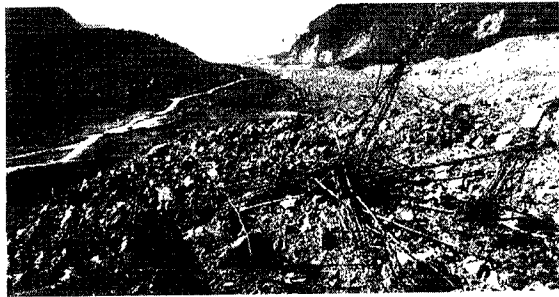
Photo 9 The debris that flowed downstream along the Qingshui-shi River (photograph was taken from the main block).

side block viewed from the helicopter. Corresponding to the main block expanding its width towards the lower end, the side block moved towards west-southwest and after reaching the channel of the Qingshui-shi River, it flowed along the channel for about 500 m (Photo 9).

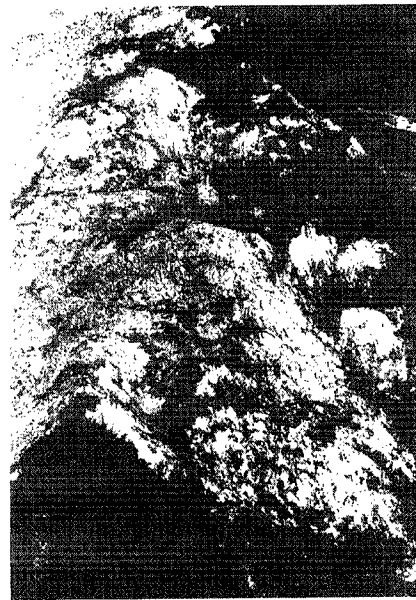
Photo 11 A close-up of the lower part of Photo 10.

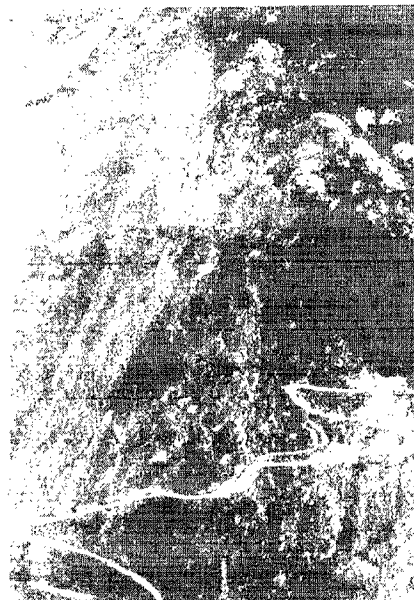
Photo 12 The hummocks in the eastern side block located at the lower left of Photo 11.

This hummocky zone continues to the original channel of the Qingshui-shi River, and beyond it, the sliding mass is bifurcated similarly to the western side block. While the western side block can be regarded as a variant of the main block due to a high mobility, the eastern side block seems to be an assembly of the regions of different dynamic properties. It includes transitional slide of highly weathered soil and slumping of the laminar formation, as well as the hummocky zone. However, these regions should be regarded as a block as a whole, since they are commonly associated with deep weathering along the eastern edge of the landslide area.

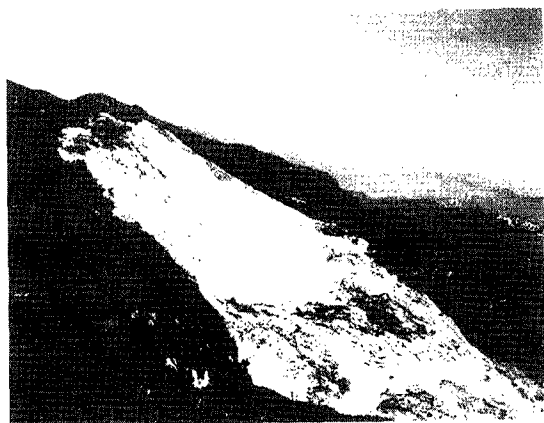
Photo 13 An overview of the Chiufengershan Landslide (the natural dam is not visible).

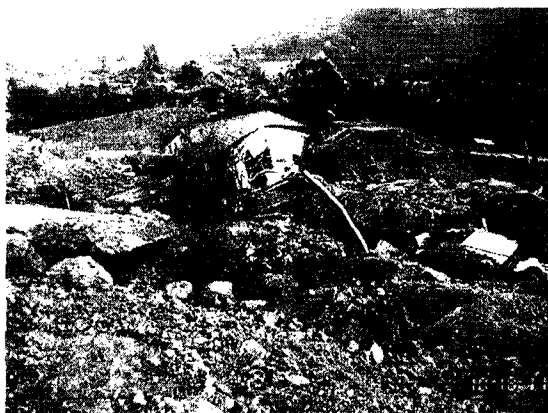
Photo 14 A house that had been near the ridge of Mt. Chiufengershan was moved along a distance of about 1 km by the landslide.

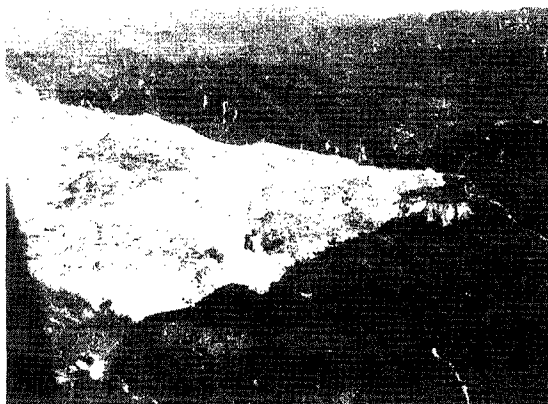
Photo 15 The lowest part of the landslide deposit that blocked a small river around its confluence with a tributary. A part of the deposit has been modified by the restoration works.

Below the denudation area is a hummocky depositional are. It is steeper on its upper part and gentler on the lower part. The lower part is underlain by the main channel of a small river and one of its tributaries, and also by a small ridge between them. The river was blocked along a distance of about 1 km (Photo 15). A small lake has been formed at the upstream side. A large construction work was in progress and the ground surface of the depositional area had been partly disturbed at the time of the field reconnaissance study.

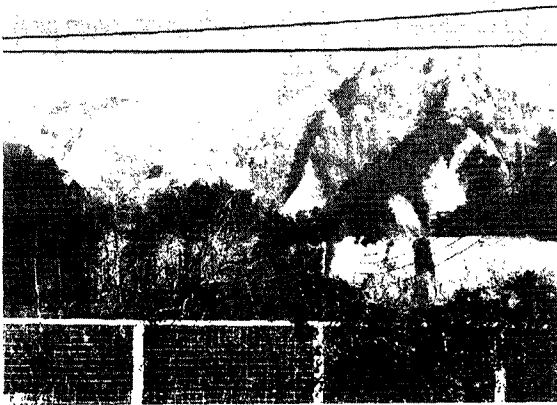
Photo 19 A view of Mt. Chiushichiu-feng denuded of vegetation due to extensive and intensive surficial landslides.

observed. In several areas, this type of landslides were connected with one another to produce a wide landslide area. An extreme example of such cases was observed on the Mt. Chiushichiu-feng (the naming came from "ninety-nine peaks") where almost all parts of the mountain slopes of conglomerate had become denuded of vegetation (Photo 19). A series of marked geomorphic changes (Okunishi et al., 1987) are anticipated in the future.
