## Assessment of Landslide Risk during Earthquake/Rainfall on Urban Areas

Kyoji SASSA, Gonghui WANG, Hiroshi FUKUOKA

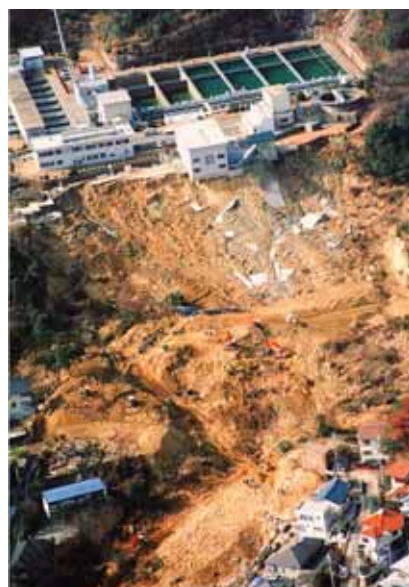
Fig. 2 Photos of the 1995 Nikawa landslide on Nishinomiya City (taken by Sassa)

At the Hyogoken-Nanbu earthquake, many landslides were triggered in the metropolitan areas between Kobe and Osaka. Among them the largest landslide disaster was the Nikawa landslide, which killed all 34 residents sleeping in 11 houses below the slope. The volume of this landslide was 110,000 ~120,000 m<sup>3</sup>, and the moving distance was about 175 m (Sassa et al. 1996). No recorded data concerning the sliding speed was available. However, it is believed that it was a rapid landslide, since no one evacuated from the destroyed houses and all 34 residents were killed. The locations of Nikawa and other two landslides introduced in this paper are presented in Fig. 1. Fig. 2 is a photograph showing

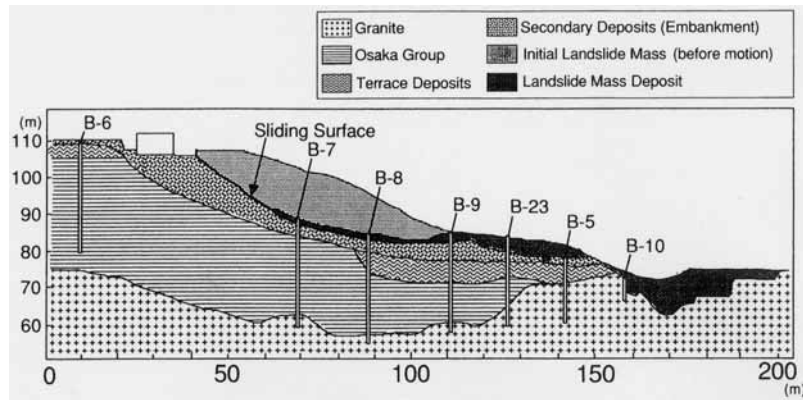
Fig. 3 Geological sections of the Nikawa landslide

the whole area of the Nikawa landslide, and Fig. 3 shows its geological section. Soon after the landslide hazard, 28 borings were executed and ground water table were monitored inside/outside the landslide area. The ground water surface existed in 6-7 m in depth, and the sliding surface was formed in 14 m deep (maximum) inside the embankment of Osaka group formation (limnic and marine deposits of granitic sands and clays in Pliocene to Middle Pleistocene). Therefore, the sliding surface was saturated. The slope was not steep, because the slope angle was about 20 degrees. The apparent friction angle that was calculated from the line connecting the top of initial landslide to the toe of deposition was 9.6 ~11.4 degrees, showing high mobility.

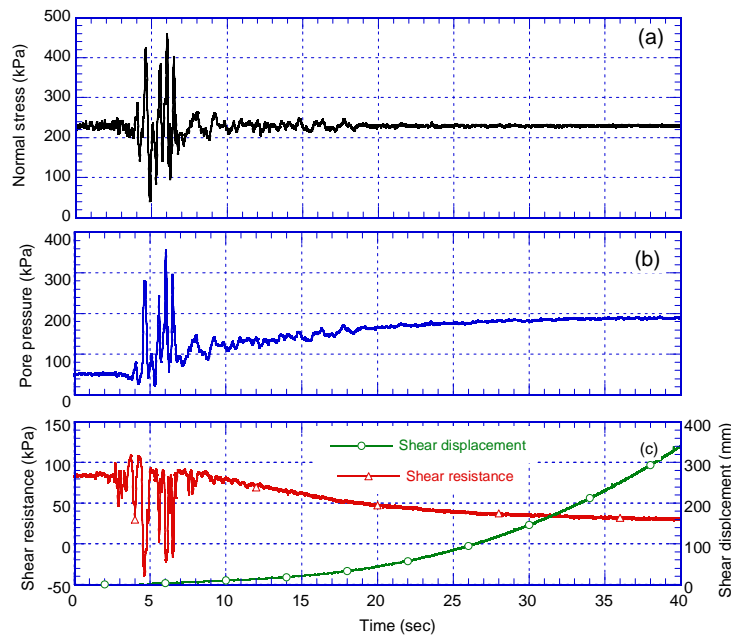
Fig. 5. Results of ring-shear undrained simulation test on the Osaka group formation in the Nikawa landslide ( $B_D = 0.99$ ,  $D_r = 121.2\%$ ). (a) normal stress; (b) pore pressure; and (c) shear resistance and shear displacement.

The test results are presented in Fig. 5. In Fig. 5a, the monitored normal stress is almost the same as the control signal. Fig. 5b shows the variation of excess pore water pressure. During the main shock (3 ~ 7 sec), the excess pore water pressure changed rapidly in response to the loading stresses. The bottom of excess pore water pressure indicates the excess pore water pressure built-up during the main shock. It should be noticed that excess pore water pressure kept increasing to a certain value even after the end of the main shock. Fig. 5c shows the variation of shear resistance and shear displacement. During the main shock, the sample failed because the loaded shear stress exceeded the shear strength of the soil. Shear displacement was still small during the main shock, however it increased rapidly after the main shock. The mobilized shear resistance gradually decreased, reasonably corresponding to the tendency of excess pore water pressure built-up after the main

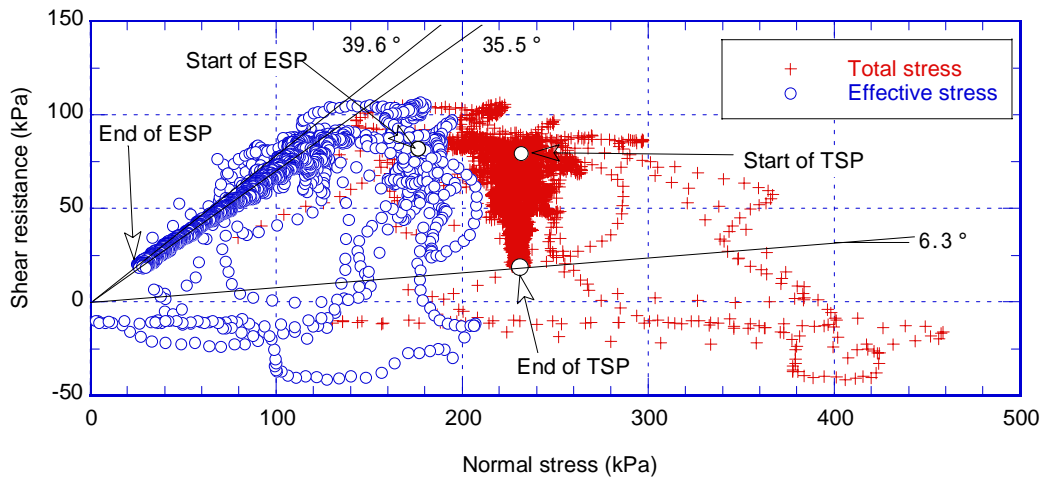
Fig. 6. Stress path for the ring-shear simulation test (ESP: Effective stress path, TSP: Total stress path)

shock. Fig. 6 shows the stress path obtained in the simulation test. ESP means the effective stress path, while TSP means the total stress path. Because of possible delay of excess pore water pressure measurement during the period of high frequency, some stress points are distributed above the failure line. Although it is difficult to follow the process of each stress path with this figure, referring to the time series data, it is reasonable to describe the stress path as follows. At first, the stress path reached the peak strength failure line ( $\phi_p = 39.6^\circ$ ) and the soil failed.

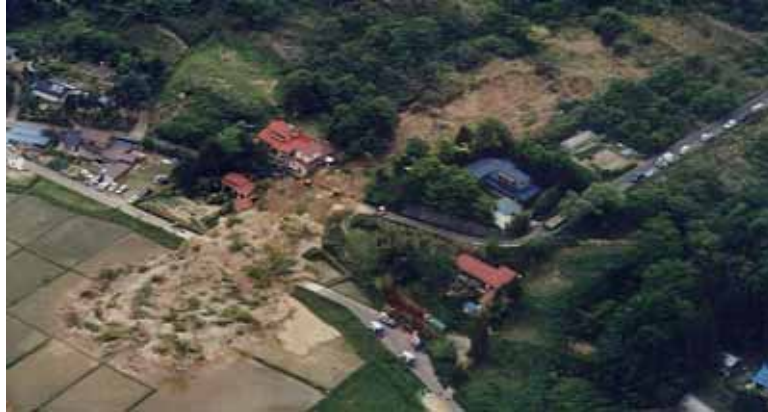
Fig. 9 Oblique side view of the landslide (Photo courtesy of Kokusai Kogyo Co., Ltd).

Fig. 9 shows an oblique side view (taken by Kokusai Kogyo Co. Ltd). From this photo, it is seen that the road on the right side is almost parallel to the landslide, indicating the nature of gentle slope. It is also noticed that almost all of the displaced landslide mass slide out of the source area and deposited on a horizontal rice paddy. Fig. 10 is the view from the toe of the landslide, which was taken four days after the event (at our survey time). The source area was covered by blue sheet for the prevention of possible second disaster during rainfall. The bamboos on the source area originally were transported with the landslide mass; however, most of them were standing almost vertically on the rice paddy with very thin landslide mass below them.

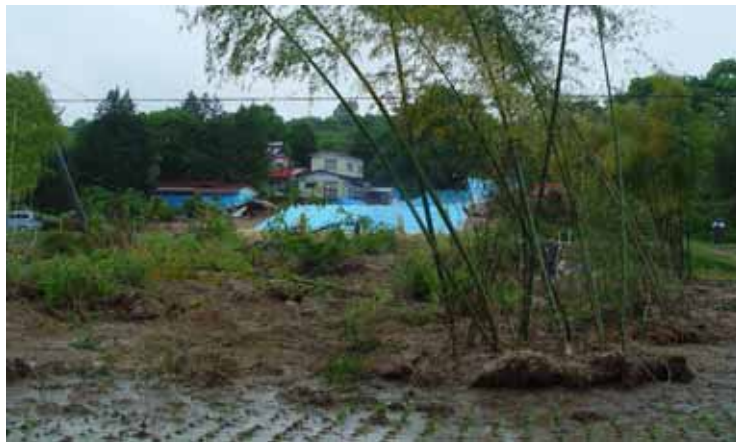
Fig. 10 View from the toe of Tsukidate landslide.

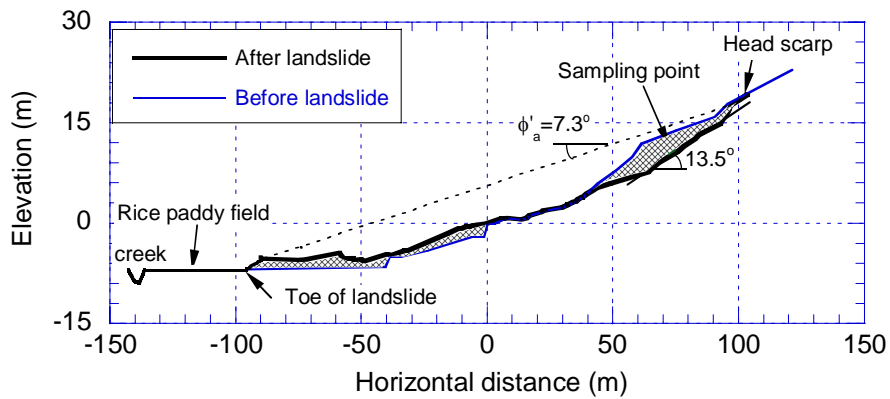
Fig. 13 Longitudinal cross section of Tsukidate landslide.

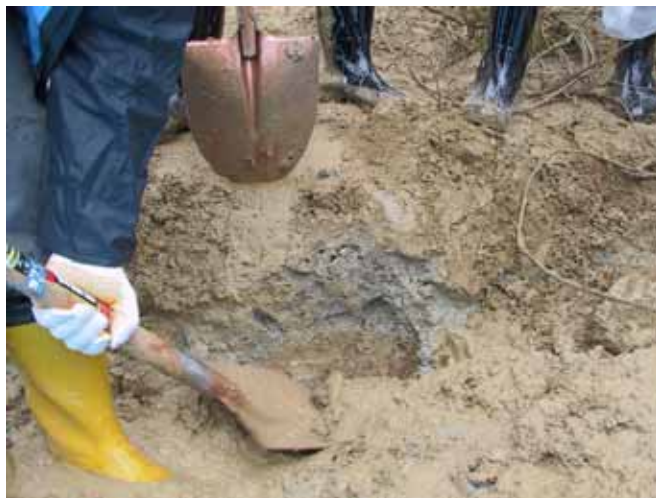
Fig. 14 Sampling on the source area

To examine the triggering mechanism of the landslide, samples were taken from the source area from the fillings, which was mainly composed of pyroclastic deposits. Fig. 14 presents the sampling site on the left side (see from the upper slope to down slope) of the landslide. As revealed by this photograph, the pyroclastic deposits changed its colour from brown (due to oxidization) to blue-grey (due to deoxidisation). This means that the iron contained in the soil was not oxidized due to the long term existence of ground water. Therefore, it was

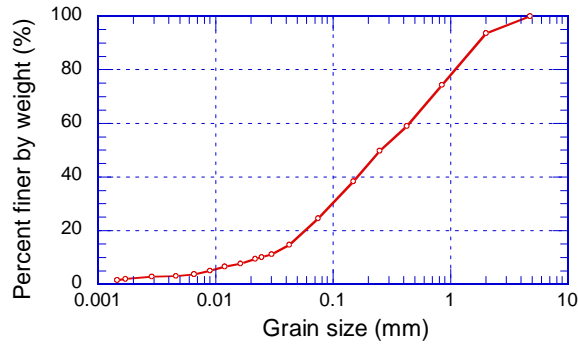
Fig. 15 Grain-size distributions of sample from the source area.

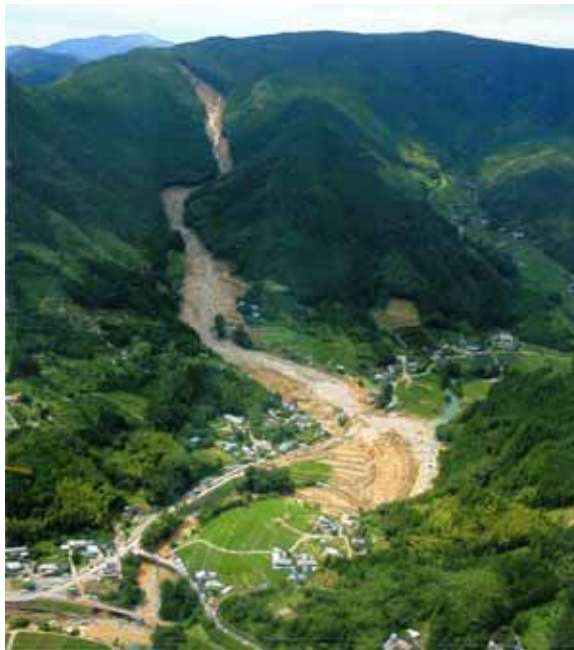
Fig. 17 Aerial oblique view of the 2003 Minamata debris flow

a debris flow that struck a village along the torrent, destroying 15 houses, killing 15 people, and injuring an additional six people. Fig. 17 presents a view of the debris flow. The initial slide can be seen at the head of the debris flow. Apparently, this debris flow was triggered by the slide, and the landslide mass flowed downstream along the torrent, increasing its volume by entraining material from the channel and weathered surface soils of the mountain slopes on both sides of the channel. Fig. 18 shows the central

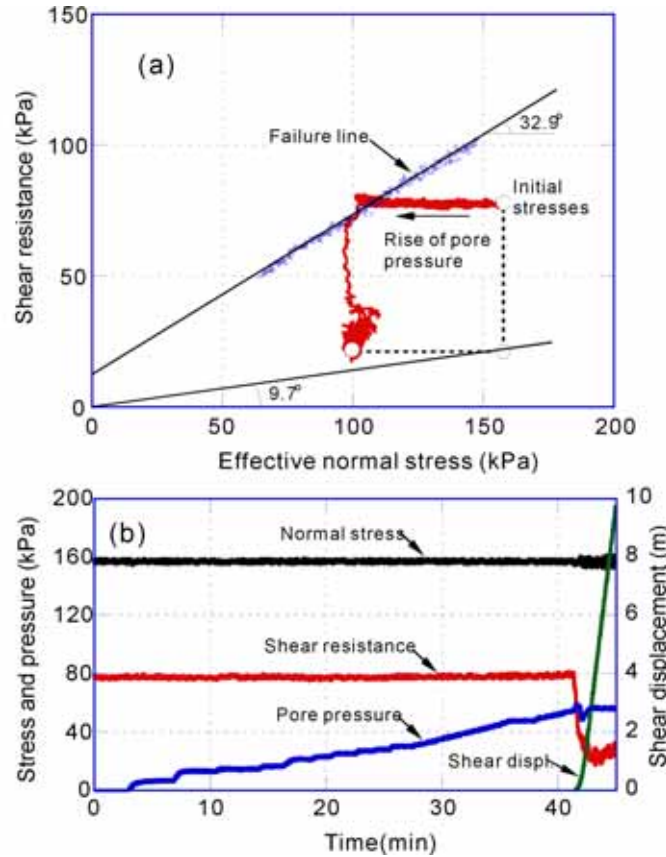
Fig. 19 Results of tests to simulate the initiation of the Minamata landslide ( $B_D = 0.86$ )

This test is called a naturally drained test because generated excess pore pressure is naturally drained from the shear zone to the upper valve. After the naturally drained test, the sample was again consolidated by dissipating the generated pore pressure. Then, slow shearing was applied. After reaching the failure line, the normal stress was decreased very slowly to maintain the drained condition, continuing slow movement without generating any pore-water pressure. This test determined the status of the failure line during motion, as shown in Fig. 19. This test gave 32.9 degrees as the friction angle during motion.

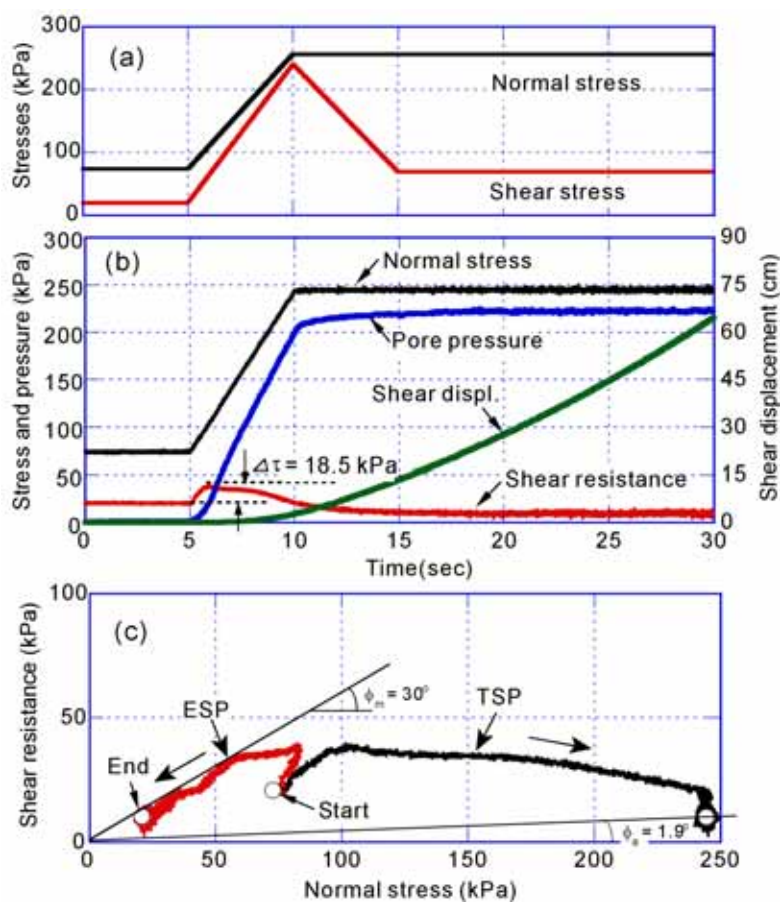
Fig. 22 Results of a test to simulate undrained loading of the tuff breccia deposits in the Minamata landslide ( $B_D=0.89$ )

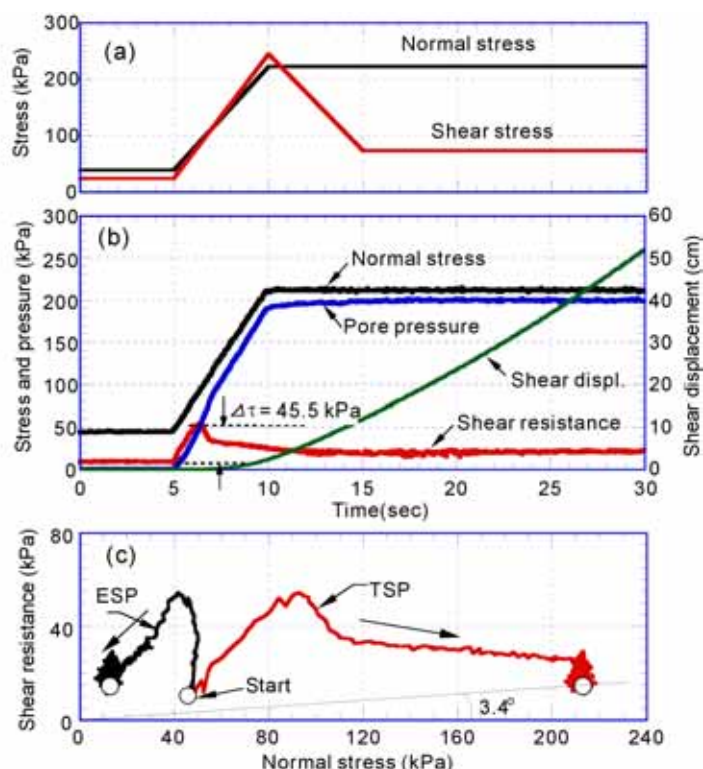
Fig. 23 Results of a test to simulate undrained loading of the weathered andesitic tava in the Minamata landslide ( $B_D = 0.97$ )

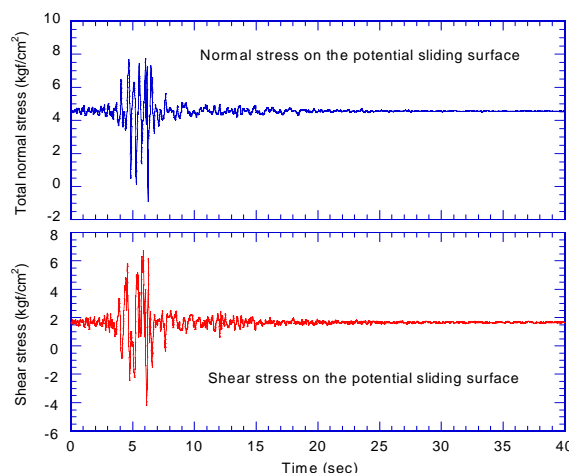
Fig. 27 Synthesized seismic loadings on the inferred potential sliding surface

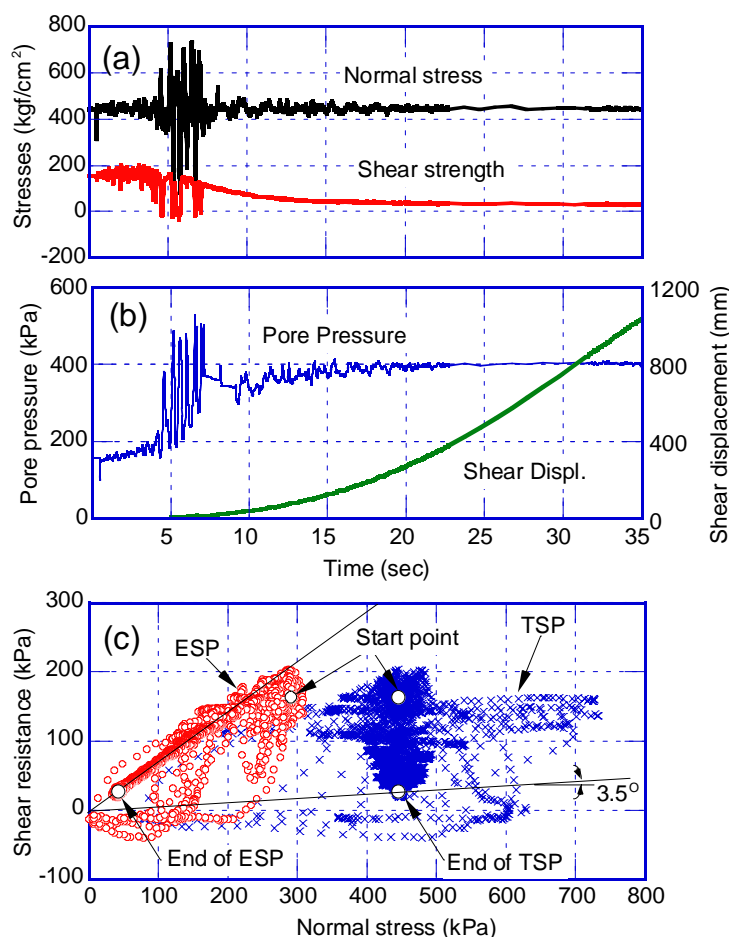
Fig. 28 Undrained cyclic tests on saturated sandy layer ( $B_D = 0.99$ , initial dry density:  $15.2 \text{ kN/m}^3$ ). (a) Time series data for normal stress and shear stress, (b) Time series data for pore water pressure and shear displacement, and (c) Stress path

From the ESP in Fig. 28c, it is noticed that the initial effective stress state was very close to the failure line. This means that a small increase in pore-water pressure (about 59 kPa, if normal stress and shear stress are kept steady) or in shear stress (about 39 kPa when normal stress and pore pressure are kept steady) could lead to the shear failure of the sample. This was facilitated by an increment in pore water pressure more than 150 kPa during the main shock (see Fig. 28b). After failure, the shear strength reduced along the failure line towards zero with progress of shear displacement. Although there are some points of ESP laid above the failure line, probably due to the possible delay of pore water pressure measurement during high frequency period, this ESP showed a typical path for sliding surface liquefaction failure phenomenon (Sassa 1996). Meanwhile, we can see that the TSP never crossed the failure line even in the seismic loading period, indicating that if there is neither initial pore water pressure nor excess pore-water pressure generation, the sample can not suffer shear failure.

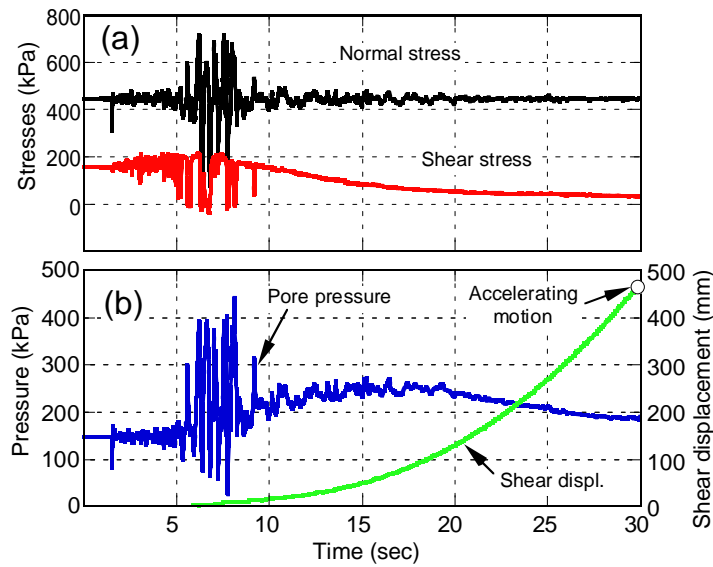
Fig. 31 Time series data for naturally drained cyclic test on saturated gravel layer ( $B_D = 0.99$ )

The test results for GL showed quite different phenomena (Fig. 31). After the main shock, the shear displacement increased continuously, showed an accelerating failure process (see Fig. 31b). The shear strength reduced gradually with time (Fig. 31a), showed typical sliding surface liquefaction failure. The great reduction in the shear resistance could be attributed to the great generation of pore water pressure within the shear zone. However, in Fig. 31b it is noticed that the monitored pore pressure was not so high in the acceleration of shear displacement. This could be interpreted as follows: during this period, because the drainage tube is open, and also the shearing was localized in the shear zone while the pore pressure was measured through a gutter located 2 mm above the shear surface (detailed pore pressure

Although the naturally drained simulation tests presented in Figs. 30 and 31, were differing from real slope condition, where the thickness of the soil above the shear zone might be quite greater than that in the ring-shear box (about 5 cm above the shear zone), from Figs. 30 and 31, it can be concluded that GL is easier to suffer liquefaction failure with long travelling distance in natural slope state.

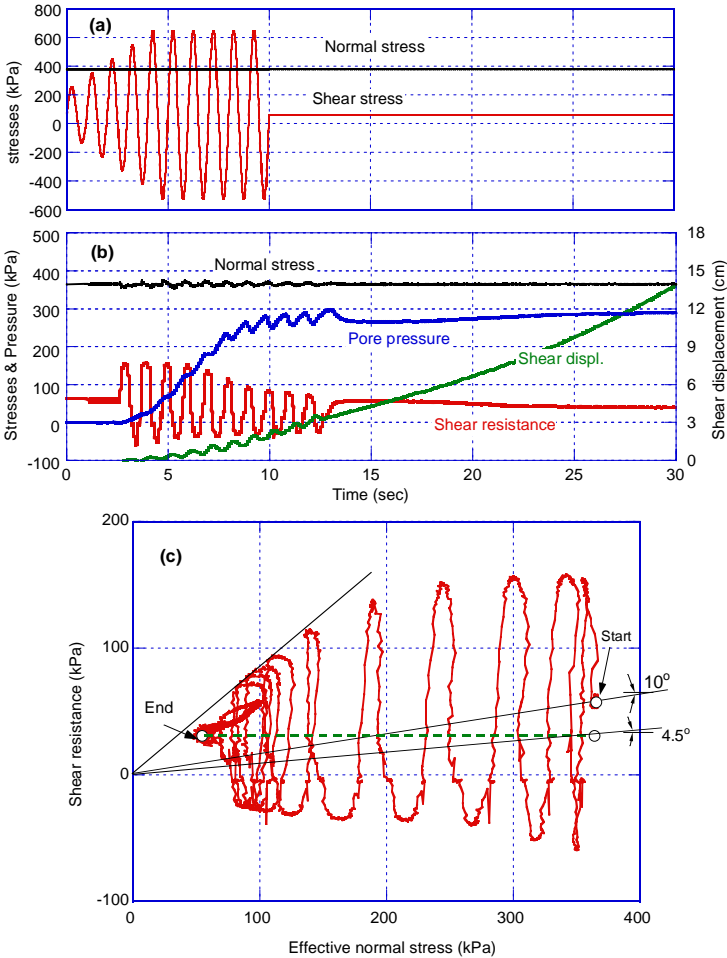
Fig. 36 Cyclic loading control signal for normal stress and shear stress (a), and the undrained cyclic ring shear test results in form of time series data (b) and effective stress path (c) ( $B_D = 0.98$ ).

Because the main purpose of the test was to examine and assess the possible landslide hazards on these area, undrained cyclic ring shear test was performed by applying a cyclic shear stress whose amplitude was kept increase with cycle, while the normal stress was kept constant (see Fig. 36a). The

frequency was 1.0, and 10 cycles of cyclic shear loading were applied. According to the above-laid soil layer thickness and the slope angle, the initial normal stress and shear stress were calculated approximately as 380 and 61 kPa, respectively. After the samples were saturated and normally consolidated, the cyclic loading (Fig. 36a) was applied. The test results were presented in Fig. 36 in the form of time series data (Fig. 36b) and effective stress path (Fig. 36c). As revealed by the test results, shear failure was triggered within 5 cycles; accelerating shearing was resulted in even after the termination of cyclic loading, i.e., shear failure continued under the static shear stress due to the soil weight itself. The shear resistance reduced with progress of shearing to a very small value at the final steady state, showing a small apparent friction angle of 4.5 degrees. Although detailed analysis on this area is still on process, it could be concluded from the results of boring survey and laboratory investigation that this area is of high possibility to suffer rapid long travel landslide hazards during earthquake.
