## Landslide Disasters Triggered by the 2004 Mid-Niigata Prefecture Earthquake in Japan

### Synopsis

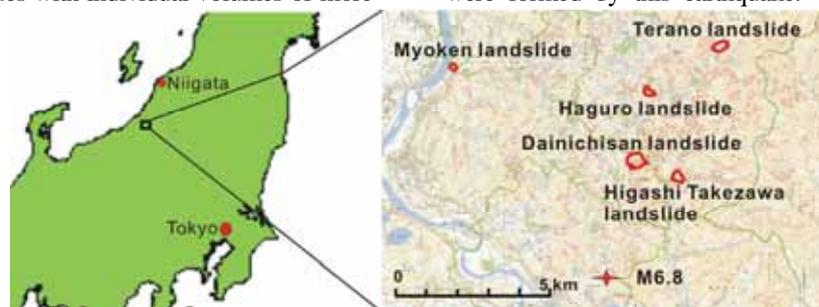
Fig. 1 Locations of the four major landslides triggered by the M6.8 Mid-Niigata Prefecture earthquake

major landslides occurred on Higashi Takezawa, Terano, Dainichisan, Haguro, and Myoken areas (Fig. 1) were the most catastrophic. The Higashi Takezawa landslide and the Terano landslide which formed landslide dams more than 25 m high were investigated in detail. This research presents the dynamic properties of these landslides and the mechanism of large-scale rapid landslides induced by earthquake within past landslide masses, as well as the landsliding computer simulation for the Higashi Takezawa landslide.

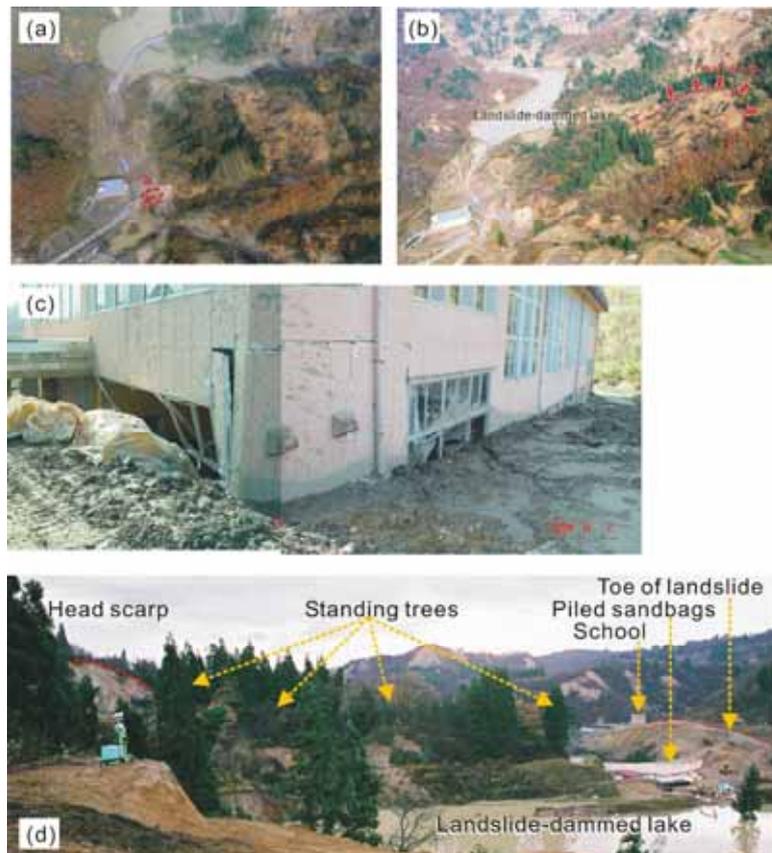
Fig. 2 General view of the Higashi Takezawa landslide. (a) Oblique airphoto taken by Marui on 3 November 2004, (b) Oblique airphoto taken by Sassa on 6 November 2004, (c) Debris intruded into a school building from the landslide mass, d) Side view of the Higashi Takezawa landslide taken on 16 November 2004.

The landslide that posed the greatest threat to the area was the Higashi Takezawa landslide, which blocked the Imokawa River, forming a landslide dam. Fig. 2a, b show the general view of this landslide taken from a chartered helicopter. Photo a) was taken on 3 November, and photo b) was taken on 6 November. The road bridge that can be seen in photo a) was submerged in the landslide-dammed lake in photo b).

Both photos clearly showed that the landslide mass was not disturbed through its approximately 100 m distance of rapid movement. As can be seen in photo b), trees on the landslide generally remained straight. However, the forest showed backward rotation at the toe of the landslide (photo a), because the landslide mass filled the Imokawa River and moved upward along the slope of the opposite bank. The building in Fig. 2a was an elementary school. Fig. 2c shows debris that flowed into the entrance and a window of the school building, and mud that scattered onto the building wall. The phenomenon suggested the rapid movement of this landslide. The debris and scattered mud at the school building probably came from a small landslide (“A” in Fig. 2a) at the toe of large displaced landslide mass. This part of the mass did not include the forest, but probably was soils from/around the Imokawa River that was scraped and carried by the displaced landslide mass. Fig. 2d shows a side view of this landslide from which high mobility can be hypothesized based on the angle from the head scarp to the toe of the landslide. The mobilized apparent friction angle was 7.5 degrees.

The toe of landslide climbed up the opposite bank. The height of the lowest part of the landslide-dam crest was raised by piled sandbags that were transported by helicopters of the Japanese Self-Defense Force to prevent overflow of the dam. Standing trees suggested a smooth movement along a liquefied sliding surface. The upper part of the landslide mass was not completely saturated although the sliding surface itself probably was.

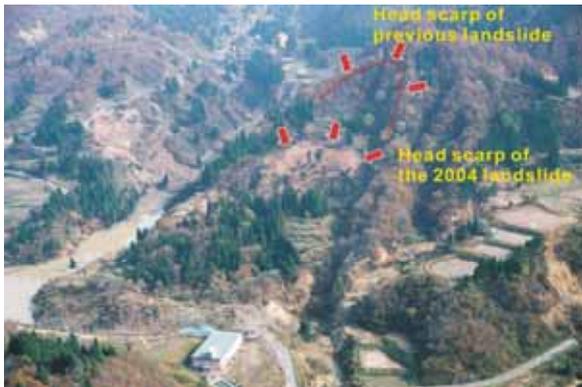
Fig. 3 Higashi Takezawa landslide and the head scarp of past landslides (Taken by Sassa)

Fig. 3 presents another view of the Higashi Takezawa landslide. The head scarp of the current landslide is shown on the figure by red arrows, and the head scarp of the previous landslide is shown by a curved line with red arrows. We investigated the head scarp of this landslide. A very straight, gently-dipping (around 20 degrees) stiff silt (stone) layer outcropped as shown in Fig.4. This layer seemed to be a part of sliding surface of this landslide. It is relatively impermeable and groundwater flowed over this stiff silt

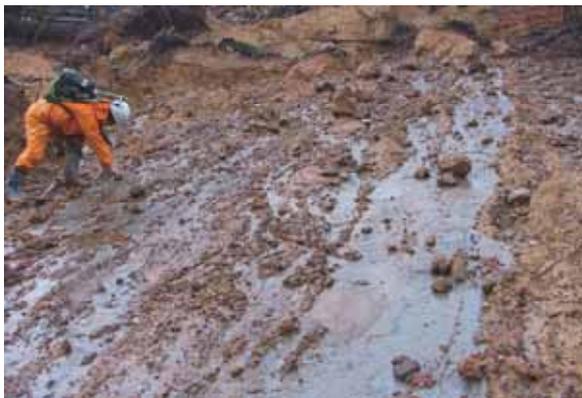
Fig. 4 Stiff silt (stone) layer outcropped in the head scarp (it inclined around 20 degrees to the landslide moving direction and groundwater flowed over the layer)

In the Higashi Takezawa landslide, a stiff silt (stone) layer outcropped in the head scarp. And a very similar stiff silt (stone) layer outcropped in the Dainichisan landslide (Sassa et al. 2005). Therefore, whether the location of sliding surface is formed on the weathered part of silt or on the bottom of sand layer is of great importance for understanding the triggering mechanisms of these landslides. The weathered part of silt can not be found, probably it is very thin. However, weathered silt (T2) was taken in the Terano landslide.

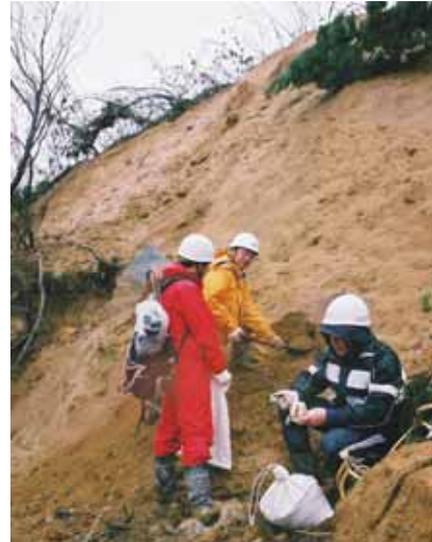
layer. The sand layer over this stiff silt layer was soft. It was probably a part of previously moved landslide mass. A sample (H2) was taken from this sand layer behind the current sliding surface as seen in Fig.5.

Fig. 5 Sampling from the sand layer behind the sliding surface and over the stiff silt (stone) layer

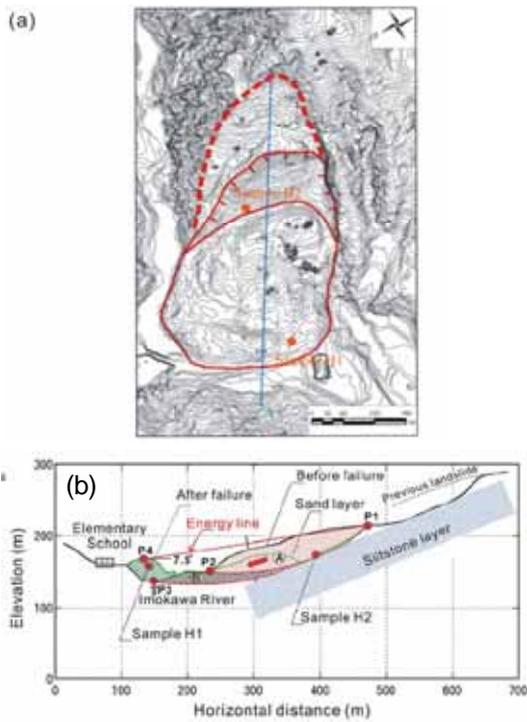
Three days after (26 October 2004) the earthquake, an air borne laser scanning survey was conducted, and Fig. 6a presents its result. The gentle slope found in the contours clearly presented the previous landslide topography above the head scarp of this landslide. The central section A-A of the landslide is presented in Fig.6b that includes an interpretation of landslide process based on the topographical map made by the air borne laser scanner after the landslide, the 1/25000 topographical map before the landslide, and field observations. In Fig. 6b, the black line presents the ground surface before the landslide, and the green line shows the ground surface after the landslide. The mass A (red dots) and the mass B (black dots) are the unstable mass before the current landslide movement.

The initial average slope angle between P1 and P2 is around 14.6 degrees, and the average slope angle between P1 and P3 is around 13.5 degrees. The mobilized energy line between P1 and P4 (highest point) is around 7.5 degrees. Hence, this rapid landslide occurred in a gentle slope less than 15 degrees, and the mobilized average apparent friction angle during motion was 7.5 degrees. The large difference between the energy line and the center of gravity of the moving mass suggests a rapid motion.

Fig. 6 (a) Plan of the landslide (the map was made by the air borne laser scanning in the courtesy of Aero Asahi Corporation. Contour lines are 2 m spacing); (b) Section of the landslide along A-A line in Fig. 6a

For this landslide, the first question arose on the position of sliding surface from this observation. The outcropped silt (stone) layer was very stiff and apparently too strong to slide. However, the silt near the border to the sand layer could be soft due to weathering because an adequate groundwater flow existed. Accordingly there are two options for the location of sliding surface of this outcropped head scarp, 1) weathered top part of lower silt layer, 2) bottom of upper sand layer. This will be examined later in this paper based on the dynamic loading tests and detailed section.

The second question arose on the sequence of landslide movement. There are two possible scenarios. 1) Block B was firstly liquefied, then the block A started to move due to loss of support in its toe, 2) Block A initially started to move due to seismic loading and the resulted excess pore pressure generation. Thus, the movement of block A then gave an undrained loading to block B. This undrained loading effect can be greater than earthquake loading for the Block B. Then, the block B started to move with the block A and crossed the Imokawa River and hit the opposite bank. Block B is near the river water, and the lower half of

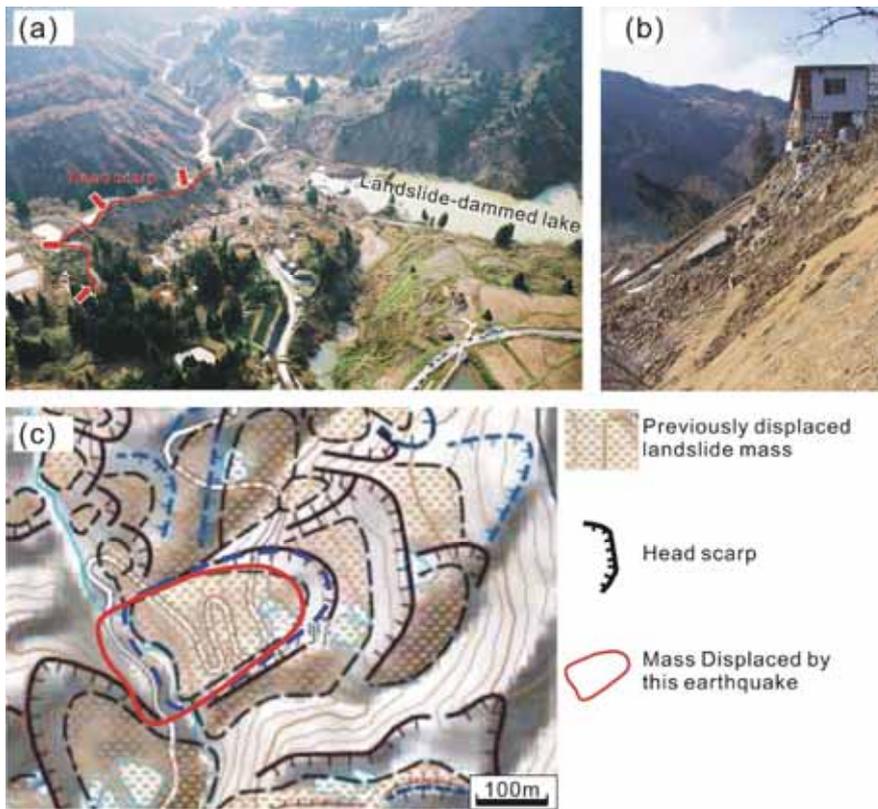
The Terano landslide (Fig. 7) also formed a landslide dam 4.5 km north of the Higashi Takezawa landslide (Fig. 1). The Terano landslide occurred as landslide blocks in a repeatedly moved residual state. Fig. 7a shows an overview of the Terano landslide, which occurred on a gentle slope; the displaced landslide mass blocked the Imokawa River, forming a landslide dam. This area had been the site of rice paddy fields. Because there was no house or other structure

Fig.7 View of the Terano landslide and landslide distribution map of the vicinity. a) Oblique airphoto taken by Sassa on 6 November 2004, b) Side view of the Terano landslide, c) Landslide distribution map and the Terano landslide (Inokuchi et al. 2004)

within the area of the Terano landslide, it was not designated as a landslide risk area. However, the adjacent areas were designated as landslide risk areas. A house stands at the margin of the Terano landslide (Fig. 7b). Fig. 7c shows the location of the landslide mass triggered by the earthquake overlaid on an earlier landslide in a previously made landslide distribution map (Shimizu et al. 2004). In this figure, brown dashed lines define the margins of the previously moved landslide mass identified by airphoto interpretation of the topography. The black dashed lines delineate the head scarps. The blue dashed lines are the main scarp of the landslide before the motion by the Mid-Niigata Prefecture earthquake and the red line presents the landslide block after the movement (Inokuchi et al. 2004).

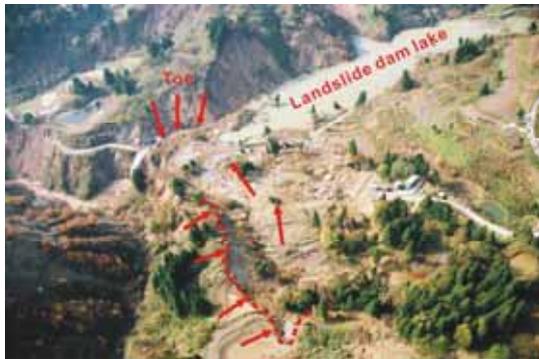
Fig.8 presents the view from the head scarp to the toe of the Terano landslide. It created a large landslide dam and resulted lake. The landslide is a part of big repeatedly-moving type of landslide complex area, which is typical in the Tertiary mudstone landslide-prone area. Fig. 9a, b show the plan and the section of this landslide. This landslide was also

Fig. 8 Overview of the Terano landslide (Taken by Sassa on 6 November 2004)

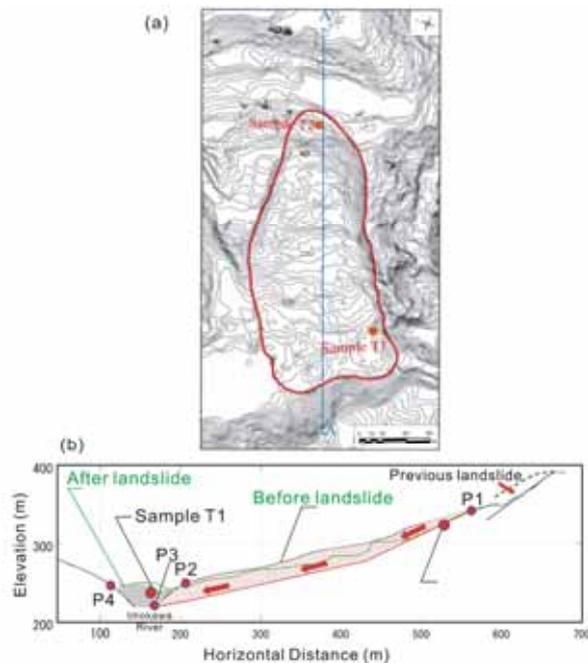
The initial slope angle was 14.9 degrees between P1 and P2 at the top of river bank, and 17.5 degrees between P1 and P3 along the river. The mobilized

average apparent friction angle during motion between P1 and P4 was 12.7 degrees. The difference between the energy line from P1 to P4 and the center of gravity suggests a slower landslide than the Higashi Takezawa landslide.

Fig. 9 Plan and Section of the Terano landslide (a: Plan obtained from air bone laser scanner. Contour lines are 2m pitch. b: Central section A-A of the Fig.9a)

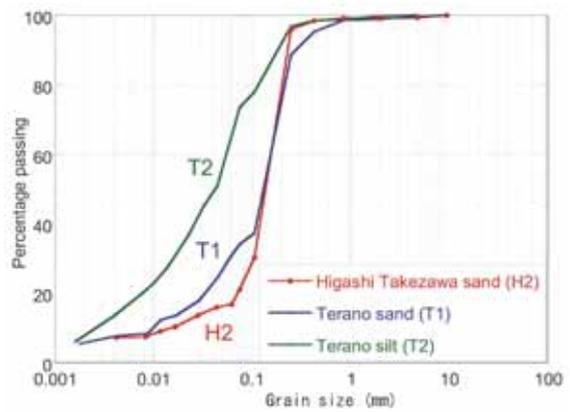
investigated. The main body of the landslide block at the toe was composed of sands (T1) that seem to be similar to the samples of H1 and H2 of the Higashi-Takezawa landslide. In contrast to the Higashi Takezawa landslide, the silt sample (T2) taken from the head scarp was well weathered and soft. The head scarp and Sample T2 was inside the previously moved landslide mass as suggested by the section shown in Fig. 9. The silt was well softened due to landslide motion and well oxidized which was suggested by its brown color. While the siltstone outcropped in the head scarp in the Higashi Takezawa landslide was very stiff and in the stable layer below the landslide mass and probably always saturated suggested by its gray color of deoxidization. The grain size distributions of samples T1, T2 and H2 are shown in Fig.10. Samples H2 and T1 are rather similar though sample T1 includes a slightly greater portion of finer grains. While silt sample T2 is quite different from samples T1 and H2, it is much finer than those sands.

Fig.10 Grain size distribution of three collected samples

The cyclic loading test result for the Terano sand (T1) is shown in Fig.22. The Terano sand was clearly subject to sliding surface liquefaction after failure. The mobilized apparent friction angle at the steady state is 3.8 degrees, slightly greater than H2 (2.5 degrees in Fig. 19b, and 3.3 degrees in Fig. 21b). The mobilized effective friction angle that is estimated from the stress path after the peak is 35.7 degrees, about one degree less than the 36.9 degrees for the Higashi Takezawa sand. This may be due to the fact that the Terano sand is slightly finer than the Higashi Takezawa sand as found in Fig.10. However, the both sands are generally similar.

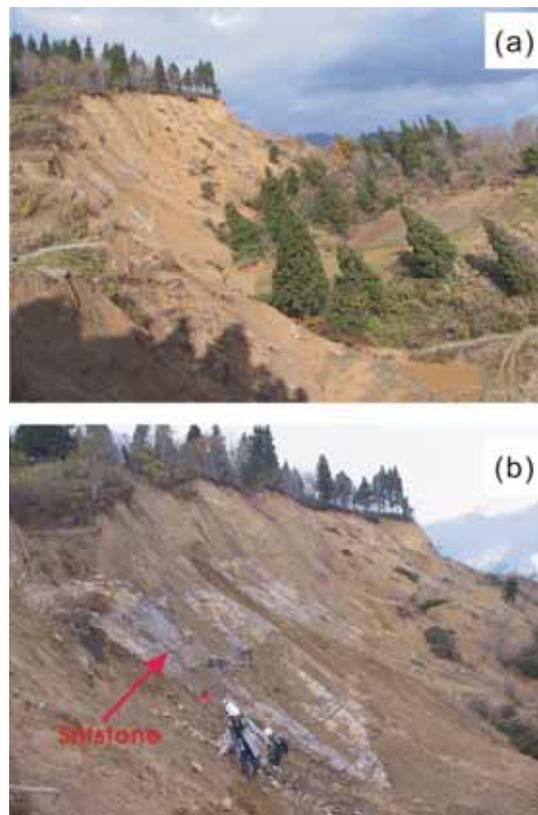
The largest landslide in area and volume triggered by the Mid-Niigata Prefecture earthquake was the Dainichisan landslide (Fig. 11), which is located 1 km west of the Higashi Takezawa landslide (Fig. 1). As indicated in Fig. 11a, the Dainichisan landslide is a typical slump. This landslide did not reach the Imokawa River, and thus did not cause a landslide dam. Fig. 11b shows the exposed probable sliding surface, which is an inclined siltstone bed.

Fig. 11 Dainichisan landslide (a) and head scarp (b)

Sand covered the siltstone bed. Almost all of the large landslides triggered by the Mid-Niigata Prefecture earthquake occurred in this sand layer and/or a silty sand or silt layer. Whether the sliding surface formed at the bottom of the sand layer or at the top of the siltstone is in question. The situation was the same for the Higashi Takezawa landslide.

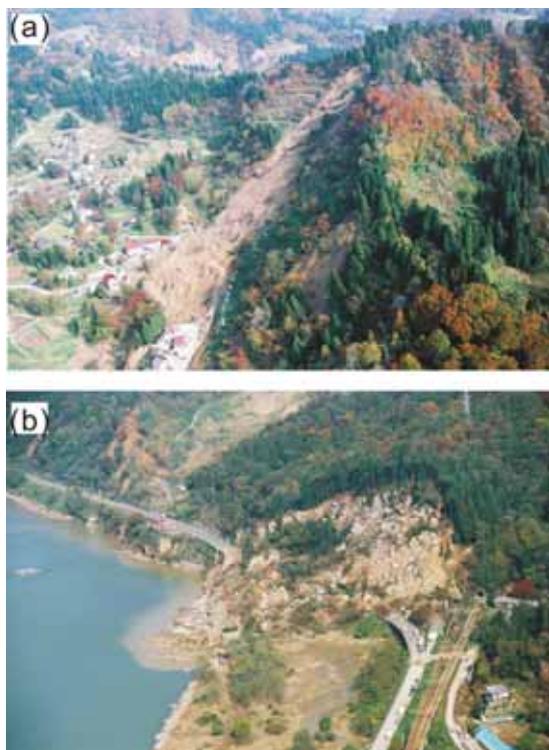
The Higashi Takezawa, Terano and Dainichisan landslides were 25-50 m deep-seated landslides. The Haguro landslide (Figs. 1, 12a) was relatively shallow, and the landslide mass was very disturbed because of

the steep slope and its shallow depth. This landslide destroyed a road and many parked cars, but fortunately no one was killed. The relatively small rock slide in the Myoken area (Fig. 12b) covered a main road and buried a car occupied by a mother and two children. The rescue team noticed the car buried under the displaced landslide mass, and tried to rescue the occupants. However, the rescue operation took three days because of the very unstable landslide rock debris. The rescue activities were monitored and broadcasted every day by TV and other media. Finally a 2-year-old boy was safely extracted from the buried car. The Myoken landslide occurred on a convex slope. In addition, it was dry, which was one reason the boy could survive for 92 hours under the landslide mass.

Fig. 12 Oblique airphoto of the Haguro landslide (a) and the Myoken landslide (b). Both photos were taken from a helicopter by Sassa on 6 November 2004.

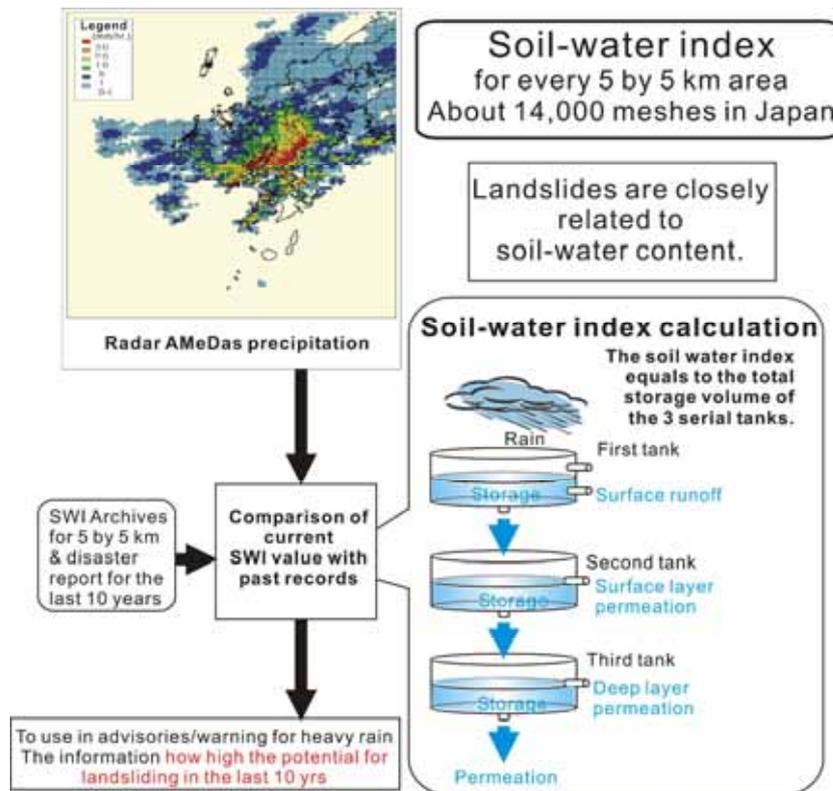
The Japan Meteorological Agency uses the so-called Soil Water Index (SWI) as an index to evaluate the water stored beneath the surface of the ground (Okada 2001). Fig. 13 illustrates the concept of the SWI. SWI is an effective technique for estimating the landslide disaster potential by comparing the values of Soil Water Index for past landslide disasters. SWI uses the Radar-AMeDas (name of radar system for precipitation monitoring) precipitation analysis as an input rain value for the three steps of a serial storage tank model to express water runoff to the ground surface, the surface soil layer, and the deeper soil layer. This model expresses the shift of rain to the ground water with time delay (Ishihara and Kobatake 1979). The groundwater will be stored in each tank corresponding to different soil layers. SWI is defined to be the total storage thickness of the three tanks. The index value is decided for each  $5 \text{ km} \times 5 \text{ km}$  cell. For Japan, number of cell in the mesh is 14,132.

Fig. 13 Soil Water Index (SWI) used by the Japan Meteorological Agency. Height of the upper outlet in the first tank is 60 mm, and the height for the other outlet in the first tank, second tank and third tank is 15 mm.

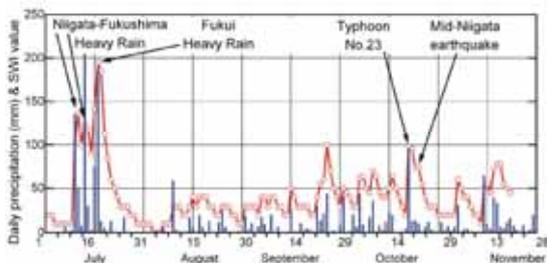
Fig.14 Time sequences of SWI at Yamakoshi Village from July 1st to Nov. 20, 2004 (Rainfall in blue; SWI in red.)

Fig. 14 shows the time sequences of SWI at Yamakoshi Village from July 1 to November 18, 2004. During 2004 many heavy-rain events struck Japan, and some of these heavy rains occurred at Yamakoshi Village, resulting in major landslide disasters. For the Niigata-Fukushima Heavy Rain from July 10 to July 14, the total amount of rain recorded by Rader-AMeDas Precipitation was 428 mm, and the maximum index value was 124 at July 13, 1900 hrs. For the Fukui Heavy Rain from July 16 to July 18, total amount recorded was 272 mm by Rader-AMeDas Precipitation, and the maximum index value was 195 at July 17, 2000 hrs. The past maximum index value during 1994 to 2003 was 142. So the maximum value in this area was exceeded in 2004.

After these heavy rains, the SWI reached zero in August and thereafter the value was around 20-40. However, typhoon No. 23 on 20 October renewed the heavy rainfall in this area. Three days after the typhoon, the Mid-Niigata Prefecture earthquake occurred. At that time, SWI value was 62, a high value in this area except for the two extraordinarily heavy rains in July.

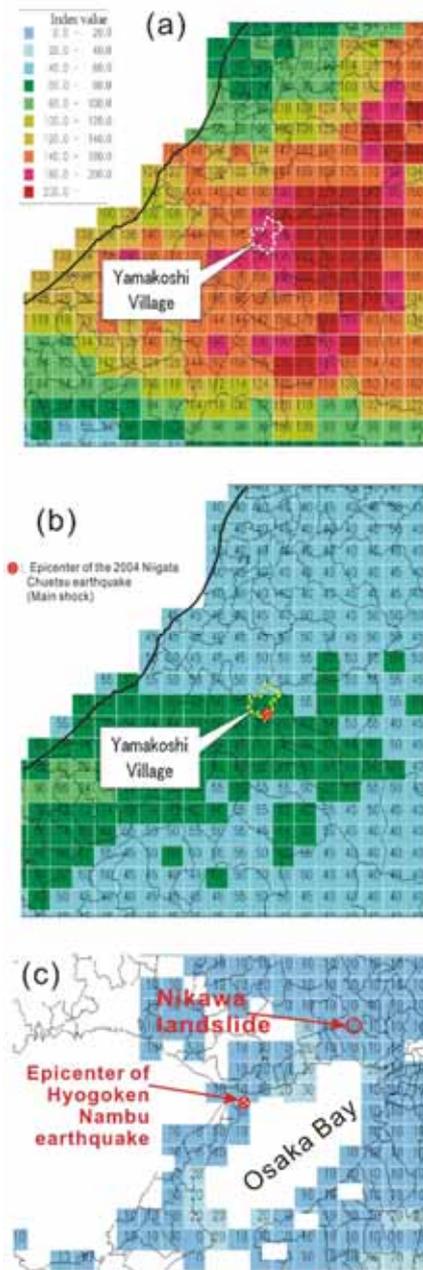
Fig. 15 SWI distributions in Yamakoshi Village and in the Osaka-Kobe area. (a) SWI distribution (Fukui heavy rain) from 16-18 July 2004 in the vicinity of Yamakoshi Village, (b) SWI distribution on the day of the Mid-Niigata Prefecture earthquake (23 October 2004) in the vicinity of Yamakoshi Village, (c) SWI distribution on the day of the Hyogoken-Nambu earthquake on 17 January 1995 in the vicinity of the Nikawa landslide.

Fig. 15 presents the SWI distribution in the area including Yamakoshi Village during the Fukui heavy rain (highest SWI value in history) and during the Mid-Niigata Prefecture earthquake, and the SWI for in the area including the Nikawa landslide, which killed 34 persons during the Hyogoken-Nambu earthquake. The SWI values were quite different in the Hyogoken-Nambu earthquake and in the Mid-Niigata Prefecture earthquake; however, the geology in the two areas was somewhat different.

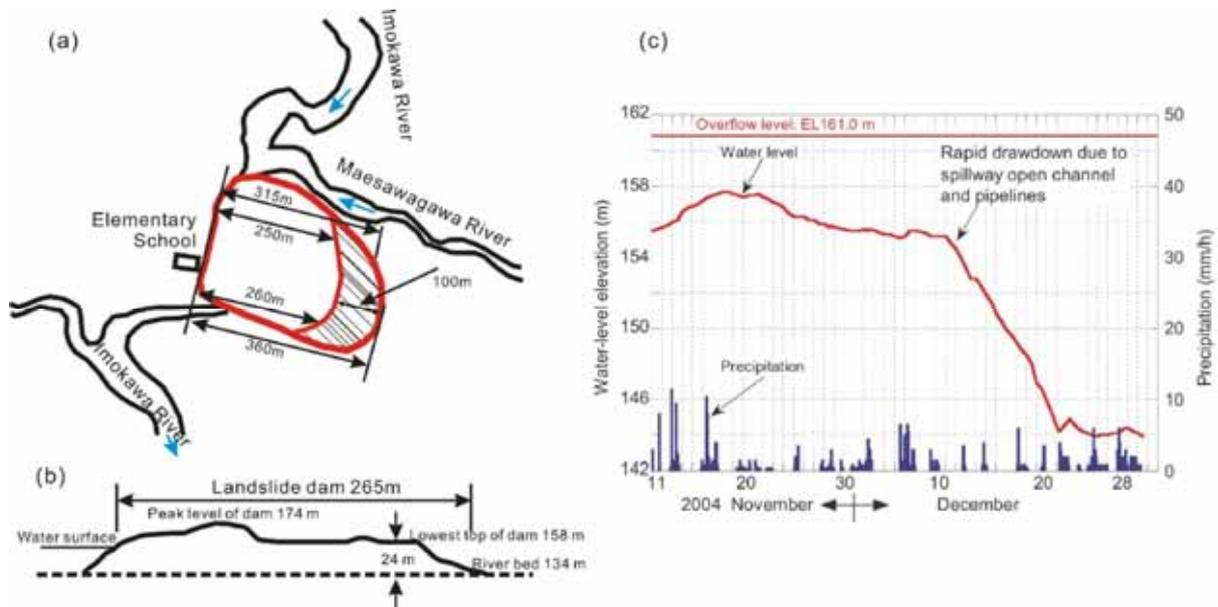
Fig. 16 View (a) and cross section of the Higashi Takezawa landslide dam (b) along the Imokawa River, and elevation of the water level in the landslide-dammed lake (c)

In both cases, the length of the buried river channel was about 10 times the maximum water depth of the lake. Therefore, the possibility of the destructive collapse of either dam by water pressure and/or piping was estimated to be low.

However, there remained the possible danger of overtopping and successive breaching of one or both dams. Failure of these landslide dams could cause outburst floods or debris flows which would endanger downstream residential areas and roads. Therefore, the inhabitants of the downstream area would have to evacuate. It was urgently necessary to lower the level of the landslide-dammed lake. Emergency measures to prevent failure of the landslide dams were carried out by the Ministry of Land, Infrastructure and Transportation with the cooperation of the Self-Defense Force (Marui 2004). The Higashi Takezawa, the largest landslide dam, which is located farthest downstream among five main landslide dams along the Imokawa River, impounded a lake that was critical. Fig. 16a, b presents the plan and the cross section of the Higashi Takezawa landslide. The width of this landslide was 265 m, and its peak elevation was 174 m. The elevation of the lowest part of the dam crest was 158 m, and the river-bed elevation was 134 m. In order to reduce the danger of overtopping, various emergency measures were undertaken. As a result, the lake level was kept lower than the overflow elevation of 161 m, and lake

level was lowered to a safer level, as shown in the figure of monitored water-level elevation and precipitation through the end of 2004 (Fig.16c).

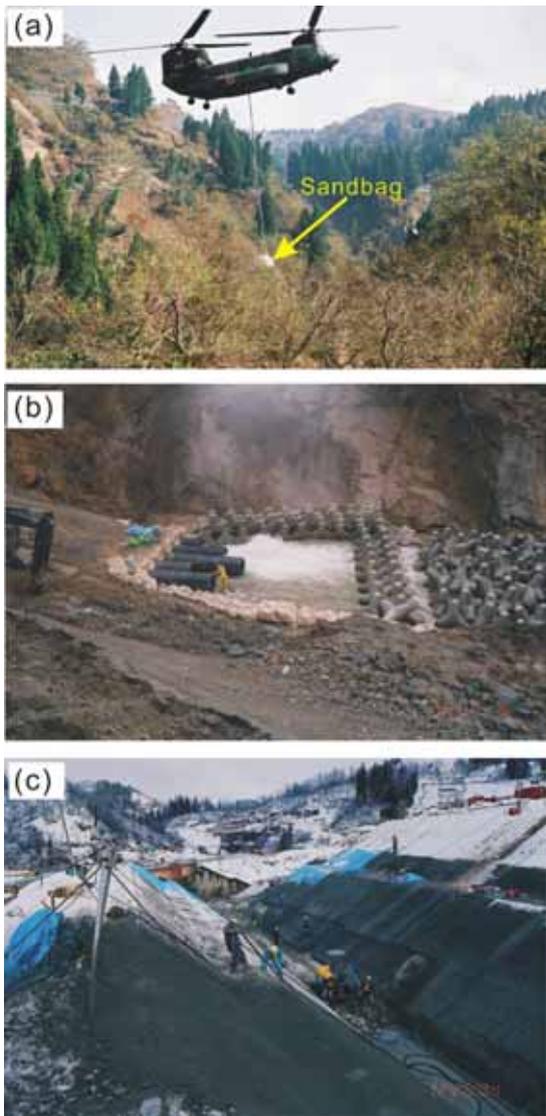
Fig. 17 Emergency measures to prevent failure of the Higashi Takezawa landslide dam. (a) Helicopters of the Japanese Self-Defense Force carried sandbags and piled them on the lowest part of the landslide dam crest every several minutes during our observation, (b) and (c) Diversion pipe lines and open-channel spillway constructed by the Ministry of Land, Infrastructure and Transportation

Fig. 17 shows photos of some of emergency measures. The Japanese Self-Defense Force transported sand bags to shift up the overflow level by 3 m from the low point of the crest at 158 m to the top of the sand bags at 161 m (Fig. 17a). Then, the water level was lowered by means of pumps and siphons. Twelve pumps were installed. As the result, the monitored water level was kept lower than the overflow level at elevation 161m. It is not suitable to use drainage pumps for the long term; thus, they should be used for only emergency purposes in the initial stages. Because of maintenance problems for the pumps, alternative diversion pipelines (Fig. 17b) were installed to prevent overtopping. These additional diversion pipelines were quite effective. Finally, an open channel (Fig. 17c) with a sufficient cross-sectional area for water discharge including snowmelt during early spring was constructed. It was absolutely necessary to retain the stability of the earthquake-induced landslide against secondary motion during construction of the channel. Therefore, excavation of the upper part of the displaced soil mass was immediately carried out as an appropriate emergency countermeasure. Monitoring on secondary displacement of the landslide was also carried out for security during the construction works.

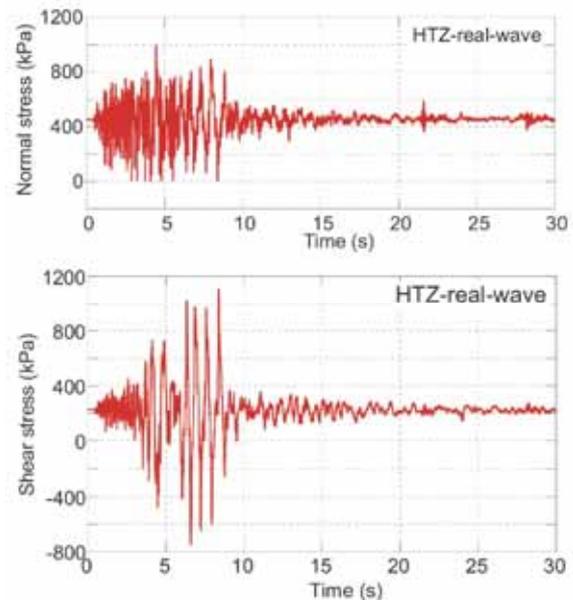
Seismic loading test was performed to simulate the initiation of the Higashi Takezawa landslide using the real monitoring record of the Mid-Niigata earthquake in the closest site. The monitored record is from one observation station of K-NET (Kyoshi Net), which is the strong earthquake motion monitoring network by the National Research Institute for Earth Science and Disaster Prevention (NIED). K-NET is a system which sends strong-motion data on the Internet. The data are obtained from 1,000 observatories (25 km mesh) deployed all over Japan. The nearest monitoring site to the Higashi Takezawa landslide is the observation station of NIG019 at Ojiya, around 10 km west of the Higashi Takezawa landslide, and WNW 7 km from the epicenter of the main shock. The Higashi Takezawa landslide is ENE 3.6 km from the Epicenter. The location of the epicenter is between the NIG019 and the Higashi Takezawa landslides, but closer to the landslide.

Fig. 18 Normal stress and shear stress during the Mid-Niigata earthquake working on the sliding surface of the Higashi-Takezawa landslide, which was calculated from the monitored earthquake record at the monitoring site NIG019 in K-NET (NIED)

The real acceleration and its wave form that affected the Higashi Takezawa landslide can not be known in detail as it is complex due to inter alia topography, geology, underground structure, and distance from the fault and the epicenter. Therefore, the monitored earthquake record in NIG019 was applied as the first approximation of input acceleration to the sliding surface. Using three components of acceleration records, normal stress component and shear stress component on the bottom of landslide were calculated based on the section of the Higashi Takezawa landslide.

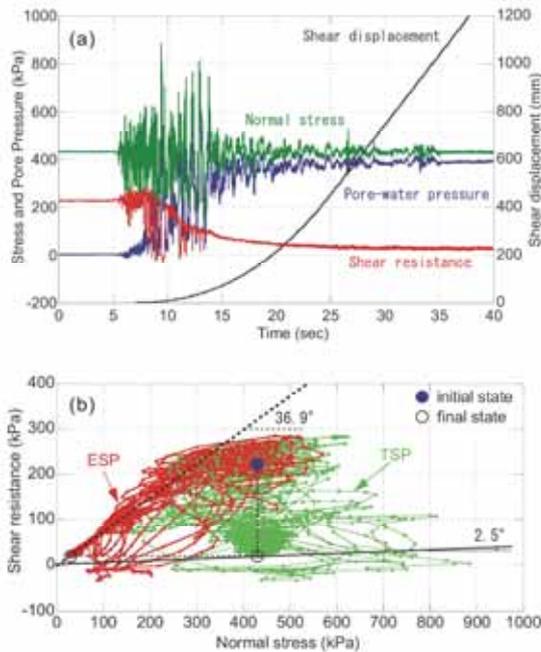
Fig.19 Undrained real earthquake wave loading test to simulate the Higashi-Takezawa landslide ( $B_D=0.98$ ). (a) Time series data, and (b) Stress path

is approximated as the one dimensional slope (20 degrees and 40 m deep, and a half of the layer was saturated, namely groundwater level was 20 m deep). The total density of soil layer was assumed to be  $1.8 \text{ Mg/m}^3$ . Sample H2 was placed dry into the shear box and saturated by firstly replacing pore air by  $\text{CO}_2$  gas and then replacing  $\text{CO}_2$  by de-aired water. The pore pressure parameter ( $B_D = \Delta u / \Delta \sigma$ ) was measured as the confirmation of full saturation ( $B_D = 0.98$ ). Then, the shear stress before the earthquake on the sliding surface of 230kPa was loaded under drained conditions. Thereafter, the shear box was shifted to the undrained state by closing the drainage valve, and then the calculated seismic stresses were applied. The data is shown in Fig.18. The result of seismic loading of the sample was presented in the time series monitoring result of loaded normal stress, mobilized shear resistance (not the same with the applied shear stress because failure occurred in the sliding surface at the failure line), generated pore pressure and the resulting shear displacement as seen in Fig.19a. Due to seismic shaking, pore water pressure was generated, then shear failure occurred and shear displacement started. As shear displacement progressed, a typical sliding surface liquefaction phenomenon was produced (Sassa 1996, Sassa 2000, Sassa et al 2004), namely grain crushing along the shear zone proceeded and a higher pore pressure was generated in progress with shear displacement. The sand was originally a marine deposit and much stronger than volcanic deposits such as pyroclastic flow deposits and pumice, and also weathered granitic sands. However, the shearing stress under 40m overburden pressure is enough to cause grain crushing and resulting volume reduction. It caused sliding surface liquefaction. The mobilized apparent friction angle is only 2.5 degrees at the steady state. The stress path of the test is shown in Fig.19b (in which a red color stress path expresses the effective stress path and a green color stress path presents the total stress path). The apparent friction angle is obtained from the ratio of mobilized steady state shear resistance divided by initial normal stress. The effective friction angle mobilized in the post failure process is not so clear in Fig.19b. So after this test, pore pressure was dissipated by opening the drainage valves. After full dissipation, sample was sheared under the speed control condition at 0.2 mm/sec. Normal stress was reduced at the unloading rate of 0.5 kPa/sec after

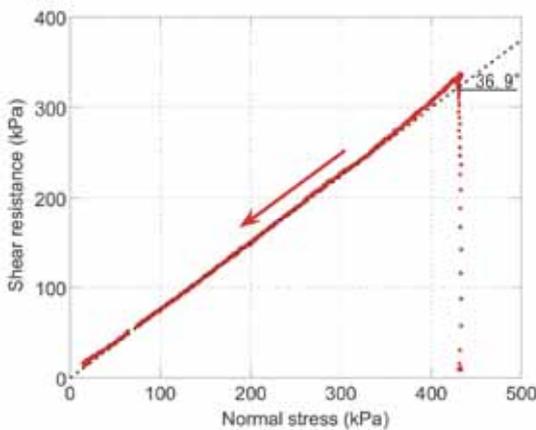
Fig.20 Stress path obtained in the drained constant speed test after the real wave loading test (Fig.19)

reaching the peak shear resistance. The failure line mobilized in the post failure process (residual state) gave 36.9 degrees for the friction angle (Fig.20).

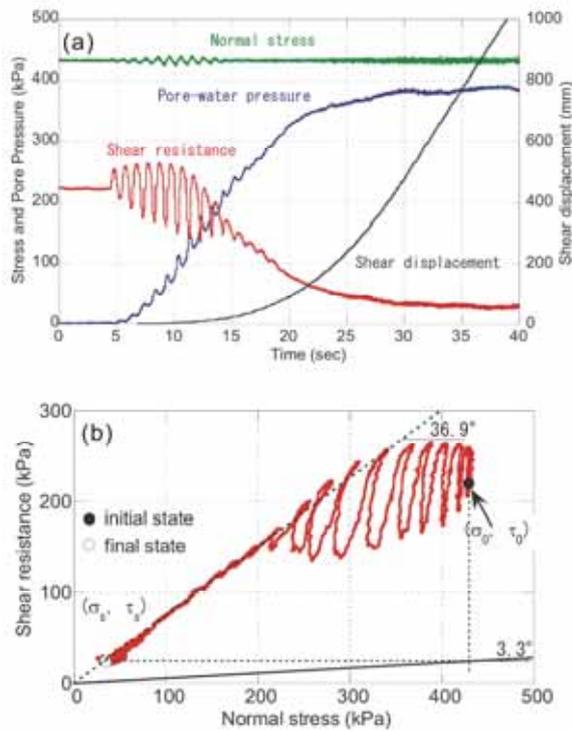
Fig.21 Undrained cyclic loading test of the Higashi Takezawa sand (H2) ( $B_D=0.98$ ). (a) Time series data, and (b) Stress path

For sample H2, the sample preparation and test condition were the same with the above mentioned test. The main differences were the loading stress, frequency and wave form. During the test, normal stress was kept constant, because the effective normal stress practically would keep constant in the fully saturated undrained condition when subjected to any change in the normal stress. Shear stress with the wave form of sine curve at 1 Hz frequency was applied. To ensure the failure, the shear stress was increased step by step until 15 cycles. The test result for the Higashi Takezawa sand is presented in Fig.21.

liquefaction as that shown in the real wave seismic loading test. The mobilized apparent friction angle at the steady state is 3.3 degrees, almost the same level with that shown in Fig.19b. The failure line estimated from the effective stress path in the post failure stress path is 36.9 degrees, see Fig.21b.

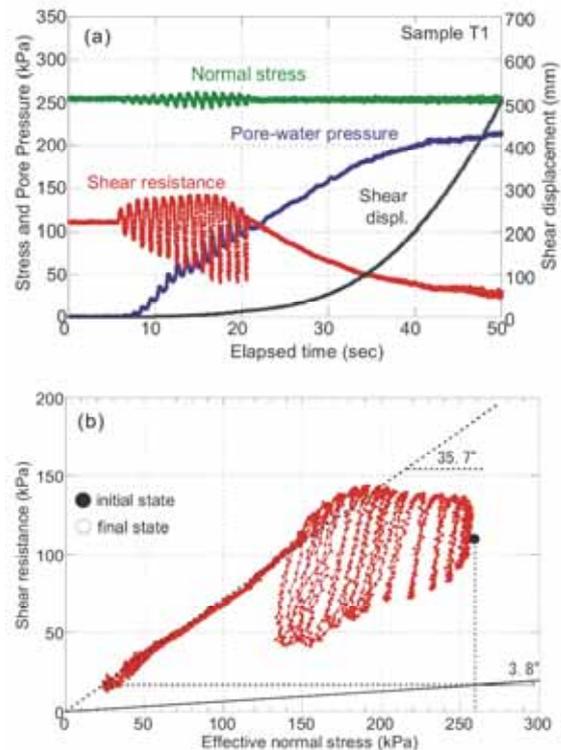
Fig.22 Undrained cyclic loading test on the Terano sand (T1) ( $B_D=0.98$ ). (a) Time series data, and (b) Stress path

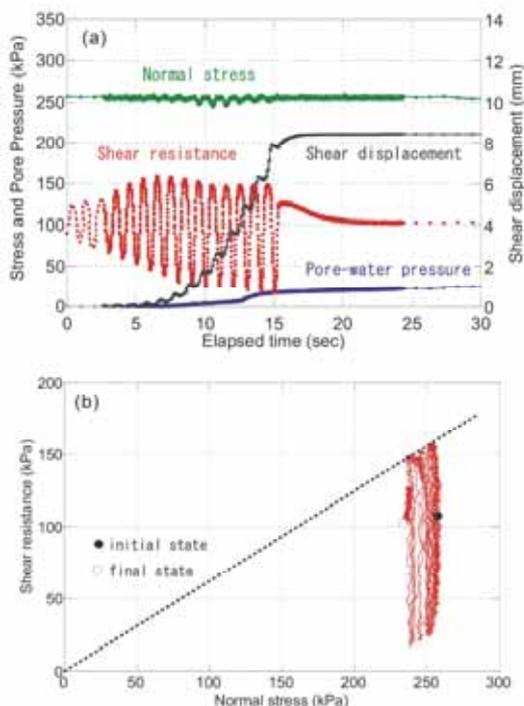
Fig. 23 Undrained cyclic loading test on the Terano silt (T2) ( $B_D=0.98$ ) (a) Time series data, and (b) Stress path

(T2) is presented in Fig. 23. The dynamic properties of the Terano silt are quite different to the sands. The sliding surface liquefaction and its resulting rapid landslide motion were not produced in this test. Shear displacement was increased only during the cyclic loading, precisely say, only in the time span when the loaded stress reached or exceeded the peak shear strength. It was the repeated movements of stop and move, and the shear movement stopped at the same time with the final cycle of loading. High pore pressure was probably not generated or at least not monitored as seen in Fig.23a.

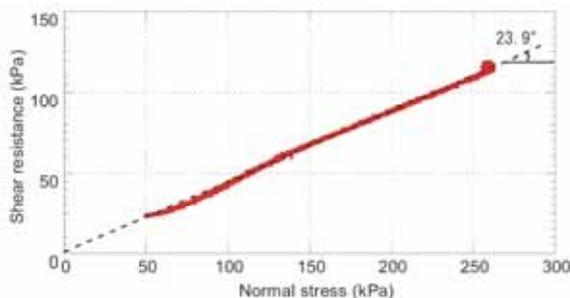
Fig.24 The residual state of friction angle for Terano silt (T2)

To obtain the effective friction angle in the residual state or the post failure condition, the sample was sheared at a constant shear speed of 0.05 mm/sec by using the shear-speed-controlled method, while the normal stress from was increased from 50 kPa to more than 250 kPa at a loading speed of 0.1 kPa/sec in the drained condition. The residual friction angle was 23.9 degrees for the friction angle (Fig.24). The friction angle was 13 degrees less than the Higashi Takezawa sand, and around 12 degrees less than the Terano sand. The silts and sands display quite different shear characteristics.

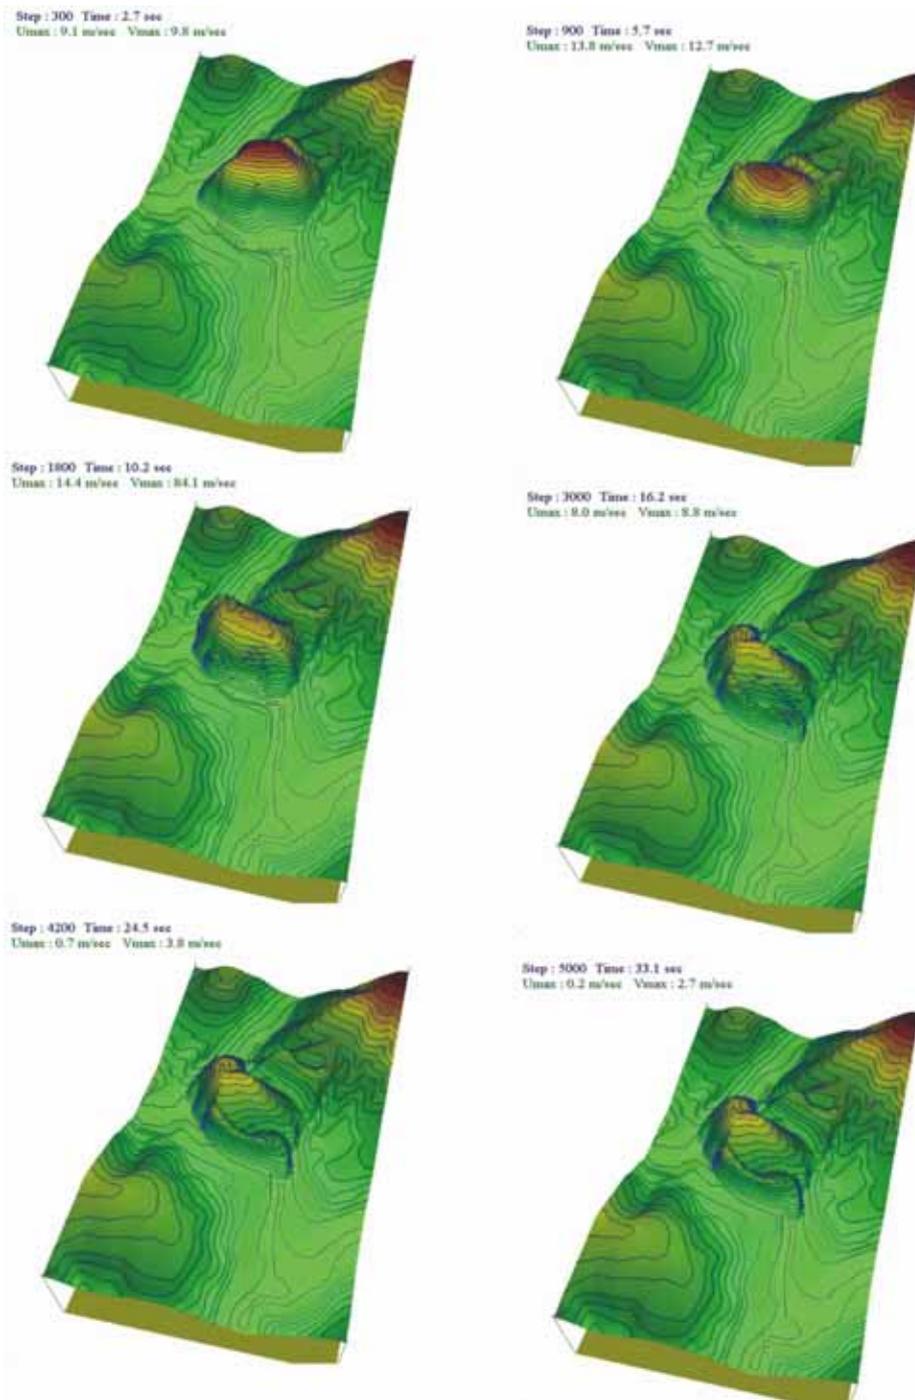
Figure 25 presents six steps of the three-dimensional visual output of the simulation results from the initial state to the final deposition state. It shows that the sliding mass rushed into the river rapidly, and horizontal flow occurred obviously thereafter.

Fig. 25 Simulation results on the Higashi-Takezawa landslide
