## Performance of Levee System at Flood Stage

### Synopsis

**Keywords:** Crevasse splay sediment, Levee breaching, Digital photo-theodolite survey

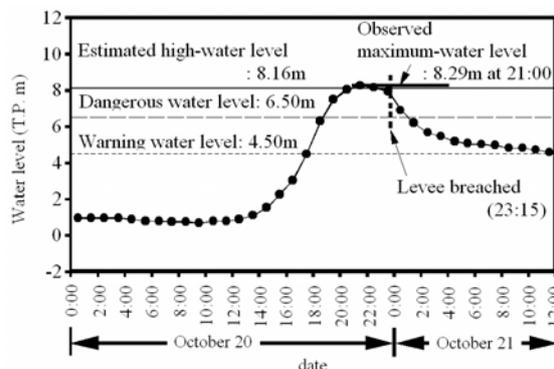
Fig. 2 Hydrograph obtained at Tachino observatory on October 20-21 (adapted from Toyooka office, 2005a)

The Maruyama River runs through a northern part of Hyogo Prefecture via the low-lying Toyooka Basin and drains into Japan Sea (Fig. 1). Typhoon 0423 made landfall in Osaka at 18:00 on 20 October 2004. It brought about precipitation as much as 278mm in the Toyooka area over a two-day period (20-21 October 2004). The associated hydrograph obtained at the Tachino Observatory (Toyooka Office, 2005a) is shown in Fig. 2. It is seen that the water level started rising from around 14:00 on October 20 and rapidly increased thereafter, exceeding the design high-water level (T.P. +8.16m) at around 21:00. Eventually, the maximum water level rose as high as T.P. +8.29m.

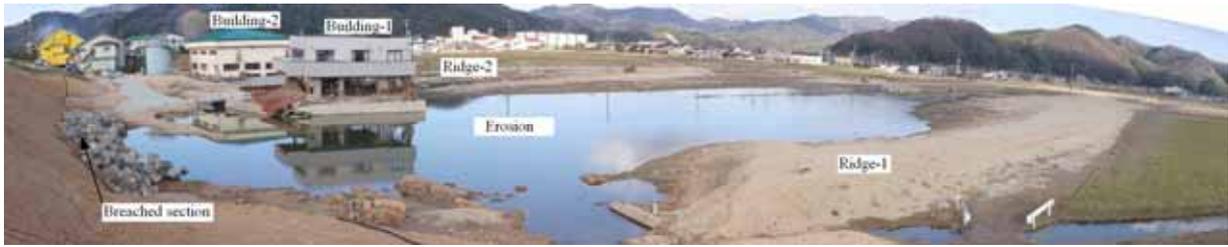
Visits to the breaching-affected area made us notice a range of marked sedimentary features such as shown in Photo. 1 (Azuma *et al.*, 2005). In this photograph one may note the central water body (erosional feature) and two distinct piles of particulate matter (depositional feature; ridges 1 and 2). In order to precisely evaluate these and other related topographical changes, we selected and used the method of digital photo-theodolite surveying (Ono and Hattori, 2002; Ono *et al.*, 2004). The features of the method will be described below.

Photo. 1 Panoramic view showing consequences of levee breaching at Tachino, as of December 22, 2004

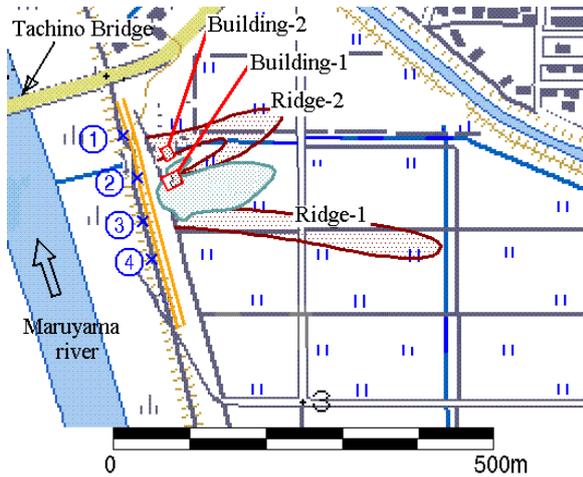
The digital photo-theodolite method is a “non-invasive” one. This feature was crucial for field survey in view of the fact that the paddy field is individuals’ property. We selected only four positions of photographing on the crown of the provisionally rebuilt section of the levee (Fig. 3). The hardware used consisted of a digital camera that was mounted on a theodolite (Fig. 4). The digital camera had eight megapixels, allowing a high spatial resolution. The theodolite facilitated the measurement of two angles of orientation on vertical and horizontal planes at every photographing position.

Fig. 3 Camera positions in digital photogrammetry

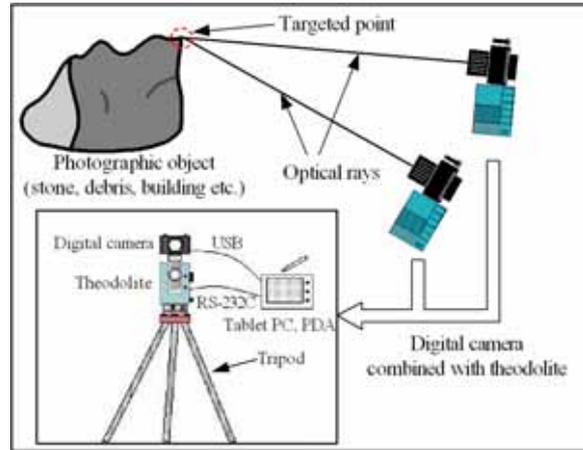
The three-dimensional coordinates of a targeted object may be determined based on the method of spatial intersection. In essence, a pair of two photographs of the targeted point from two different positions permits its three-dimensional coordinates to be determined.

Fig. 4 Digital photo-theodolite system, together with identification method of an object

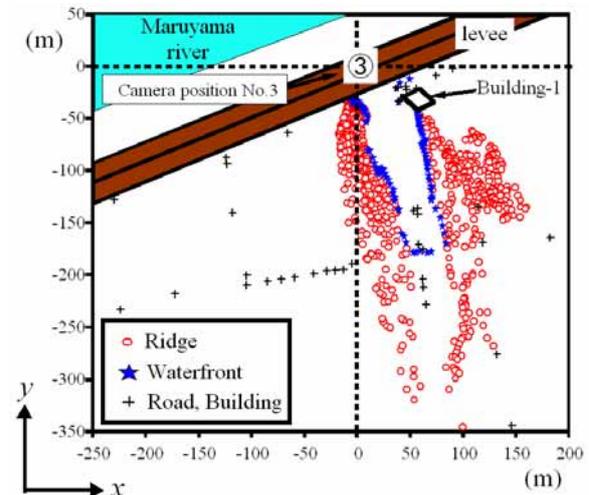
A total of 1029 points were identified in the affected flood plain using the photo-theodolite method. Technically, a key for the identification was to seek objects that had sharp corners. For this purpose, angular stones or debris made a good target. The locations of those identified points are projected onto a horizontal plane and are represented using an  $x$ - $y$  coordinate system, with the camera position No.3 being chosen as the origin (Fig. 5). Note herein that the reference horizontal plane was selected at a level numerically equal to the surface of the water body at the time of photographing.

Fig. 5 Identified survey points plotted on the  $x$ - $y$  coordinate system indicated

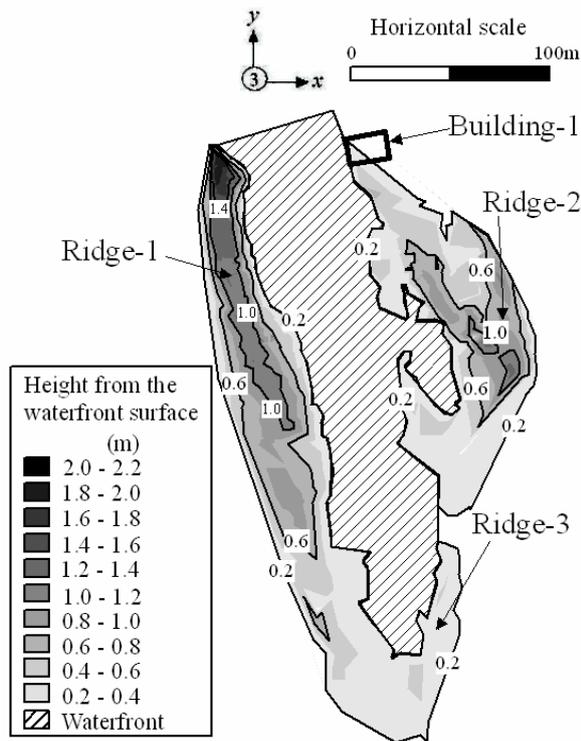
The relative heights of the identified survey points are shown in Fig. 6 in terms of contours. These contours were constructed using ArcGIS software (ESRI). It is noted that ridge-1 extended 300 meters in a direction

nearly normal to the levee. The height of the ridge took a maximum value (2.2m) near the levee and decreased gradually with distance from the levee. The occurrence of ridge-2 is also apparent in Fig. 6. A close look at Fig. 6 suggests the presence of another, much shallower pile of sediment (ridge-3) at the far end of the central erosional region where most of the outbursts were

Fig. 6 Contours showing topographical changes induced in the flood plain

An aerial photograph of the affected flood plain is shown in Photo. 2 (courtesy of Prof. Y. Fujita). In this photograph, ridges 1, 2 and 3 are clearly visible. The extents of ridges 1 and 2 appear to be in general conformity with the contour plots shown in Fig. 6. Although Ridge-3 manifests itself as a relatively narrow strip of sediment in Photo. 2, it is only marginally discernible in Fig. 6. This performance suggests that

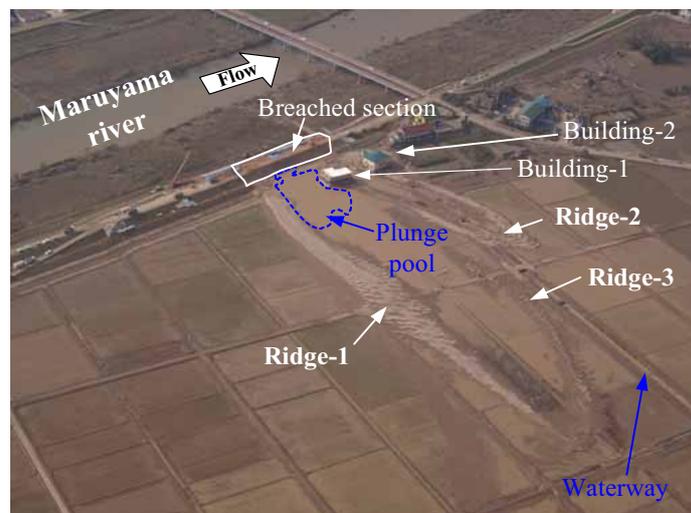
ridge-3 was a less pronounced feature and was likely to have undergone secondary modifications.

Ridge-2 took a horseshoe shape behind Building-1 and Building -2 as shown in Photo. 2. The maximum height of ridge-2 was 1.4m and appeared near the levee. The volume of ridge-2 was evaluated to be equal to 5000m<sup>3</sup>.

Photo. 2 Aerial photograph of the flood plain, taken on October 25, 2004 (courtesy of Prof. Y. Fujita)

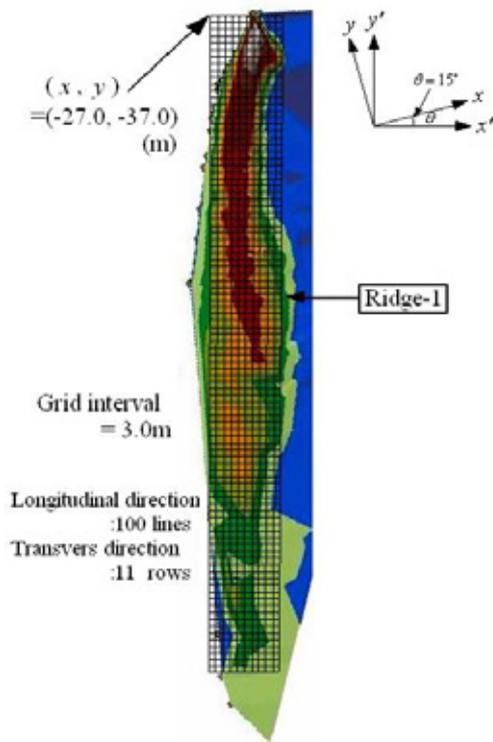
In order to evaluate the volume of deposition of ridge-1, we covered the ridge with a computational grid of 100 rows by 11 columns (Fig. 7). The grid intervals were set at 3.0m. The use of ArcGIS permitted us to evaluate the cross-sectional area of the ridge along each grid line. Thus the volume of ridge-1 was evaluated to be 12000 m<sup>3</sup>. In the course of the volume analysis for ridge-1, we obtained the surface profile along each grid line. Those results are integrated to give a three-dimensional representation such as shown in Fig. 8.

Fig. 7 Computational grid covering ridge-1

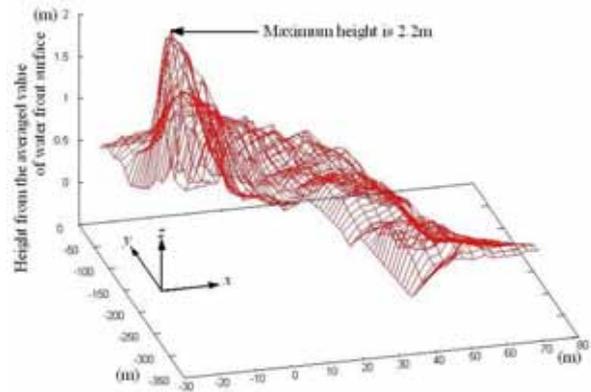
Fig. 8 The surface topography of ridge-1 by three-dimensional representation

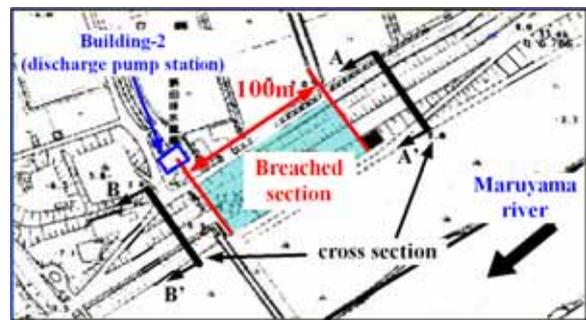
A plan view of the breached levee section approximately 100 m wide is presented in Fig. 9. In order to calculate the volume of loss due to the breaching, we chose a section marked A-A' on Fig. 9, which was located 80m upstream from the breached section. The cross-section through A-A' is shown in Fig. 10. Note in this figure that the body of soil above the dotted line represents the volume of the levee material lost due to the breaching. Note herein that we drew the dividing line

Fig. 9 Map showing the extent of the breached section

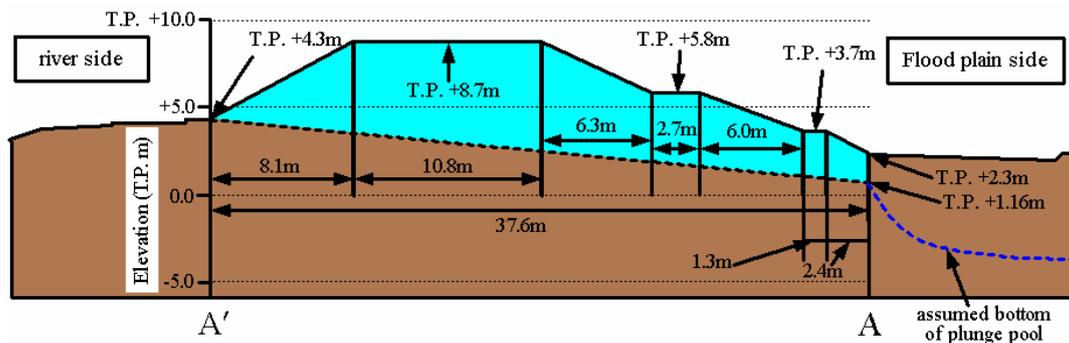
in such a way as to pass through the riverside toe of the levee (T.P.+4.3m) and to meet with the edge of the plunge pool (T.P.+1.16m). The calculation of the volume above the dotted line was then straightforward. Namely, the area multiplied by the 100m length gave rise to the volume of loss of the levee equal to 16000m<sup>3</sup>.

Fig. 10 Cross-section A-A' through the levee (Toyooka office, 2005a). We have added the dividing bottom line.

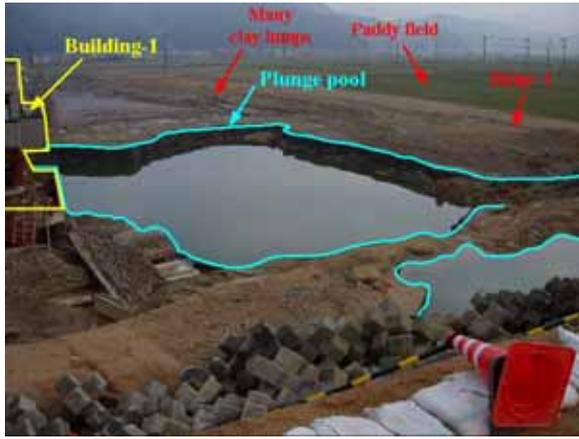
Let us first look at Photo. 3 that captures the sedimentary features of the plunge pool and adjacent areas. The periphery of the plunge pool had nearly vertical faces. This feature is compatible with the observation that the plunge pool was formed by scouring of the clayey subsoil in the paddy field. Also, a close look at Photo. 3 beyond the plunge pool shows the

presence of a number of clay lumps that were produced by scouring, transported and finally left on the affected flood plain. The size of the clay lumps has a practical implication and will be referred to later in this paper.

Photo. 3 A view of plunge pool and adjacent areas (photograph taken on November 25, 2004)

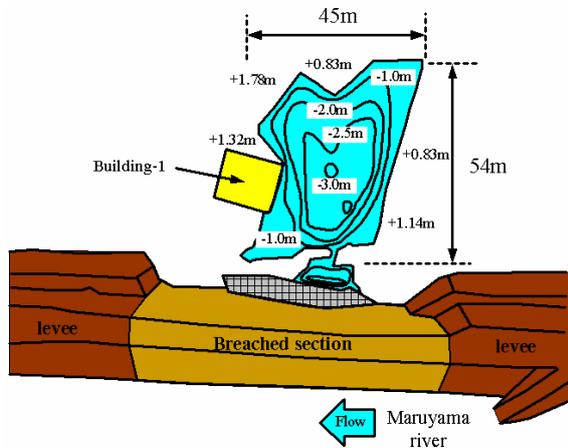
Let us now focus the discussion on the configuration of the plunge pool (Toyooka Office, 2005a). The plunge pool was 54m long and 45m wide in plan (Fig. 11). Its maximum depth was 4.3m from the ground surface, whose average elevation was T.P.+1.16m. In order to evaluate the volume of the plunge pool, we simplified the configuration as shown in Fig. 12. Then the volume

Fig. 11 Contours of equal elevations, in terms of T.P., of the plunge pool and surrounding ground surface (adapted from Toyooka office, 2005a)

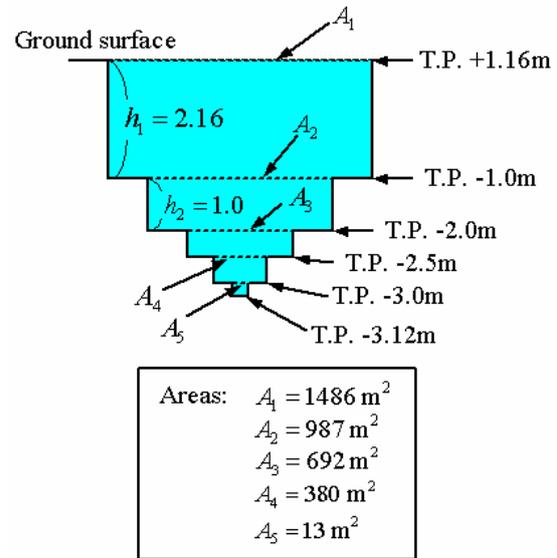
$$V = A_1 h_1 + A_2 h_2 + A_3 h_3 + A_4 h_4 + A_5 h_5 \quad (1)$$

where  $A_i$  represents the area of the horizontal cross-section designated and  $h_i$  stands for the thickness between the two horizontal planes involved. Thus the volume of the plunge pool was estimated to be equal to  $5000\text{m}^3$ .

Fig. 12 Simplified representation of the configuration of the plunge pool

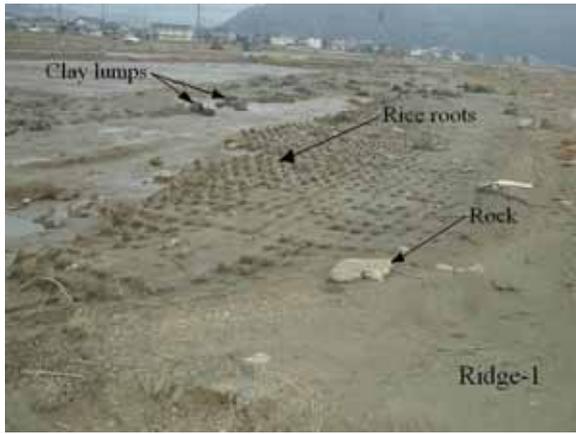
As mentioned earlier, we noted the presence of a number of clay lumps in the flood plain beyond the plunge pool (Photo. 4). The clay lumps were evidently oversized, compared with the deposited sandy materials. The size of the large clay lumps were 50cm or so in diameter (Azuma *et al.*, 2005). The question now arises as to how such clay lumps were formed. Our idea about this is schematically shown in Fig. 13. The stream power due to the overflow may be the principal agent for scouring the clayey subsoil in the paddy field, producing clay lumps. Indeed, if the clayey soil had a significant tensile strength, it could then fail in the form of blocks under the action of water jet or stream power; this failure mode should be contrasting with that of cohesionless sandy sediments.

Photo. 4 Clay lumps left on the severely eroded surface in the clayey subsoil

pool. A view of such an area after the event is presented in Photo. 4. Many clay lumps can be seen left on the severely eroded surface of the clayey subsoil. The surface conditions were markedly different from the adjacent zone where the rice roots remained. It will thus be worth exploring the stream power that can completely erode such rice roots.

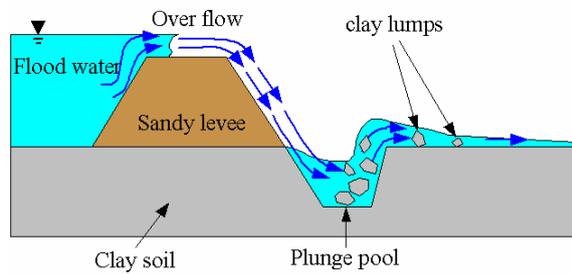
Fig. 13 Sketch illustrating the process of producing clay lumps

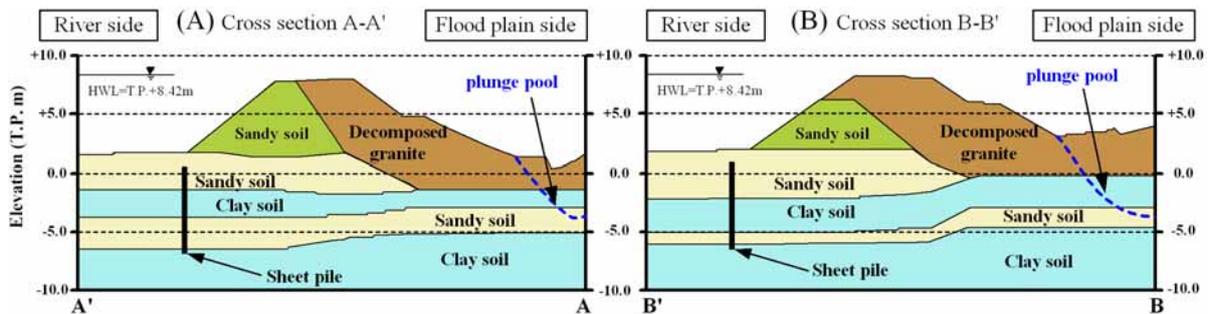
The Soil strata in cross sections A-A' and B-B' through the levee is shown in Fig. 14 where the assumed bottom line of plunge pool were added. It is noted that the clayey subsoil existed below the breached levee. As the plunge pool was formed, the clayey subsoil was scoured to form the clay lumps. Also, it is important in Fig. 14 to note that the seepage flow through the foundation soil was insignificant, if any, during the flood stage because of the sheet pile already provisioned.

Fig. 14 Soil strata in cross sections A-A' and B-B' through the levee (adapted from Toyooka office, 2005b).

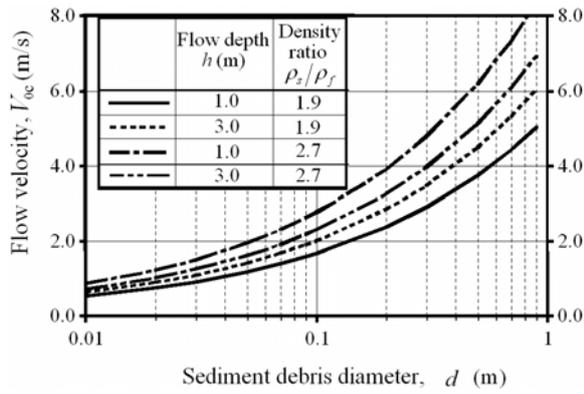
Fig. 15 Relations between critical flow velocity and sediment debris diameter

The relations between the critical flow velocity,  $V_{0c}$ , and particle diameter,  $d$ , are shown in Fig. 15 for four sets of flow depth  $h$  and density ratio  $\rho_s/\rho_f$ .

We suppose that the maximum size of the sediment debris occurring in the flood plain was 50cm or so, as realized by the clay lumps. Note herein that the levee construction was essentially with decomposed granite soil. The grain sizes involved may not exceed 30cm. If the sediment debris is 50cm in diameter, then we can read off from Fig. 15 a range of the critical velocities  $V_{0c} = 3.8 \sim 4.5$  m/s for the density ratio equal to 1.9. This estimation should be applicable to the inundating water that flew down the paddy field beyond the plunge

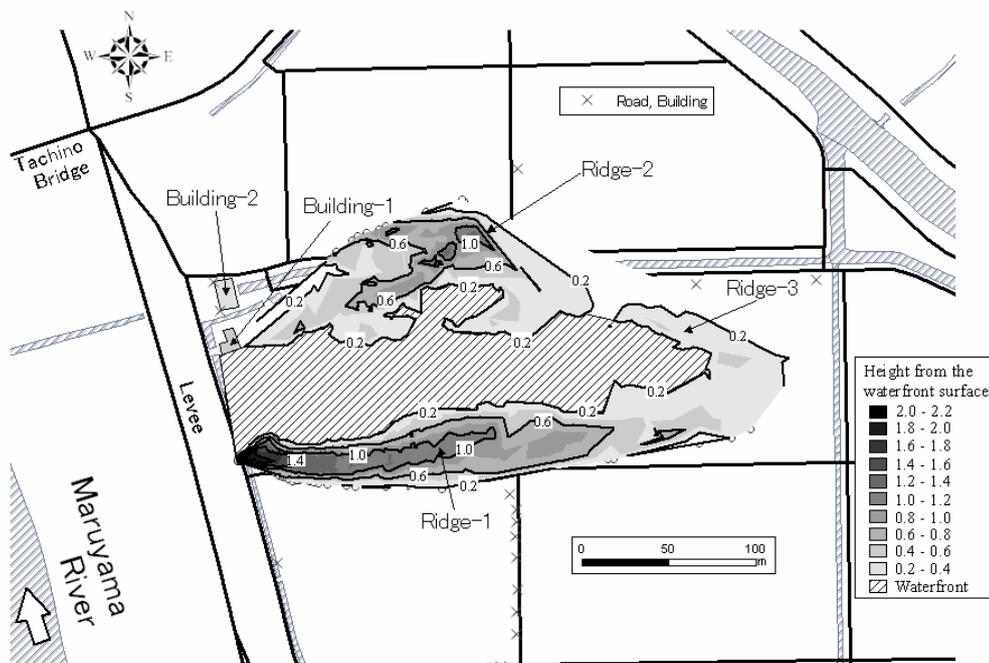
One of the important considerations is to share the GSI's high-resolution spatial data framework designated Digital Map 2500. An example is shown in Fig. 16. This representation was made possible by superimposing the digital topographical dataset obtained from the photo-theodolite survey on a Digital Map 2500 of KINKI-1. The accuracy of our photo-theodolite surveying may be confirmed in Fig. 16 by referring to the locations of stable structures, such as building-2 which has fortunately stood essentially intact.

Fig. 16 Contours of topographical changes that are overlain onto a digital numerical map available from GSI

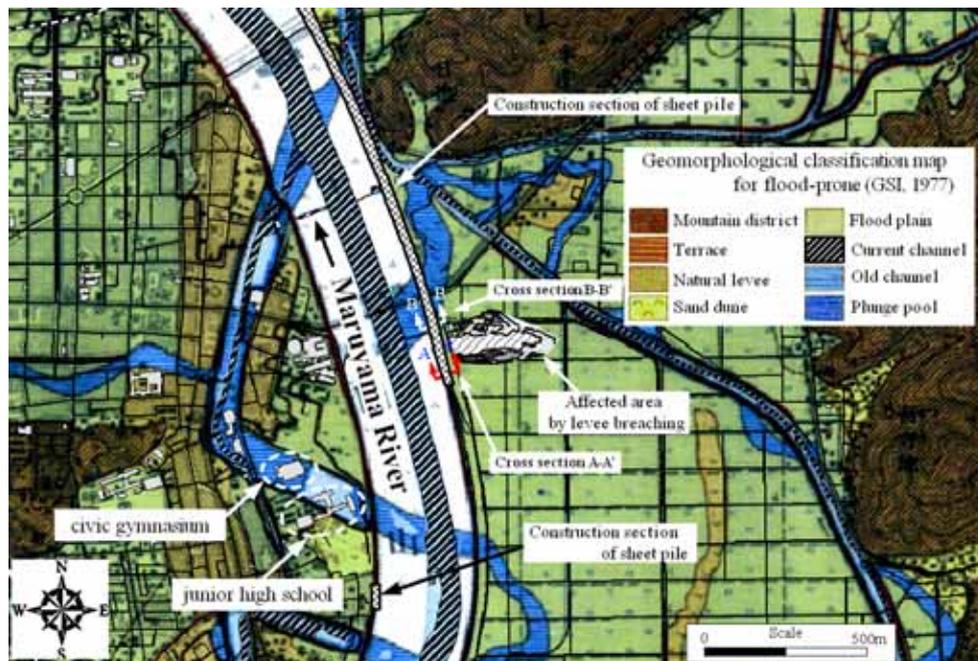
Fig. 17 Digital topographical data set superimposed on a digital image of the GSI-issued

record a range of flood-related morphological features, such as plunge pools, old channels, natural levees and sand dunes. Such a GSI-issued classification map is available for the Maruyama River basin and is represented in Fig. 17. Note herein that the classification map was initially published in 1977 and has recently been reprinted without any updating. Accordingly, it is informative and useful in its present form, but calls for special care regarding the land-use evolution that has occurred over the past thirty years or so. For instance, one may notice a few buildings standing on a part of the old meandering course of the Maruyama River. The shift in the river course was performed by the authority concerned as part of the extensive river training work. So, we believe that the old-channel site should have turned into land with well engineered designs.

As far as the management of flood-related hazards is concerned, the representation of old channels or the like on a geomorphological classification map is just a start for thorough engineering assessment. Indeed, a range of important engineering measures should be represented as well, as illustrated in Fig. 17. Note, for instance, a long stretch of sheet piling on the right bank of the Maruyama

River. The sheet piling was performed many years ago so as to reinforce the seepage-vulnerable areas. Accordingly, we think that the location of the well treated old channel near Tachino should not directly affect the 2004 levee-breaching case. This statement may be supported by the observation that the foundation soil below the levee withstood the October 2004 excessively high flood stage.

The purpose of plotting the 2004 crevasse-splay sedimentary features on the 1977 map was to draw attention to the extent of the levee-breaching case which we surveyed using the digital photogrammetry. It really was a record-worthy large event.
