The July 17, 2006 West Java Earthquake and Tsunami

Jim MORI, Walter MOONEY*, Afnimar**, Sandy KURNIAWAN***,
Aan Ibnu ANAYA** and Sri WIDIYANTORO**

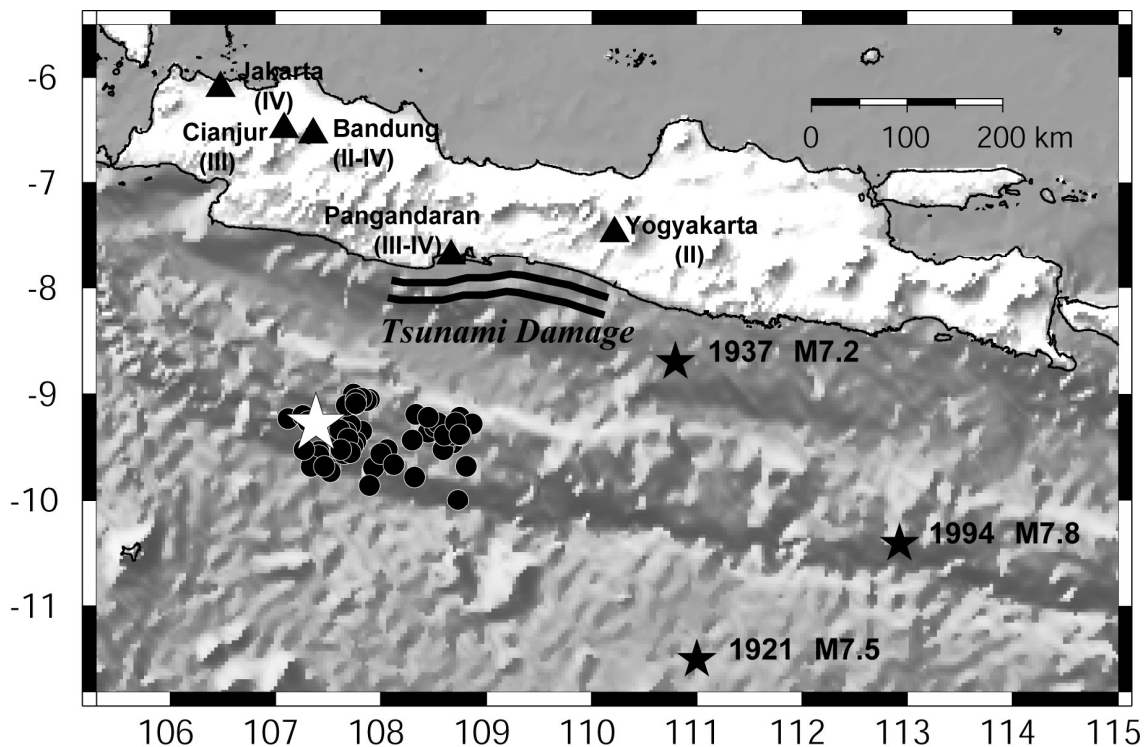
Fig. 1 Locations of mainshock (white star) and aftershocks (black circles) from USGS for the July 17, 2006 West Java earthquake. Roman numerals under place names show felt intensities.

The July 17 earthquake occurred about 220 km off the southern coast of Java with a hypocentral depth of about 10 km (USGS). The mainshock and aftershock epicenters shown in Figure 1 indicate primary unilateral rupture for about 150 km to the east. In the larger surrounding region there is fairly high rate of subduction zone seismicity with large shallow events in 1921 ($M=7.5$), 1937 ($M=7.2$), and 1994 ($M_w=7.8$), although there are no records of large earthquakes close to the rupture area of the recent event (Figure 1).

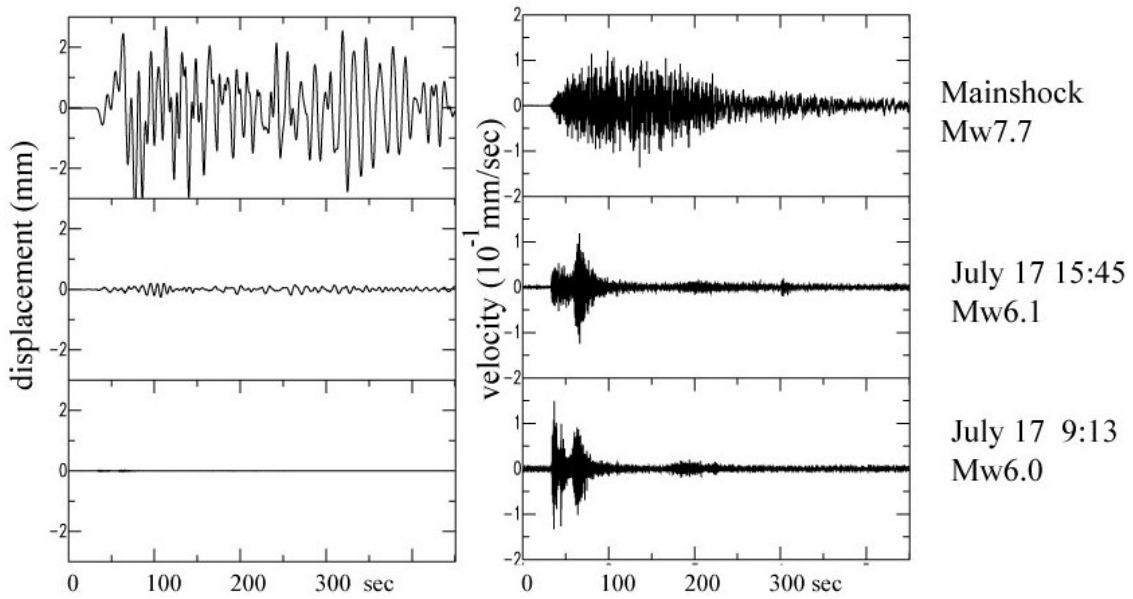
Fig. 2 Waveforms of displacement (left) and velocity high-passed filtered at 1 Hz (right) for the mainshock and two larger aftershocks recorded at Christmas Island, about 200 km to the southwest.

This difference in frequency character can be seen in the seismograms of Figure 2, which compares the mainshock with two aftershocks recorded at Christmas Island, about 200 km to the southwest. On the left are displacement seismograms showing that the $M=7.7$ mainshock had much larger low-frequency amplitudes than the $M=6$ aftershocks. On the right are velocity seismograms high-pass filtered at 1 Hz to show the high-frequency content. The much smaller (in terms of seismic moment) aftershocks have about the same, or slightly larger, peak amplitudes for the higher frequencies, although

the duration is much longer for the mainshock.

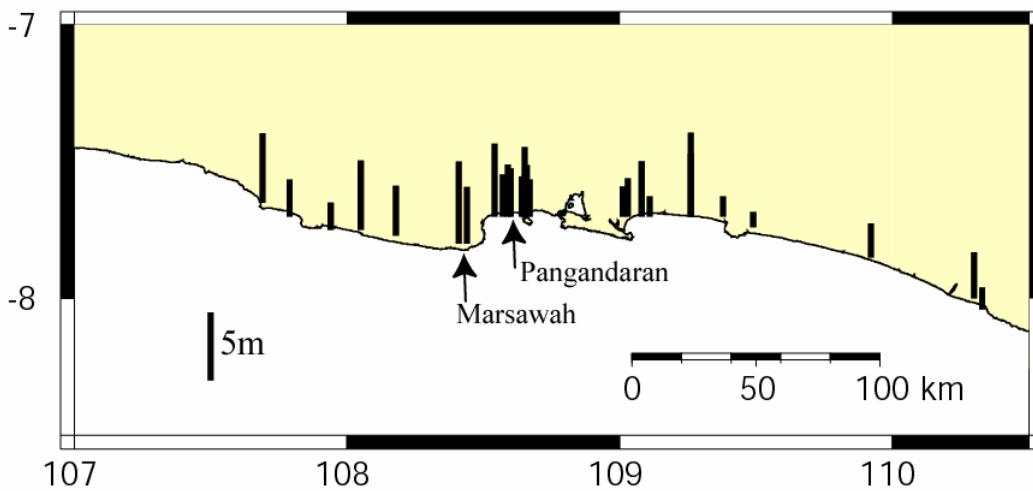
Figure 3. Tsunami run-up heights measured by Kongko et al.(2006) and the Indonesia Ministry of Marine Affairs and Fisheries et al. (2006).

A large tsunami occurred over more than 250 km of the south Java coast from Garut prefecture in the west to Yogyakarta prefecture in the east. In the heavily damaged area of Pangandaran, the estimated run-up heights from eyewitness accounts is 4 to 6 m. Along the southwest shore of the Pangandaran National Park, which is a small spit that extends about a kilometer to the south, the tsunami was relatively small. From observations of markers consisting of lines of sands and leaves, the tsunami did not appear very high - about 1 to 2 m. Measurements of run-up heights (Indonesia Ministry of Marine Affairs and Fisheries, 2006, and Kongko et al., 2006) show variable inundations ranging from 1 to 8 meters across the region (Figure 3). Also, Fritz et al. (2006) reported one area near Nusa Kambangan that had an unusually high 21 m runup. A tide gauge at Christmas Island, located about 200 km southwest of the epicenter, recorded a tsunami height of 83 cm.

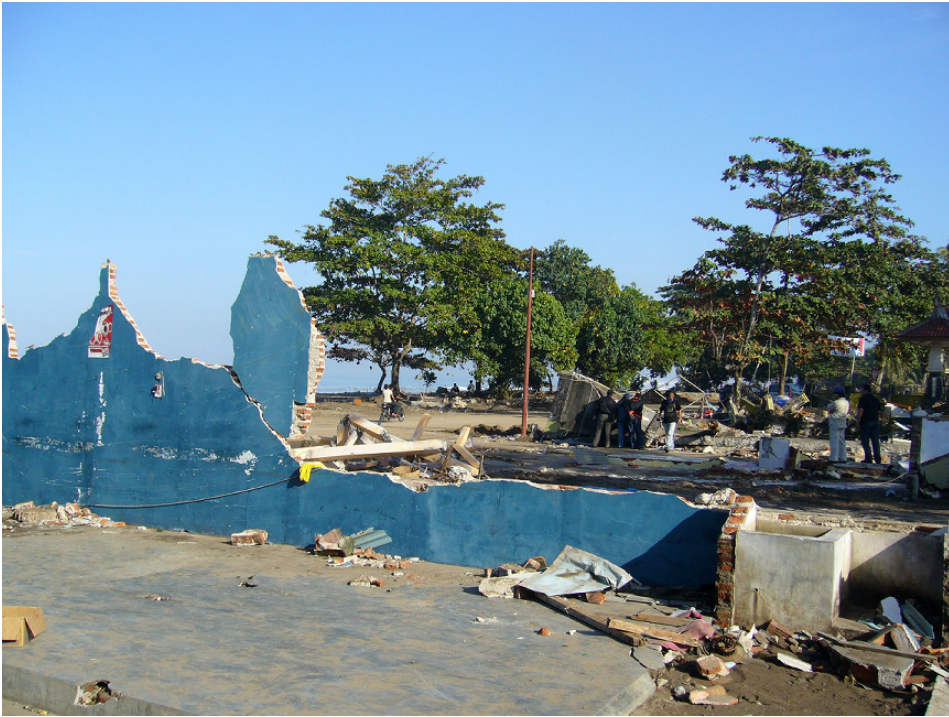
have better construction and suffered less structural damage. Damage consisted of collapsed walls, walls with large holes, especially where windows and doorway existed, and large piles of debris consisting of building material and small boats (Figures 4a and 4b). Damage extended several hundred meters inland from the shore. At other villages, Batu Hiu and Batu Karas, located 13 and 18 km west of Pangandaran, respectively, there was similar tsunami damage to buildings.

Fig. 4a Tsunami damage to unreinforced masonry buildings and debris in Pangandaran.

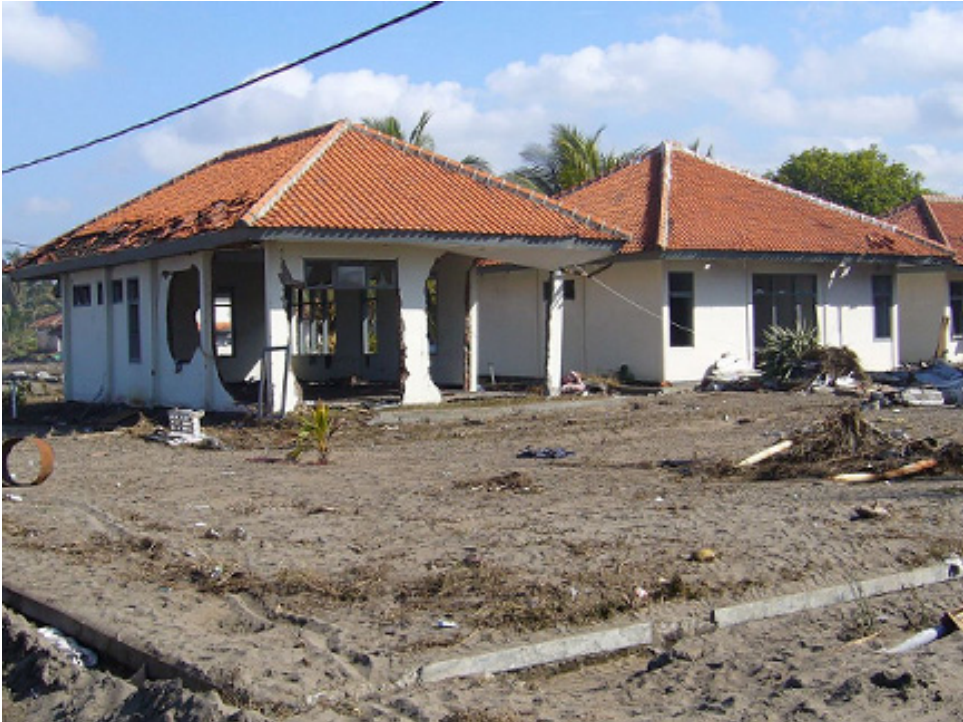
Fig. 4b Damage to buildings near Pangandaran. Note the damaged roof for the building on the left, indicating the height of the tsunami.

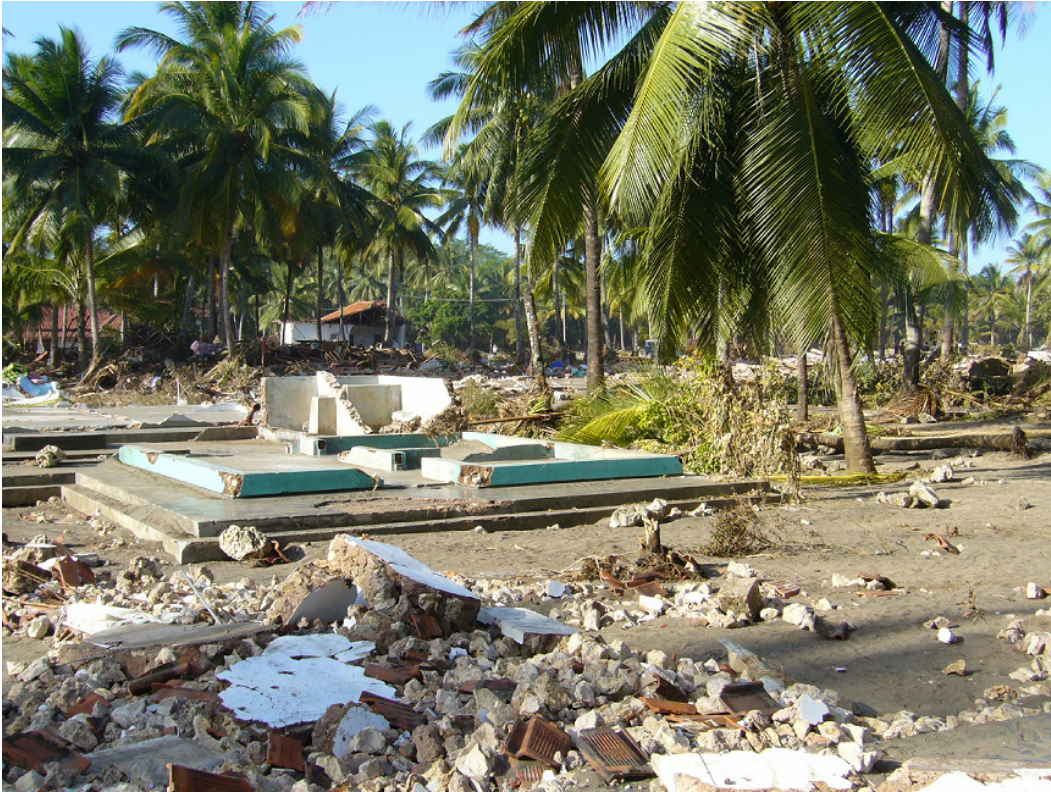
The most severe damage we saw was in Marsawah village, Bulakbenda, located about 22 km southwest of Pangandaran. Within about 150 meters of the coast, all of the buildings were completely washed away, there were no walls standing and only the floor and foundations remained (Figure 5). The buildings were one and two story residences of clay brick masonry construction. Further inland, at distances of 300 to 500 meters, many of the buildings were also completely destroyed. Eyewitness accounts report that the tsunamis had heights of 6 to 8 m. It was reported that waves broke about 200 to 300m inland from the shore and came down vertically on top of the houses in this region

Fig. 5 Severe damage in Marsawah village where no walls were left standing for buildings within about 150 m of the shore.
