Possible Scenarios for Rjecina River Catchment – on the Example of Grohovo Landslide

Maja OSTRIC*, Yosuke YAMASHIKI, Kaoru TAKARA and Tamotsu TAKAHASHI

Synopsis

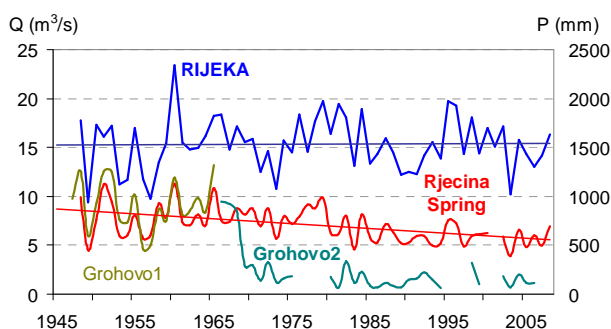
Fig. 2. Changes in the water regime before and after the construction of dam in 1968. Mean annual flow (m³/s) is shown for two profiles (Rjecina Spring and Grohovo) and MAP for Rijeka station (mm), for the period 1947-2007.

For hydropower purposes, the hydropower plant Rijeka was constructed in 1968, which uses water from the Valici reservoir (useful capacity 0.7 million m³) located in the middle part of the valley. To show the changes in water regime of Rjecina river after the reservoir (dam) construction, discharge for the Grohovo profile (downstream from the dam) before (up to 1967) and after (starting from 1969) the construction of the dam are shown on the Fig. 2.

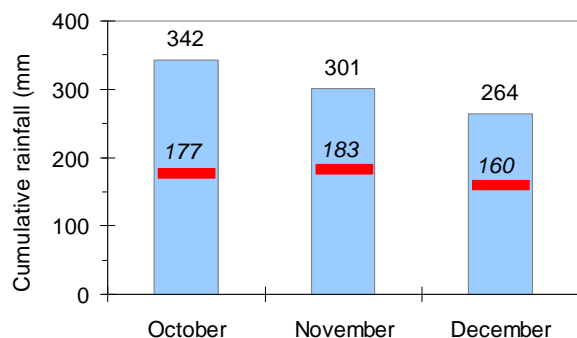
Fig. 3. Bars show cumulative rainfall at the Rijeka rain gauge for October, November, and December 1996. Red lines and italic numbers show long-term (1948–2009) monthly averages.

Figure 3. shows the cumulative rainfall measured at the Rijeka rain gauge in October, November, and December, 1996. In the considered period, the monthly rainfall was from 94% (October) to 64 % (November) higher than the average monthly values in the period from 1948 to 2009 (red lines in Fig 3).

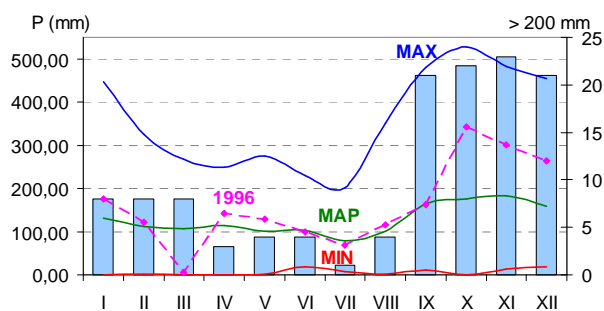
Fig. 4. Bars show number of events when monthly rainfall exceeds 200 mm. Lines showing mean annual precipitation (MAP), minimum annual precipitation (MIN) and maximum annual precipitation (MAX) for the period 1948–2009. Violet line shows annual flow for 1996.

Analysis of the available historical record indicates that monthly rainfall at the Rijeka rain gauge exceeded 200 mm more than 20 times in the period from September to December, with a maximum monthly value of 526,7 mm in October 1998 (Fig 4).

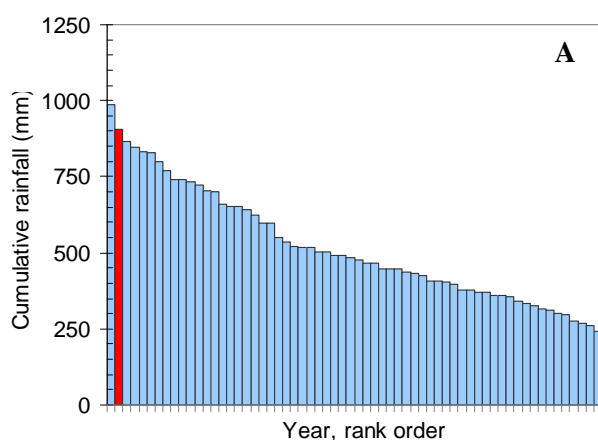
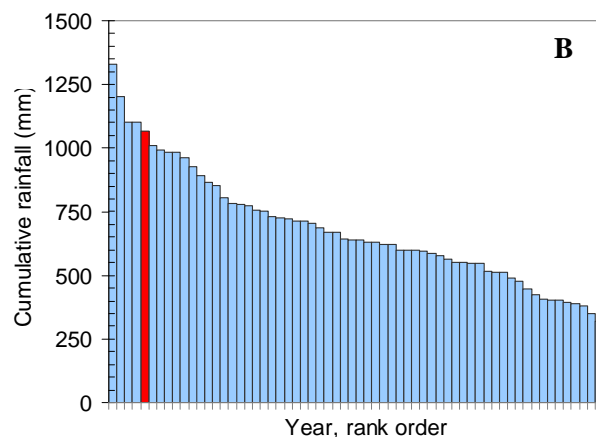
Fig. 5. Blue bars show cumulative rainfall for the Rijeka rain gauge, for the 3-month period from October to December (A), and for the 4-month period from September to December (B), in the period between 1948 and 2009. Bars arranged from high (left) to low (right) values of cumulative yearly rainfall. Red bars show cumulative rainfall for the same 3-month and 4-month periods in 1996.

However, analysis of the cumulative rainfall for the 3-month period from October to December (Fig. 5a) indicates that only once (in 2000, 986 mm) the cumulative rainfall for the 3-month period from October to December exceeded the cumulative value measured in 1996 (907 mm), and four times (in 1960, 1328 mm; in 1976, 1202 mm; in 1993 1103 mm; and in 2000, 1101,3 mm) the cumulative precipitation for the 4-month period from September to December (Fig. 5b) exceeded the rainfall measured in 1996 (1069 mm).
