Landslides induced by typhoon Hagibis

- Typhoon Hagibis crossed the Japanese Islands from 12 to 13, October 2019, and brought record-breaking rainfall and strong wind.
- This typhoon induced river floods and landslides in eastern Japan and caused tremendous damage with 93 fatalities and 3 missing.
- This paper reports the characteristics of 3 fatal landslide areas, referring to the possibility of their prediction.

Chigira et al. (Disaster Prevention Research Institute, Kyoto University)

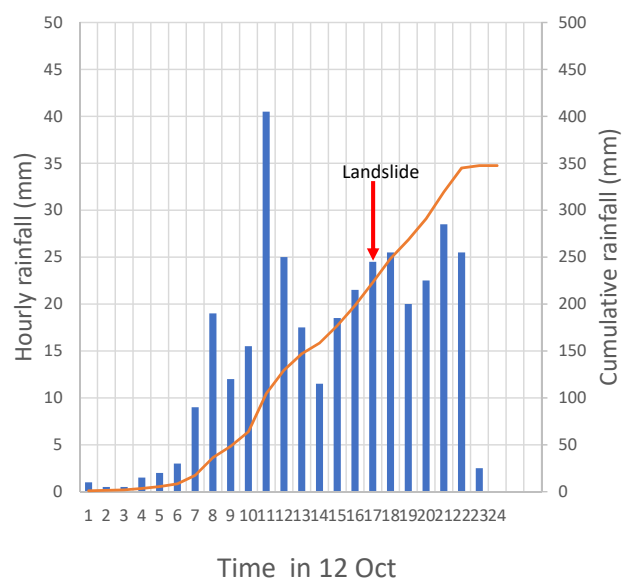
Rainfall at Fujioka (AMEDAS) 15 km east of Tomioka

350 mm at 12 Oct. Before that almost no rain in one month.

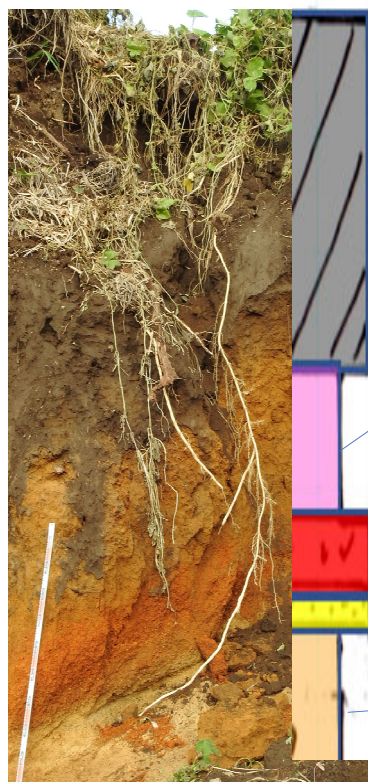
Materials that slid were from the Asama volcano

0 Sliding surface was in As-Pm

Black soil

Brown volc. Soil
Many root holes

As-BP (20-25ka)
Reddish brown scoria, <1cm, fragile,
easily smeared

As-MP
Pale yellow pumice, fine to very
coarse sand size, clayey, easily
smeared

Mudflow deposits (clayey, including
3 m gravels)—Less permeable

- Landslide occurred on gentle slopes with 20° angle on a margin of a terrace.
- Slid materials were pyroclastic fall deposits up to 3 m thick on less permeable mudflow deposits.
- Sliding surface was made in the lower part of As-MP (pumice), which was weathered to be clayey materials.
- As-MP layer was eroded underground at the rim of the terrace, where bedding dip becomes steeper toward downslope.
- This underground erosion formed piping holes, where water pressure could have been buildup to trigger the landslides.

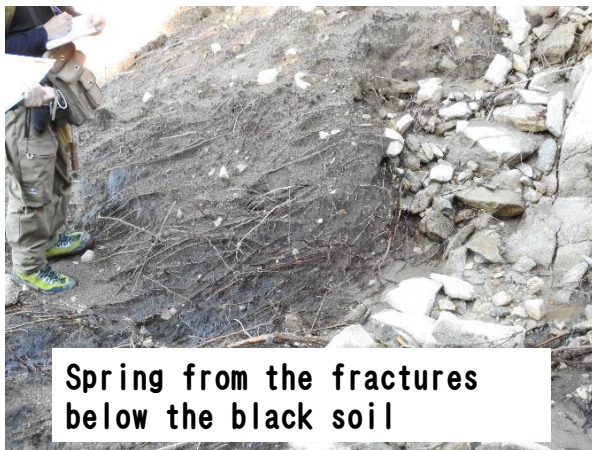
Profile of the landslide and the debris flow

Springs from fractures and openings between core stones caused the landslide.

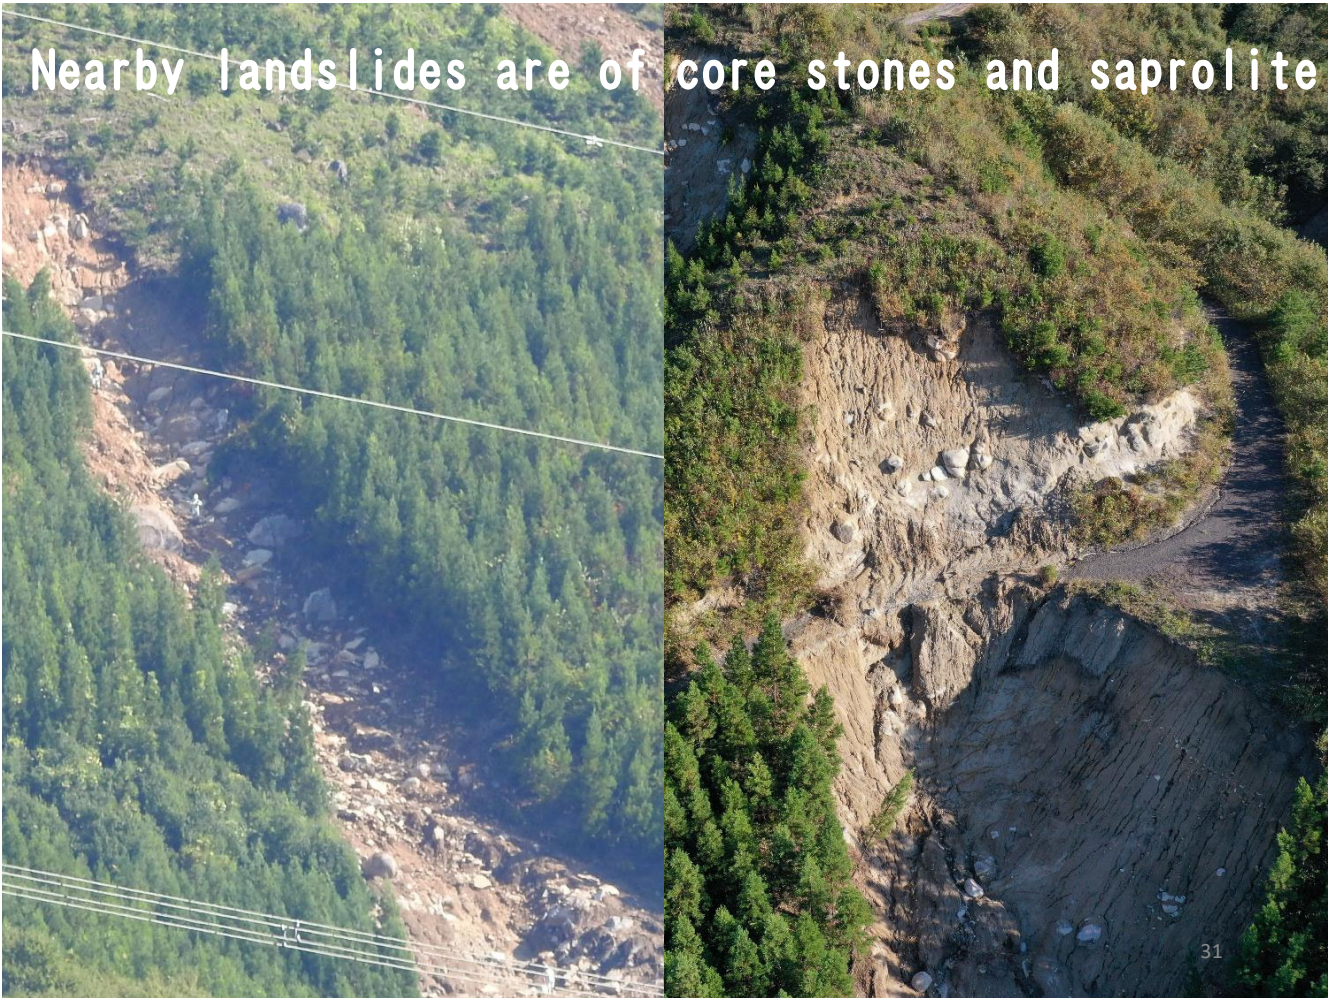
Nearby landslides are of core stones and saprolite

- Shallow landslides and debris flows occurred mainly in granite areas with a rainfall over 400 mm/24 h (particularly Mawarigura and Gofukudani areas).
- Weathering styles are different between the Mawarigura and Gofukudani areas.
- Core stones and the surrounding saprolite failed in the Mawarigura area, and the core stones must have made the debris flow more destructive.
- Major type of the landslides in the Gofudani area likely is a shallow landslides of soil on micro-sheeted granite.

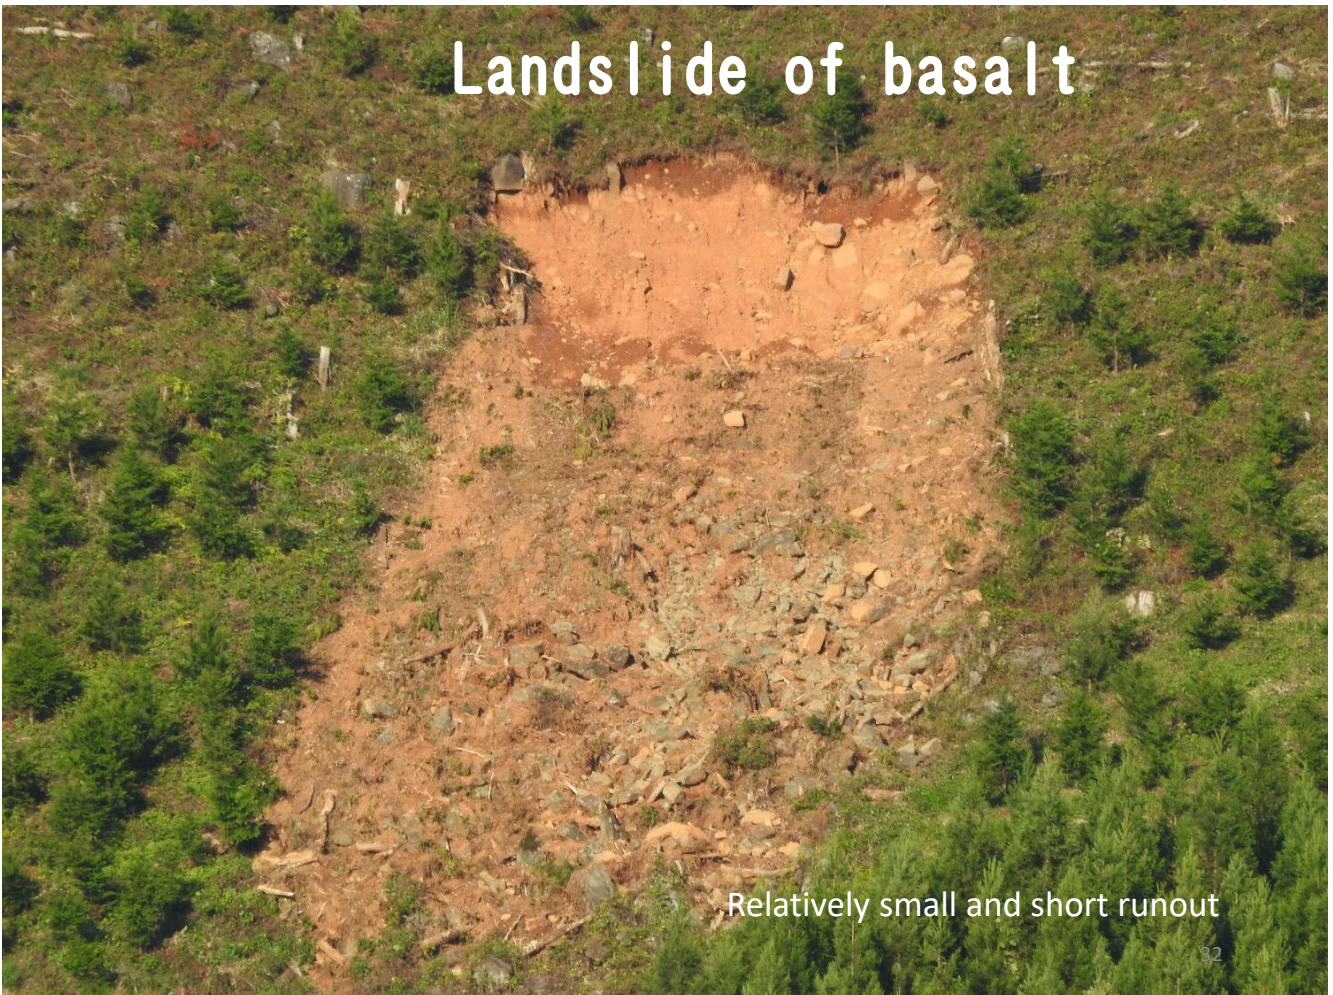
Landslide of basalt

Relatively small and short runoff

Huge volume of sand

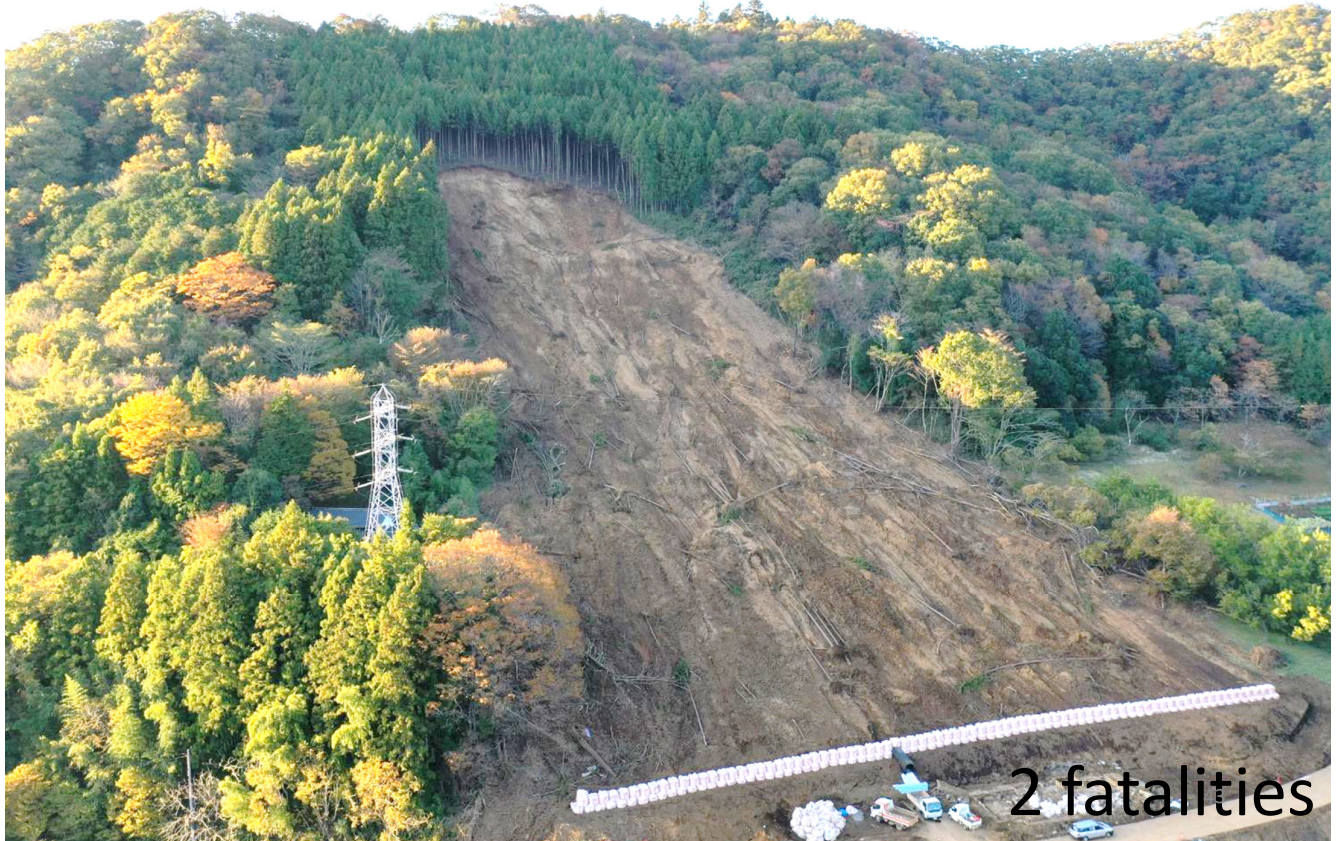
Overview of the landslide at Magino

(occurred 9:45 pm, 12 Oct)

Source area is at the top

- The source area of the Magino landslide was its top.
- Erosion holes were made in the weathered autobreccia below massive andesite lava.
- Water gushed out from the autobreccia and induced the landslide.
- Near the landslide source are at least five circular depressions, from where water gushed out.
- These depressions are inferred to be made by water gushing probably from autobreccia like that in the landslide this time.
- These depressions could be a clue to predict the landslides of similar type.

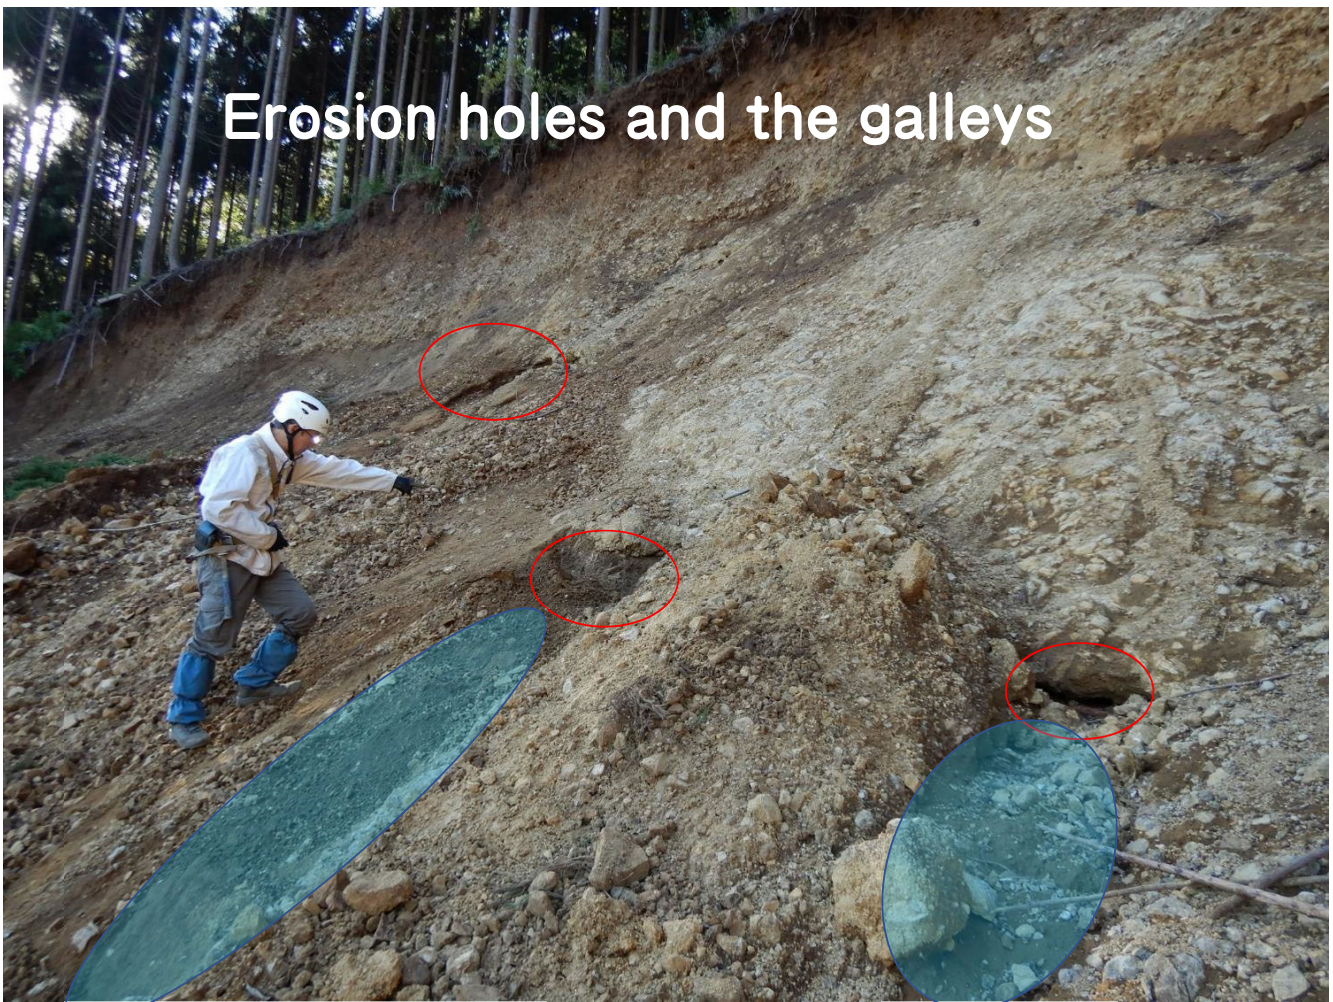
Profile

Erosion holes and the galleys

The volcanic soil has many rock fragments in its lower part.
Sliding surface was made from the surface of andesite lava to the boundary between the upper and the lower volcanic soil.

Trigger was the spring gushing out.
