Landslides in Kisawa area, Tokushima Prefecture during the 2004 Typhoon Namtheun

Gonghui WANG, Akira SUEMINE, Gen FURUYA,
Masahiro KAIBORI*, and Kyoji SASSA

Synopsis

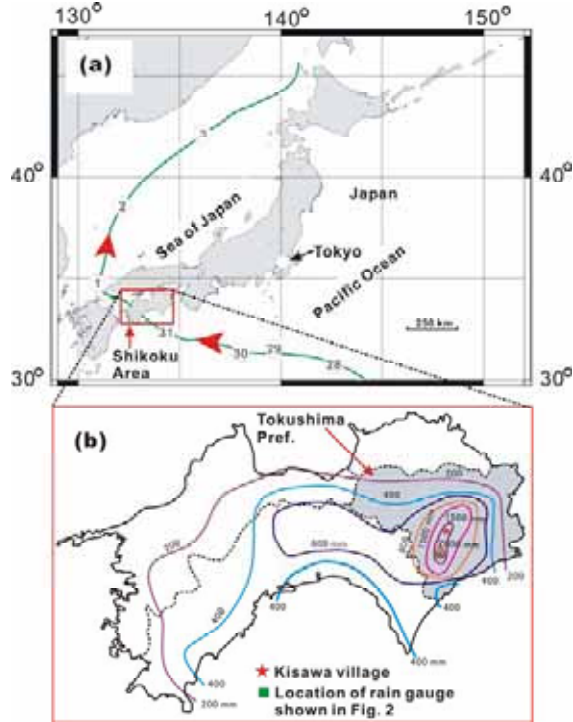
The area where precipitation exceeded 1,500mm for the storm was centered on Kisawa village and Kaminaka town, as a very narrow area of 5-6 km in the east-west direction, and 10-20 km in the south-north direction (Fig. 1b). Within this area, many landslides were triggered.

Fig. 1 (a) Path of Typhoon Namtheun (after National Institute of Informatics, 2004). (b) Rainfall distribution in the Shikoku area from July 30 to August 2 (after Nakagawa River Office, Shikoku Development Bureau, Ministry of Land, Infrastructure and Transport (MLIT), Japan, 2004)

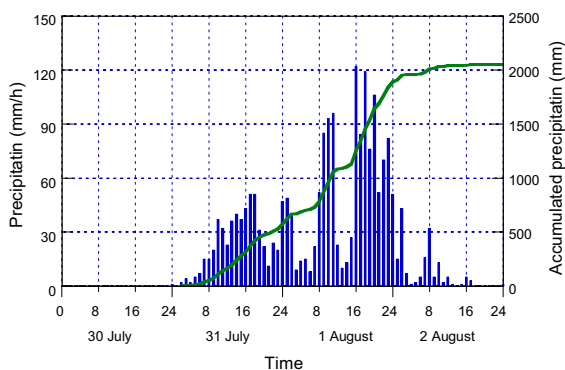
Torrential rain in Tokushima and Kochi Prefectures accompanied the slow approach and passing of Typhoon Namtheun. At Kaminaka town (about 10 km far away from these four landslides) of Nakagawa District, Tokushima Prefecture, the total precipitation from July 30 to August 2 was more than 2,000 mm (Fig. 2). This is several times the normal precipitation for the months of July and August in this area. Hourly precipitation reached more than 120 mm (Fig. 2). The highest daily precipitation of 1,317 mm was recorded on 1 August (Fig. 2); this value exceeds the previous Japanese daily precipitation record of 1,114 mm, recorded at Kito village (about 16 km southwest of Kisawa village) on September 11, 1976 accompanying Typhoon Fran.

Fig. 2 Hyetograph of the heavy rainfall (data courtesy of Shikoku Electric Power Co., Inc.)

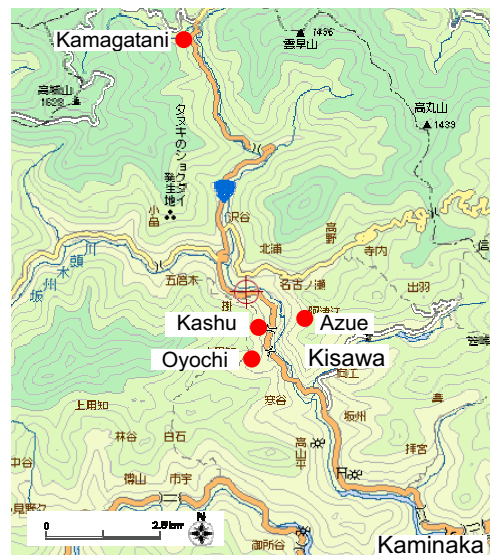
Fig. 3 Location of Oyochi, Kashi, Azue and Kamagatani landslides

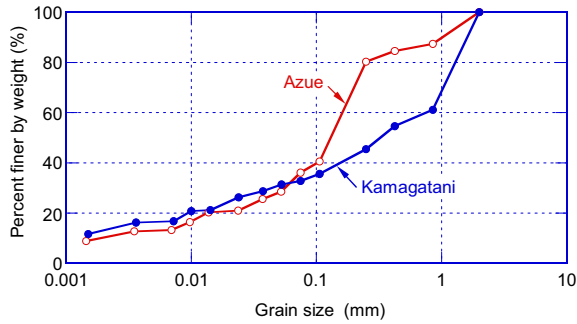
As mentioned previously, the Oyochi, Kashu, and Azue landslides have very similar geological backgrounds, while the Kamagatani landslide is different. Nevertheless, they all were rapid to some extent. To understand the triggering, as well as the possible movement mechanism, it is important to understand the shear behavior of these materials before and after the failure, and how these are affected by rainfall. Therefore, samples were taken from the source area of Azue landslide (S in Photo 5) and from the Kamagatani landslide (S' in Photo 9), for laboratory examination, and testing in a ring-shear apparatus described in Sassa et al. (2004a). Due to a size limitation imposed by the shear box, gravel greater than 2 mm in diameter was removed by sieving before testing. The grain size distribution of the samples used in the tests is presented in Fig. 7.

Fig. 7 Grain-size distributions of samples from the Azue and Kamagatani landslides (after removal of the >2 mm size fraction)
