## Detection of Collapse Position in Mountainous Slope by Underground Sound Method

### Synopsis

**Keywords:** underground sound, water path, collapse position

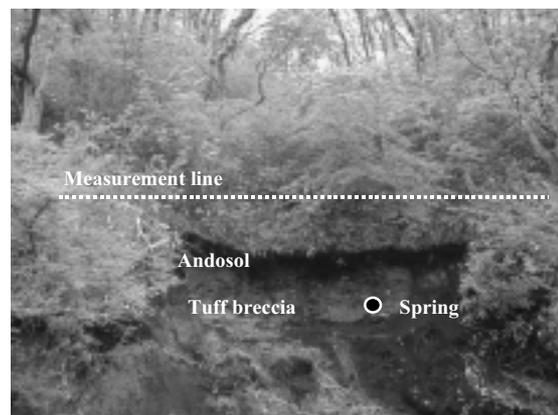
Photo 2 Soil exposure at the road cut in Hirusen A

[1] Hirusen A (Photo2) ; Spring position in forest road cut slope was inquired. Ground surface is covered with the andosol of 0.5 m in thickness. And the lower soil layer is composed of tuff breccia. There is one spring in tuff breccia soil layer. Spring occurred in heavy rainfall event or snow melting event. There were a few spring waters when the investigation was executed.

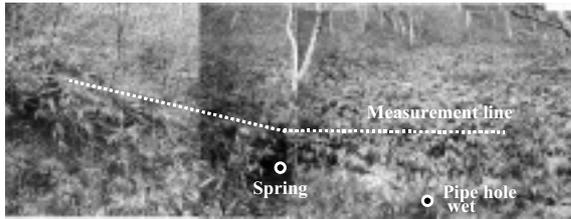
Photo 3 Soil exposure at the road cut in Hirusen B

[2] Hirusen B (Photo3) ; Two spring position in forest road cut slope were inquired. Ground surface is covered with the andosol of 1.5 m in thickness. The lower soil layer is composed of tuff breccia. There are two springs in road cut. One spring in andosol layer (spring A) has a few discharge when road cut slope

were inquired. Another spring existed in tuff breccia soil layer. This spring B has few discharge when road cut slope were inquired.

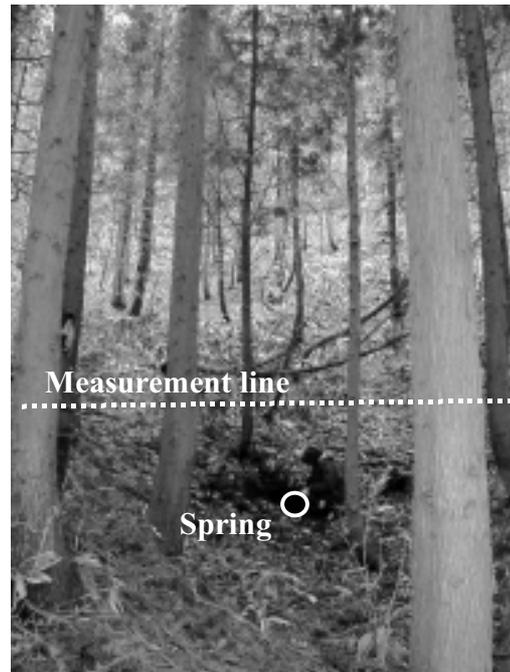
Photo 4 Condition around the spring in Hirusen C

[3] Hirusen C (Photo4) ; One spring position in bottom of the slope were inquired. Ground surface is covered with the andosol of 2.0 m in thickness. The lower soil layer is composed of tuff breccia. There was the spring in andosol. And, spring occurred in heavy rainfall event or snow melting event. This spring has not discharge when slope were inquired.

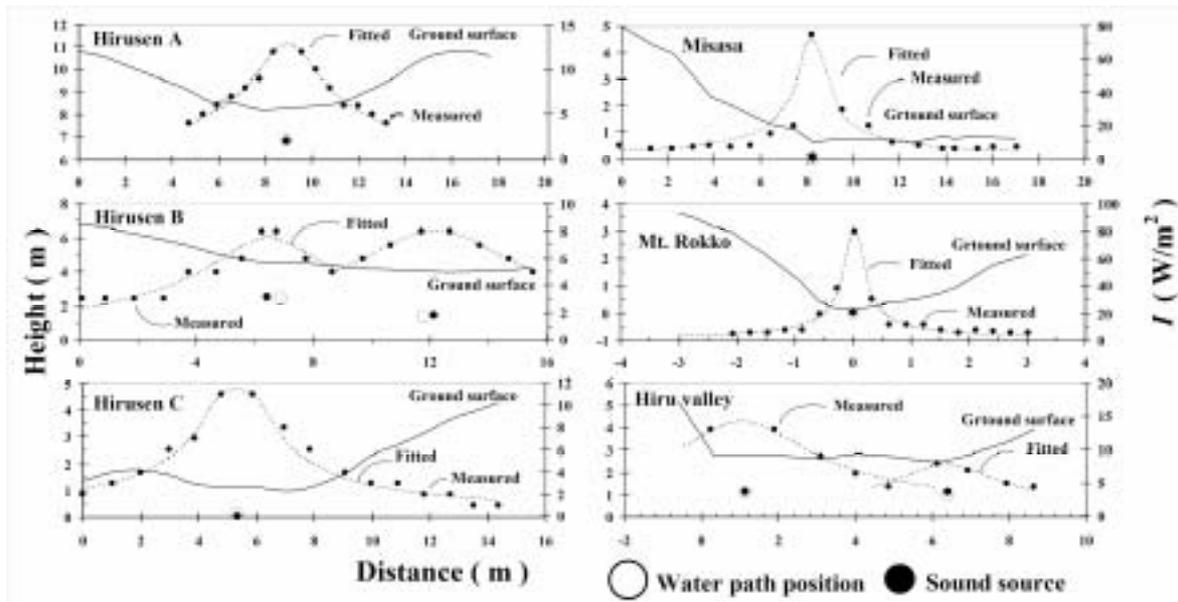
Fig. 6 Measurement results of underground sound and calculation results of water path position

Figure 6 shows the results of water path investigation. The solid line in figure shows the ground level, and white circle shows an actual spring water point. Black circle shows the underground sound that measured in the ground surface.

In all sites, underground sound was biggest on the spring point. And underground sound in measurement point has become small while going away from the spring point. This tendency is the same in case of two or more spring water exist.

These results in natural slope conformed to experimental results. And, It is interesting that there is a sound peak in the position where spring was not seen (Hirusen B, C).

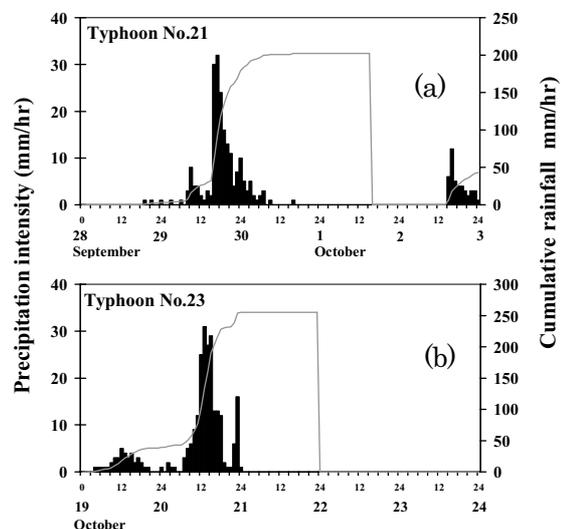
Fig. 14 Rainfall intensity and cumulative rain precipitation

Figure 14(a) showed the appearance of precipitation. Peak of rainfall intensity was 30mm/hr. Cumulative rain precipitation was recorded 200mm.

The underground sound was measured on July 12 in 2004. After measurement, Typhoon No. 23 brought heavy rainfall in Tottori and Okayama aria on October 20-21, 2004. Figure 14(b) showed this precipitation result. Peak of rainfall intensity was 30mm/hr. Cumulative rain precipitation was recorded 250mm. Photograph 13 showed the appearance of road cut slope

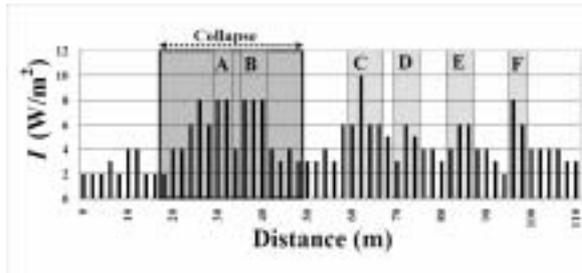
Fig. 15 Collapse position in road cut slope C

Appearance of load cut slope C after the typhoon was shown Photograph 12. The road cut slope was collapsed by heavy rainfall of typhoon. Photograph 12 indicated that Collapse was occurred in left side of grating crib works. Collapse was 30m in width, and 1.5 m in depth. This collapse position was collated with the underground sound distribution chart (Fig. 15). The collapse was occurred in the part that had three peaks of underground sounds.

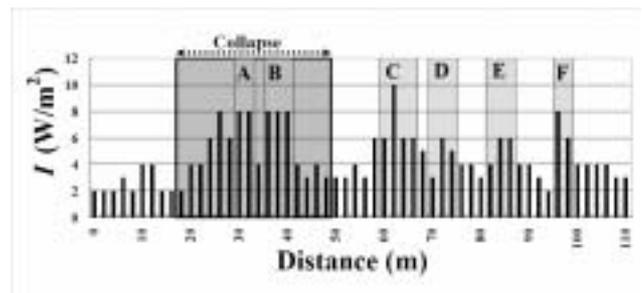
図1 地中音の分布と豪雨後に発生した崩壊の位置

▶▶崩壊は水みち上で発生している（図1）。

②地中音にピークが検知された崩壊の非発生部位が、その後の豪雨で崩壊した（図1、写真1）。

自然斜面には、日常的に地下水の集中する部位（水みち）が存在し、豪雨時にその部位に多量の地中水が供給されることで崩壊は発生する。
