Study on Landslides in Weathered Granite Areas of Hai Van Mountain, Vietnam

Pham Van TIEN, Kaoru TAKARA and Kyoji SASSA⁽¹⁾

Synopsis

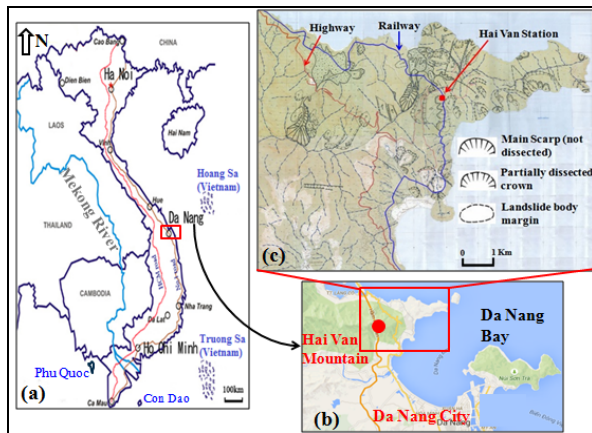
Fig. 1 (a) Location of Da Nang City; (b) Hai Van Mountain and (c) Study area modified from landslide classification map created by Miyagi, 2015

The mountain is widely known as one of the most landslide risk hotspots in Vietnam. Slope failures frequently took place in this area, which seriously destroyed transportation infrastructures and threatened operation safety along 21 km of the

national railway and near 30 km of the national highway in Hai Van Mountain. Notably, the area was confronted by the hardest hit of the 1999 historic storm that triggered numerous sliding, earth flows and debris flows along the transport systems with about 2 million m³ in total volume (Tam, 2005). Landslides induced by rainfalls derived from the storm initiated from 3rd November in a large area of Hai Van Mountain.

Slope failures and landslides are mostly concentrated along national transport system (including the highway and railway lines) and contiguous zone to South China Sea. The extent, location and types of slope failures can be found in a landslide classification map created by Prof. Miyagi in 2015 as an output of the SATREPS project in Vietnam (see in Fig. 1 above).

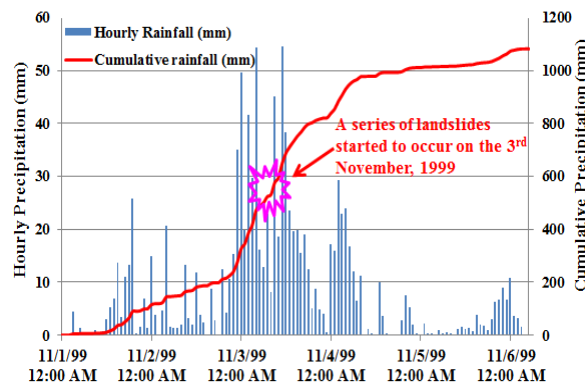
Fig. 2 Cumulative precipitation at the Da Nang gauge station for the period from Nov 1 to Nov 6, 1999 and landslide occurrence in time.

The occurrence time of slope failures and rainfalls derived from the 1999 storm at Da Nang Meteorological Observatory 20 km far from Hai Van Mountain is presented in Fig. 2.

As can be seen, the accumulative precipitation was recorded to 1,074 mm during 6 days of which the rainfall of 512 mm was produced on 3rd November only. While the cumulative precipitation of 1,851 mm during the storm period was monitored at Nam Dong Rain-gauge Station which is about 35 km from Hai

Van Mountain. In such disasters, landslide phenomena occurred between more than 20 segments of the national highway separately, which caused interrupted the operation of the road for 8 days and seriously destroyed infrastructures both railway and highway. In addition, according to statistical data of Management Unit for Roads, many slope failures were induced by maximum daily rainfall of 301 mm in November 11, 2007.

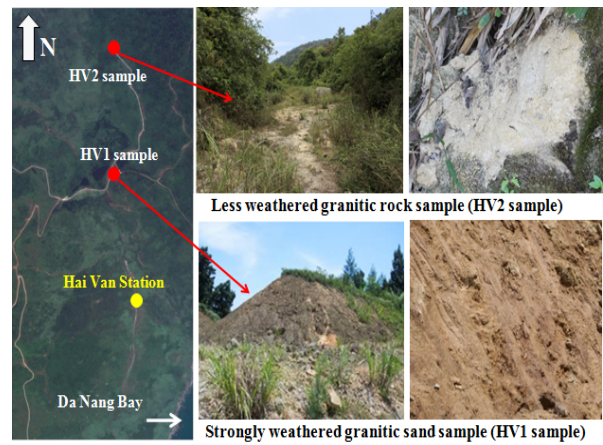
Fig. 5 The locations of soil sampling

Two suspected landslide samples, namely a less weathered granitic rocks sample and a strong weathered granitic rocks sample (hereinafter called as HV2 sample and HV1 sample, respectively), were taken to study on their shear behavior during motion and post-failure by ring shear simulator (Fig. 5).

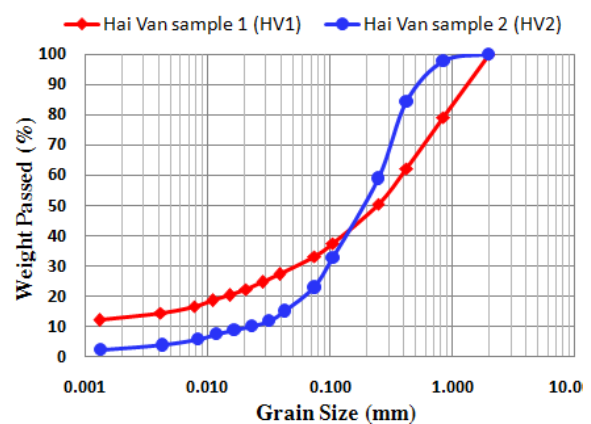
Fig. 10 Grain-size distributions of two samples

The grain size distribution curves showed that HV1 sample contains clay-like fine grains much more than HV2 sample. Basically, HV1 sample is slightly clayed sand, while HV2 sample is sand. Both materials are fine to coarse grained with fine gravels and mica fragments.

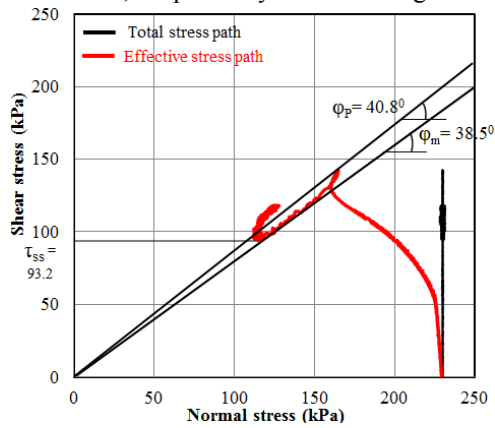
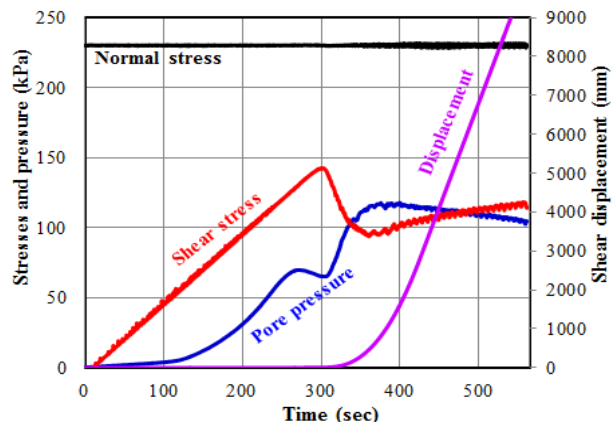
Fig. 11 Effective stress path (left) and time series (right) of shear stress control test for HV1 sample

Undrained monotonic shearing was carried out to explore landslide mechanism and to observe the pore water pressure generation as well as initiation of failure motion. Test results showed that excess pore water pressure generated during shear displacement after failure of HV2 sample, but there was not much pore water pressure increasing during shearing (Fig. 11 & 12). Seen from results, the steady state shear resistance of HV1 sample was 93.2 kPa while HV2 sample obtained 5.9 degrees of apparent friction angle. The peak friction angle of HV1 sample and HV2 sample are around 41.0 degrees and 36.0 degrees with 143.5 kPa and 133.1 kPa maximum shear resistance, respectively. Friction angle during

motion of two landslide samples at large displacement are about 38.0 degrees for clayed/slightly clayey soil and 33.5 degrees for sand. (2) Rainfall-induced landslide simulation
