Modelling the deposition process of failed bank material

○Ahmed ALY EL-DIEN, Hiroshi TAKEBAYASHI, Masaharu FUJITA, Shusuke MIYATA

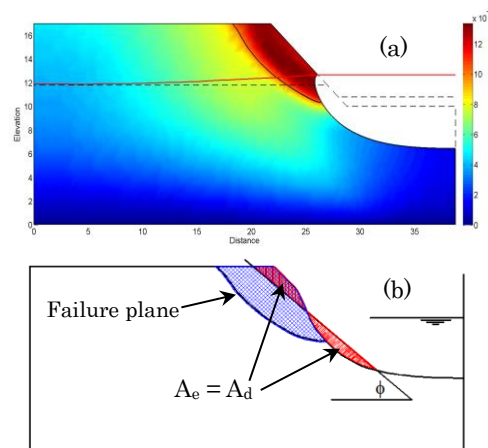
The stability model uses the finite element technique, there is no assumption needs to be made in advance about the shape or location of the failure surface. Failure occurs "naturally" through the zones within the soil mass in which the soil shear strength is unable to resist the applied shear stresses. The rotational, planner, cantilever failures are considered the most common failure types observed in riverbanks. Each type depends on the geometry and the material of the bank. The expected plane of failure for the riverbank at the end of the hydrographs is shown in figure (2-a). On the other hand, the shape of the riverbank after failure is shown in figure (2-b). If the mean angle of bank slope increases due to lateral erosion, it consequently becomes less stable. As a result, bank failure occurs. The failed sediment at the bottom of the bank can be entrained and the process repeats itself.

Fig.(2) (a)Expected plane of failure, (b) shape of the riverbank after failure.

The geometry of the bank after collapse is modified based on two basic assumptions: (1) the failed bank material become loose and turned into small separate pieces (crumbs) that

rests on a slope having the an angle of repose less than the original bank angle, (2) the collapsed sediment volume equals the deposited sediment volume.
