# Study on Wind Vulnerability of Non-engineered Houses in Leyte Island, the Philippines

○Kazuyoshi NISHIJIMA, Hiroaki NISHIMURA, Liezl Raissa TAN, Jaime HERNANDEZ

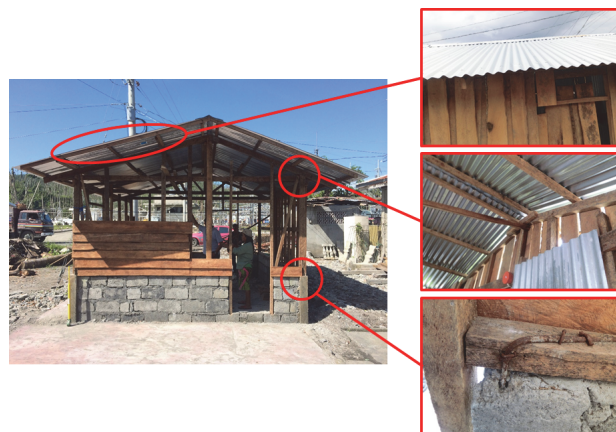
A residential house located along the east coastline of Leyte island is considered as the model building in the study. It is built by non-experts, who do not rely on engineering knowledge and skills and hereby classified as non-engineered house. The appearance and its details are shown in Fig. 1. Its geometry and employed construction materials are listed in Table 1.

Fig. 1. Model building and its details.

Having inspected the details of the model building three parts are identified as weak points. These are (a) attachment of GI sheet to roof structure, (b) connection between roof structure and column and (c) connection between column and foundation, see the right photos in Fig. 1. For part (a), three failure modes are considered in the following assessment; i.e. (a-1) nail pull-out, (a-2) nail pull-over, (a-3) GI sheet shear tear-out. These are illustrated in Fig. 2.
