This paper reports the seismic damage observations of typical Japanese suspended ceiling, and highlights

the important role of the reinforcing bars between the two ceiling elevations.

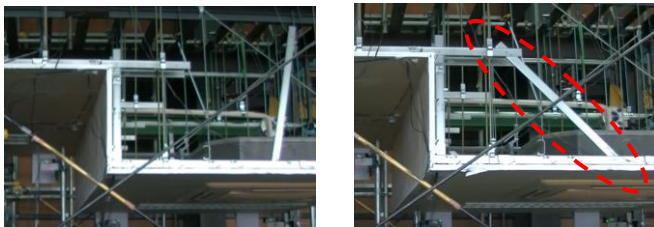
(a) Without reinforcing bar (b) With reinforcing bar

Fig. 4 Reinforcing bar

The reinforcing bars (Fig. 4) were analyzed in detail to see its influence on the seismic behavior of the integrated ceiling system. Under JMA Kobe L2, no apparent damage occurred, and the maximum relative drift (MRD) between two ceiling elevations was only 0.61%, indicating the great integrity of the ceiling system.

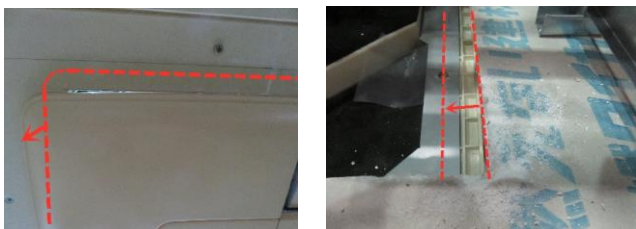
(a) Twisting of AC (b) AC movement

Fig. 5 Damage observations

Under JMA Kobe L3, The AC cover was stuck into the original clearance and certain twisting deformation existed (Fig. 5). MRD increased to 1.81% and relative residual deformation between the two elevations of

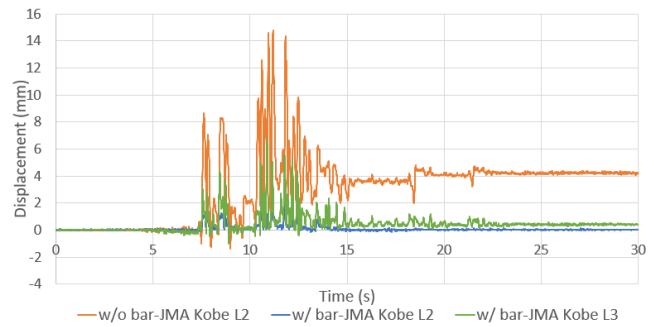
Fig. 6 Relative displacements of two elevations

0.4 mm appeared. After removing the reinforcing bar, MRD under JMA Kobe L2 reached 3.9%, resulted in very large residual deformation of 4.2 mm, demonstrating the important role of the reinforcing bars. Besides, the lighting fixtures are very flexible to resist the input seismic force. Fig. 6 shows the drift variation between two ceiling elevations with different ground motion excitation.
