## Study on Piping Failure of Natural Dam

### Synopsis

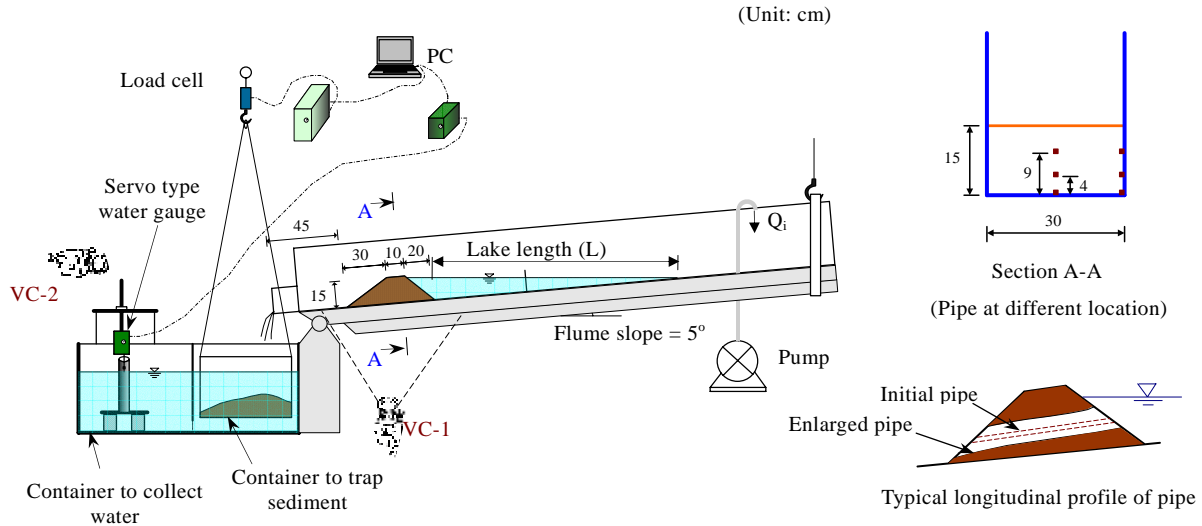
Fig. 2 Schematic diagram of the experimental setup.

The schematic diagram of the flume and other accessories used in the experiments are shown in

Fig. 2. The rectangular flume of length 500cm, width 30cm and depth 50cm is used. The shape and size of the dam used in experiments for the flume slope of  $5^\circ$  is shown in Fig. 2. In the case of the flume slope of  $2.5^\circ$ , the upstream and downstream slope lengths of the dam are 27.5cm and 22.5cm

respectively. The height of all dams is 15cm.
