地震時に崩壊した降下火砕物の層序,貫入抵抗プロファイルの共通性について Common characteristics of sequence and cone-penetration profiles in pyroclastic fall deposits that slid during earthquakes

○千木良雅弘・中野真帆・土谷樹生・鈴木毅彦○Masahiro CHIGIRA, Maho NAKANO, Tatsuki TSUCHIYA, Takehiko SUZUKI

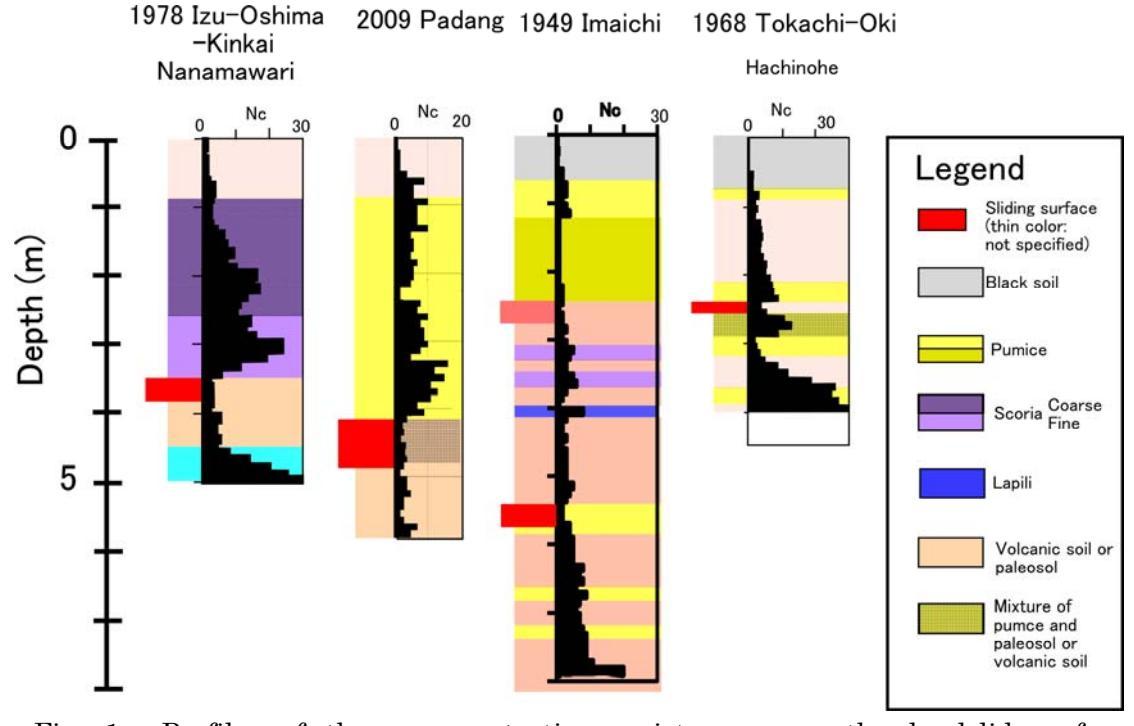
Figure 1 には、4 つの地震による崩壊の代表的 な層序と簡易貫入抵抗プロファイルを示す.4 か 所の内、伊豆大島近海地震、パダン地震、および 今市地震によるものは、表層部に軽石あるいはス コリアがあり、その直下の風化火山灰土あるいは 古土壌にすべり面が形成されている.+勝沖地震 の時には、これらの軽石やスコリアに比べて軽石 層の厚さが薄いが、やはり、軽石の直下の火山灰 土にすべり面が形成されている.

貫入抵抗を示す Nc 値に注目すると,いずれの 崩壊においても,地表に近い所に相対的に Nc 値 の大きな層があり,その直下の Nc 値の小さな層 にすべり面が形成されている.このように物性の コントラストのあるところで崩壊が発生する可能 性は Sugimoto et al. (2012) によっても指摘され ている.

Fig. 1 Profiles of the one-penetration resistance near the landslides of pyroclastic fall deposits induced by earthquakes.

2. 層序と簡易貫入試験による物性プロファイル 軽量の簡易貫入試験器を用いて4地点の崩壊直 近で簡易貫入試験を行った.この試験器は、戸邉 (2007)によって制作されたものであり、先端コ ーン直径1.94cm,先端角60°のコーンを質量3kg の重りの50cm落下によって叩き、10cm貫入に 要する打撃回数(Nc)を測定するものである.こ れを用いた試験結果と丸東製貫入試験器を用いた 試験結果とはほぼ同じであることが示されている (戸邉, 2007).
