2011 年台風 12 号による和歌山県での河道災害  
River Disaster in Wakayama Prefecture due to Typhoon 1112 TALAS

- 武藤裕則・馬場康之・久保輝弘・村田明広・中野 晋・  
西山賢一・宇野宏司・宇民 正・中川 一  
○MUTO Yasunori, BABA Yasuyuki, KUBO Teruhiro,  
MURATA Akihiro, NAKANO Susumu, NISHIYAMA Ken-ichi,  
UNO Koji, UTAMI Tadashi and NAKAGAWA Hajime

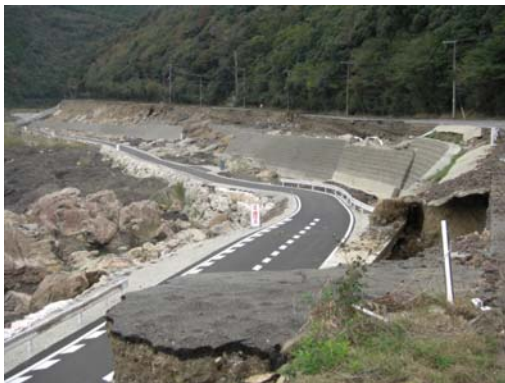
図 1 日高川における側岸侵食（日高川町高津尾）

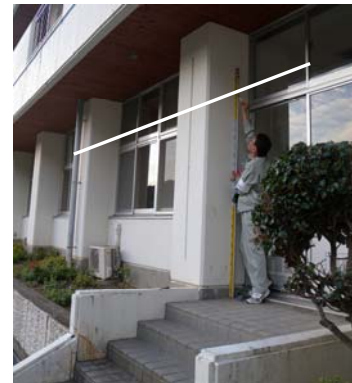
図 2 古座川における氾濫痕跡（古座川町明神）

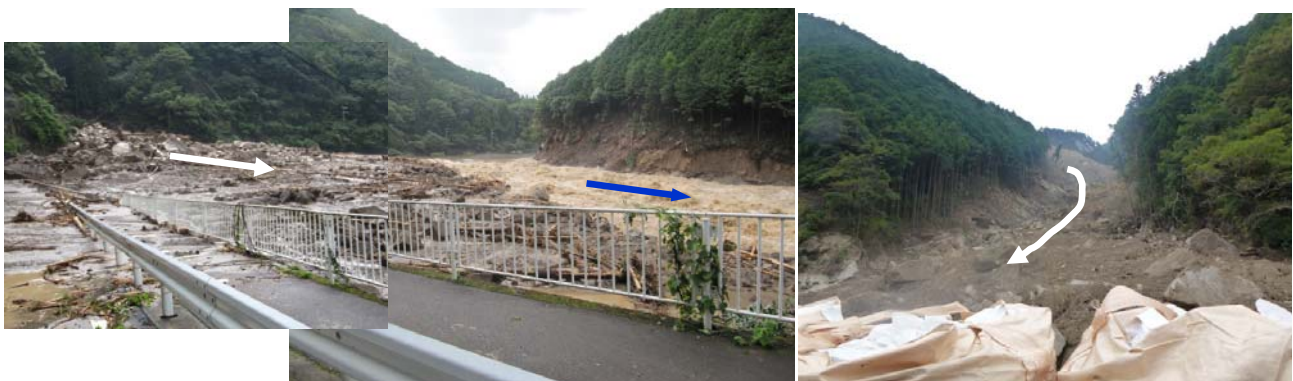
図 3 富田川における河道閉塞（田辺市中辺路，右写真は崩壊箇所）
