2013 年島根県江津市・浜田市における豪雨災害
Flood Disaster in Gotsu and Hamada Cities, Shimane Prefecture, in 2013

○武藤裕則・宇野宏司・原 諭

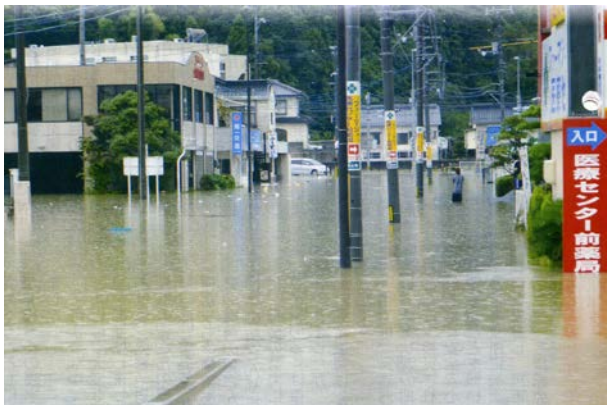
図 1 浜田市内の冠水状況 (広報はまだより)

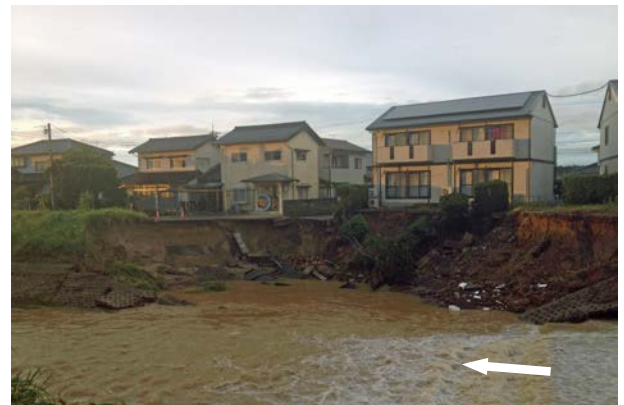
図 2 水尻川における側岸浸食 (江津市都野津町)

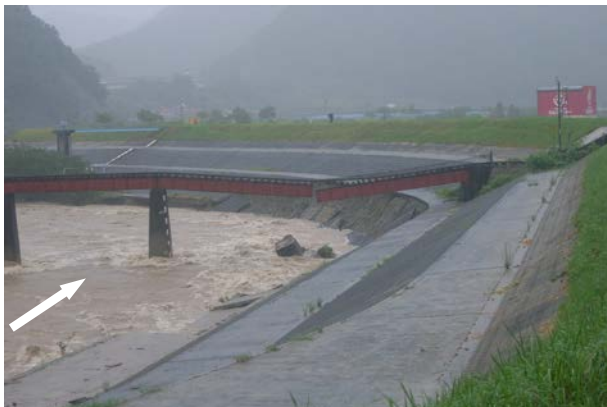
図 3 濁川における JR 橋脚の倒壊 (川本町因原)

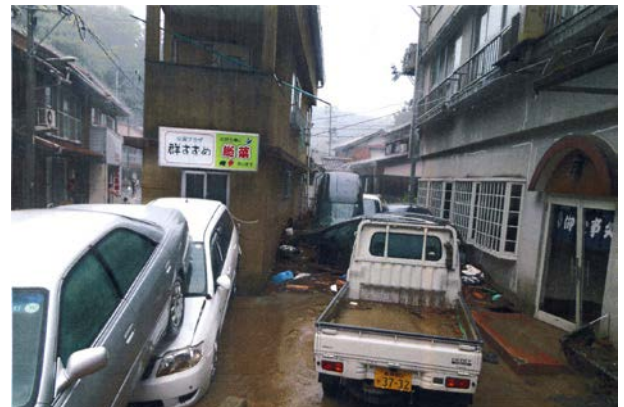
図 4 有福温泉町における氾濫被害状況 (江津市提供)
